Advanced Research in Conservation Science

Archaeometric Study and Restoration Implementation of Archaeological Roman Adobe Bath at Karanis – Fayoum, Egypt

Mahmoud Abd El Hafez M. Adam

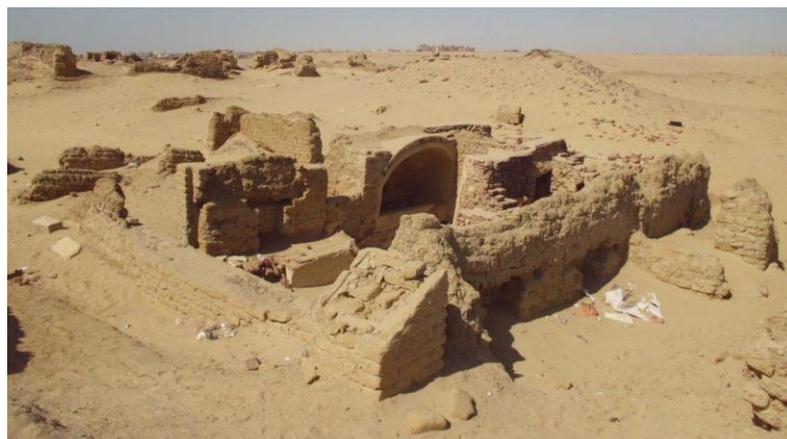
Fig. 2. General view of the Roman bath in Karanis.

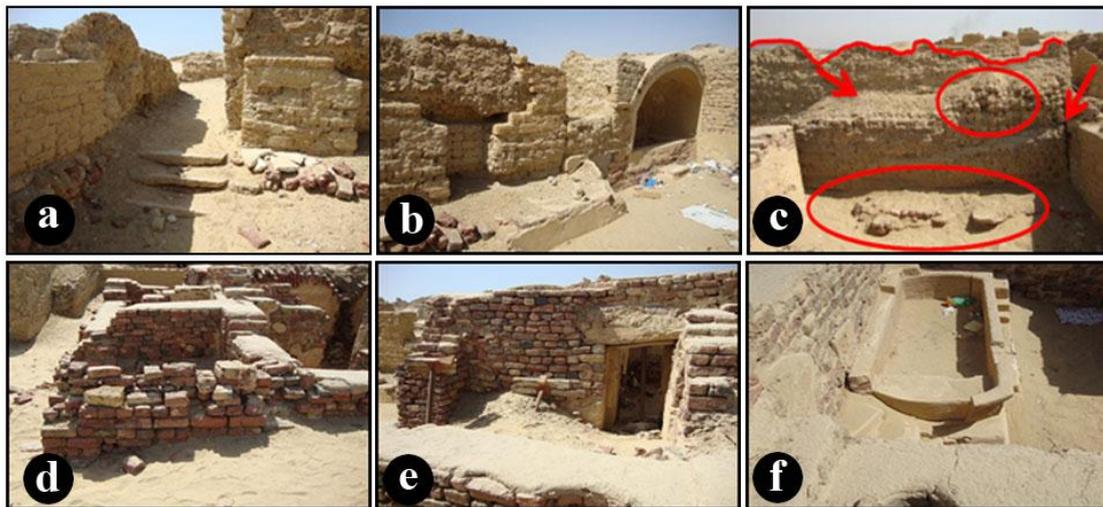
There were many deterioration manifestations of the Roman bath building, which are due to a lot of reasons, the most important reasons are: its location in harsh desert environment, and the neglect for long times without any intervention to restore and protect the site. These reasons led to many deterioration manifestations, such as (Fig. 5a– f):

Fig. 5. Some deterioration manifestations of the Roman bath (a) The main entrance of bath building was covered by sand and dust, dismantling of stairs and disintegration between fired brick blocks, (b) The main hall of bath building, it is clear the presence of garbage, decomposition and fall of mud plaster, loss of the wooden lintel for the niche, falling of mud brick courses from the upper parts of the wall, and a general weakness in the mud brick walls due to environmental factors, (c) The floor, terrace "Mastaba" and walls were covered with sand and mud fragments, the terrace was eroded, rain water and wind storms caused erosion of the walls, the upper courses of walls were totally eroded and crushed, (d) Disintegration and general weakness in the fired brick walls, (e) Covering the tepid room by sand due to wind storms, breaking in the stone lintel of the tepid room, threatening the fired brick building, there are temporary supports for walls. (f) Fractures and missing parts in the bathtub.

- Dismantling of stairs of the main entrance.
- Severe erosion and under-cutting of mud brick walls.
- Various cracks in the building walls.
- Disintegration, separation and falling of some fired brick blocks.
- Loss of binding mortar in the fired brick walls.
- Falling of mud and lime plasters.
- Breaking in the stone lintels.
- Fractures and missing parts in the bathtub.
- Decomposition of upper courses of bath walls.
- Deformation of the overall shape of the site [7], [9].

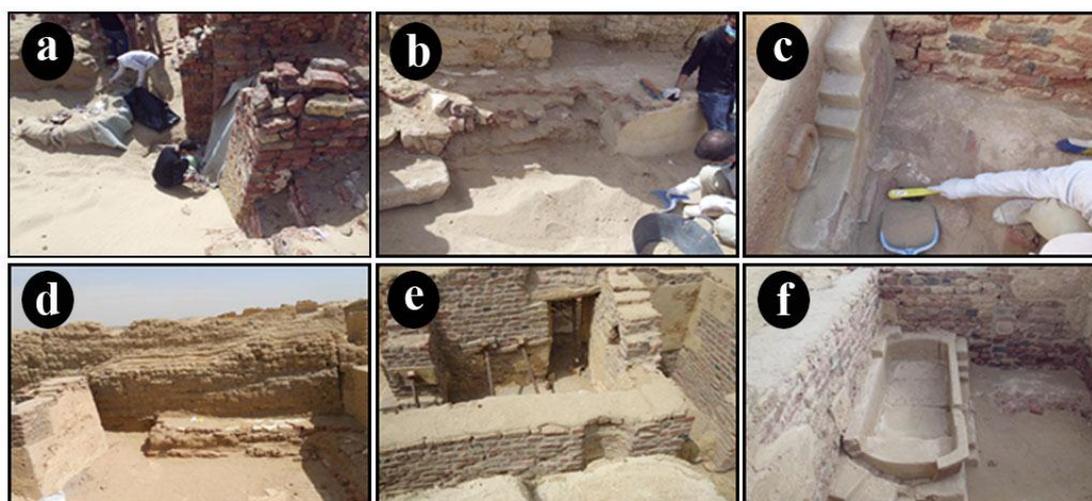
Fig. 11. Different parts of the bath building during and after carrying out cleaning works (a) Removal of garbage, (b, c) Removal of accumulated sand and fragments, (d, e, f) Different parts of the site after general cleaning.

The site was cleaned from the rubbish and waste, as shown in Fig. 10. Before any restoration works, the garbage was removed and the site was cleared of accumulated sand, dust, broken bricks and all residues in order to reveal the floors, foundations and the lower parts of walls and to facilitate movement to and from the bath building (Fig. 11 a–f).

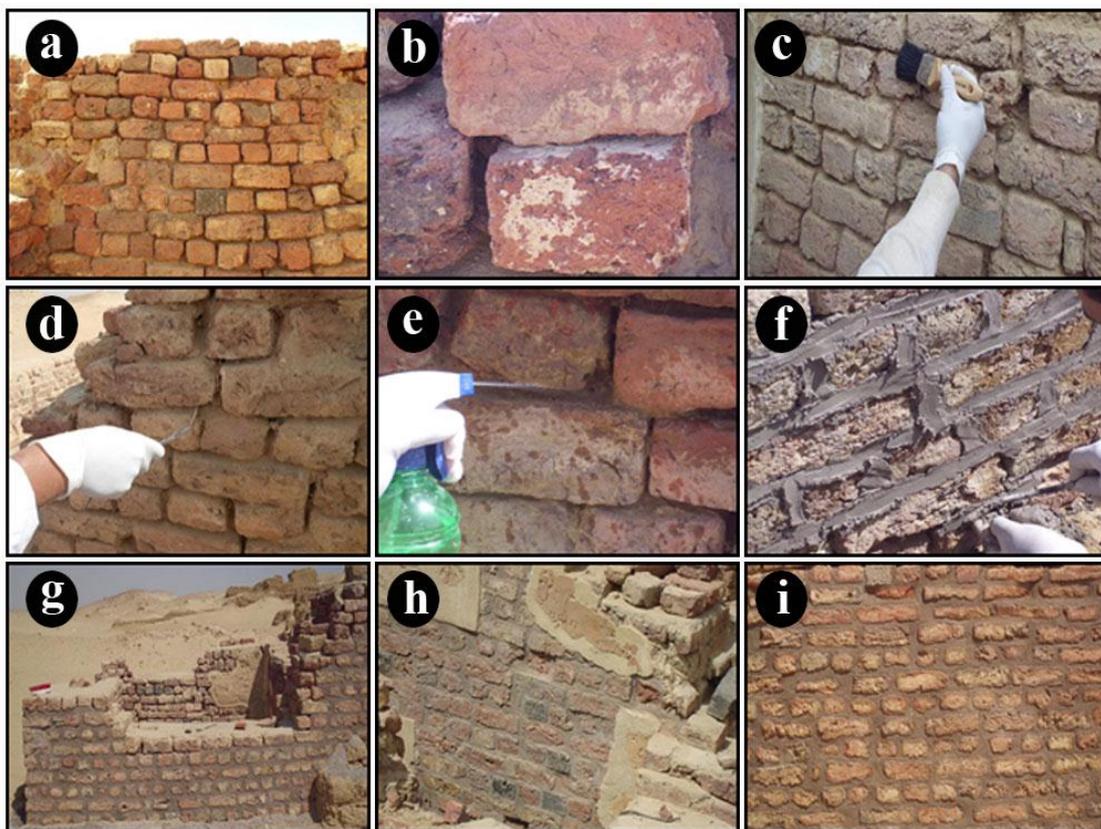
Fig. 12. Fired brick walls before, during and after restoration works and filling voids between brick blocks (a) Showing the gabs between fired bricks, (b) Detailed from the previous image, (c, d) Cleaning the walls mechanically and remove the decomposed mortar using coarse brushes, scalpel and metal sticks, and opening the gaps between brick blocks, (e) Wetting the spaces between brick blocks by fresh water, (f) Applying the modern filling mortar in the gaps, (g, h, i) The walls after finishing the filling process between brick blocks.

No.	Component material	Ratio (by weight)
1-	Crushed clay	1.5
2-	Salt-free sand	4
3-	Slaked lime	3
4-	Ash	0.2
5-	White cement	0.2
6-	Brick powder (Humra)	1.5
7-	Fresh water	To attain good mix consistency

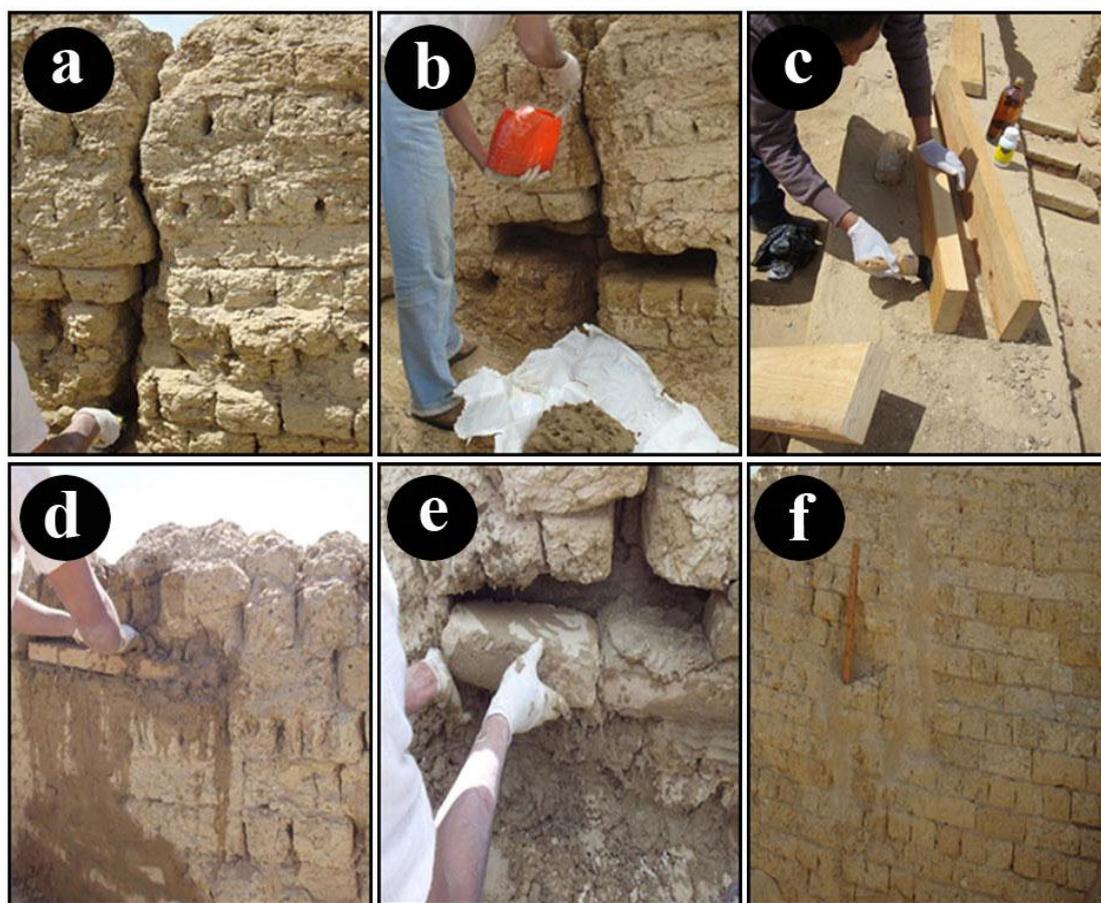
Due to negligence and lateral loads, some vertical cracks occurred in the walls causing serious structural damage. In order to treat the problem of cracked walls, and to maintain the continuity of the walls "*reconnection*", wooden beams were used to make a connection between both sides of the crack. The treatment process took place as follows; firstly, the cracks were cleaned accurately by brushes and air blower, then a rectangular hole was dug in the lower part of the cracked wall. After that the hole was cleaned mechanically and wetted with fresh water. The preparation process was concluded by putting a thick layer of mud mortar at the base of the hole and inserting the wooden beam in the core of the wall and putting another thick layer of mud mortar above the wooden beam so as to have "*the wooden beam sandwiched between the layers of mud mortar*". It was necessary to complete the missing parts of cracked wall with new mud bricks, and make wooden beams long enough (45 cm in both sides of the cracked wall). Additionally, it was necessary to treat the wood to protect it from attacking insects using Clorzane 48%

Fig. 13. Mud brick walls before, during and after treating the cracks (a) A cracked wall before treatment, (b) Making a rectangular hole in the wall perpendicular to the crack, (c) Treating the wood beams with the pesticide, (d, e) During reconnecting the cracked wall using wood beams with mud mortar and mud bricks, (f) The cracked wall after treatment.

EC which was applied on the wood by brush. The above-mentioned method of treating was repeated on the upper part of the cracked

wall [21], [22]. Fig. 13 shows the cracked walls and the steps of treatment and restoration.

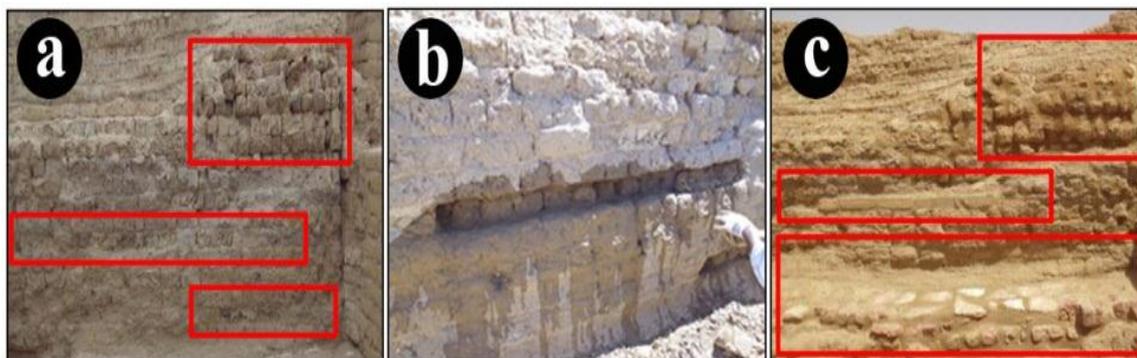
There were many missing parts in the mud brick walls due to atmospheric and biological weathering. These empty places in the walls resulted in a structural riskiness in the building, so the rubbish and fragments were removed and the spaces were opened using coarse and fine brushes, scalpels and metal sticks. After that, the missing areas were wetted by water, then filled with mud bricks and mud mortar (*this mortar has the same components of the modern mud brick as shown in Table 4*). Fig. 14 shows the missing parts in mud brick walls and the method of restoration and filling of the spaces.

Fig. 14. The method of restoration and filling the missing parts in mud brick buildings (a) Some disintegrated mud brick courses in the wall, need to be removed and rebuilt, (b) During rebuilding with modern mud bricks and mud mortar, (c) The wall after rebuilding.

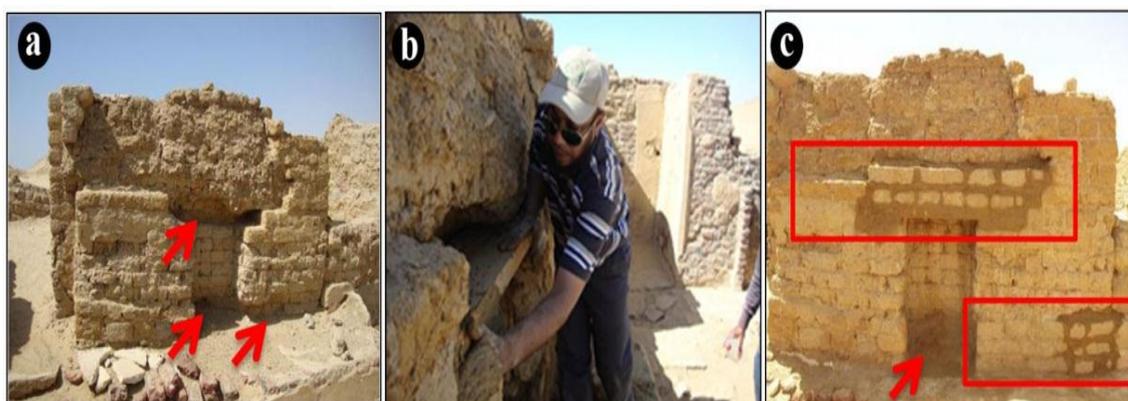
This niche lies in the inner part of the entrance wall of the bath building, and was built of mud brick. The niche was mostly probably a wooden or stone lintel, but this lintel is now missing. It was also eroded and mostly damaged. The restoration process of the niche relied on putting a new disinfected wooden lintel and reconstructing the missing, eroded parts, using mud bricks and mud mortar. Fig. 15 shows the restoration works of the mud niche. It is worth noting that this restoration procedure can be considered as an initial restoration, because the entrance wall will be subjected to subsequent restoration, which is capping and plastering "troweling" with mud mortar.

Fig. 15. Steps of the initial restoration of the niche (a) The niche wall before restoration, (b) During restoration and inserting the wooden lintel, (c) The niche wall after initial restoration.

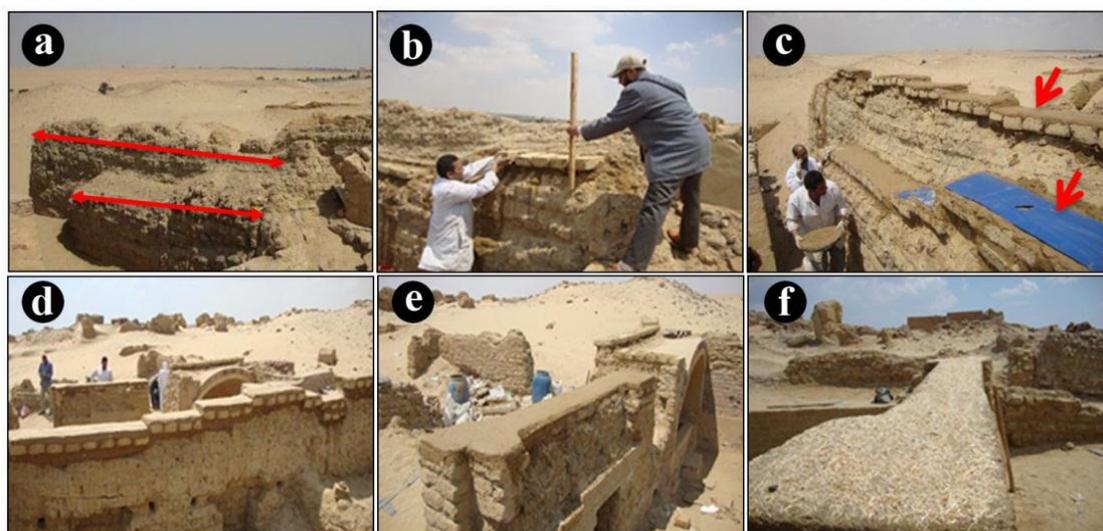
Fig. 16. Steps of reconstruction and capping of upper courses in adobe walls (a) Some adobe walls, the upper courses of which were completely destroyed by rain water and other atmospheric agents, (b, c) During reconstruction and capping using mud bricks, mud mortar and plastic sheets, (d, e, f) Some adobe walls after reconstruction and capping.

- Cleaning the upper parts of mud brick walls, mechanically by brushes, putty knife and air blower.
- Removing the remains of mud brick and mortar.
- Wetting the upper/missing parts by spraying with fresh water.
- Completing the missing parts in upper courses of mud brick walls using modern mud bricks and mortar.

- Putting a thick layer of mud mortar on the upper course of the wall, this layer should fill all gaps.
- Spreading plastic sheets "Kartunal" on the above-mentioned layer of mud mortar [23].
- Putting a thick layer; 3-4 mm. approximately of modified mortar (its components are shown in Table 6 on the plastic "Kartunal" sheet.

It is worth noting that the plastic sheets and modified mortar make a protective layer to the upper parts of the adobe walls. Moreover, the plastic sheets will serve as an indicator when the upper mortar is damaged by the effect of rain water and sun rays, where the mud mortar layer is constantly renewed to ensure that the ancient walls are protected from damage [24]. Fig. 16 shows the steps of reconstruction and capping of upper courses.

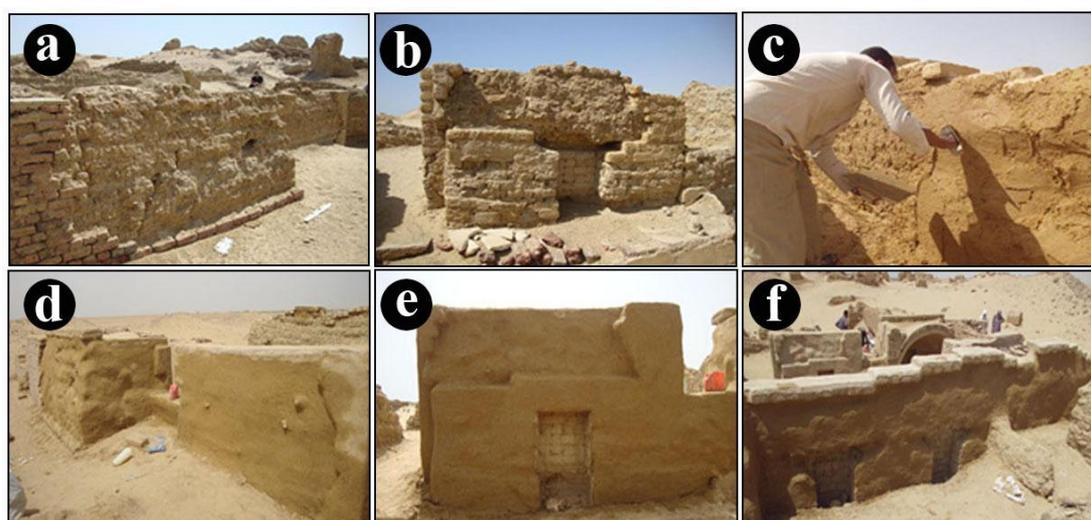
Fig. 17. The technique of troweling with mud plaster (a, b) Some mud brick walls before plastering, (c) During plastering "troweling", (d, e, f) Some mud brick walls after troweling with mud plaster.

No.	Component material	Ratio (by weight)
1-	Crushed clay	1
2-	Salt-free sand	5
3-	Slaked lime	2.5
4-	Chopped straw	4
5-	Fresh water	sufficient quantity
