Failure Analysis of Welded Steam Boiler Flange

Abstract

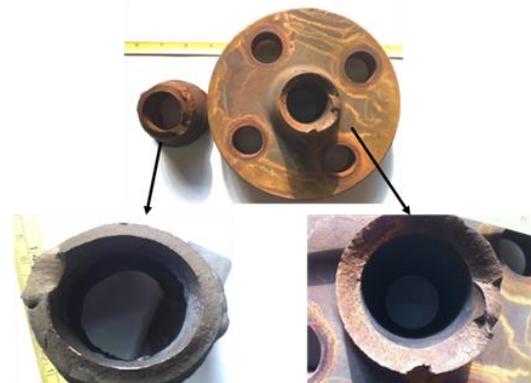
Figure 1 shows a general view of the flange and connected pipe that failed. The fracture surface was free from corrosion products and/or deposits. Figure 2 displays detailed views of the fracture initiation zone in the failed pipe. Figure 2 shows the initial fracture zone in the final filling weld layer region on the flange side, specifically at the weld toe.

Fig. 1 Fracture surface off the flange and connected pipe (as received).

The fatigue region of the fracture surface appeared smooth, while the remaining area corresponding to the final and rapid fracture exhibited the typical features of a brittle fracture, with minimal or no evidence of plastic deformation. No cracks were observed near the ruptured areas, and there was no damage or loss of thickness (8mm) in the flange wall.

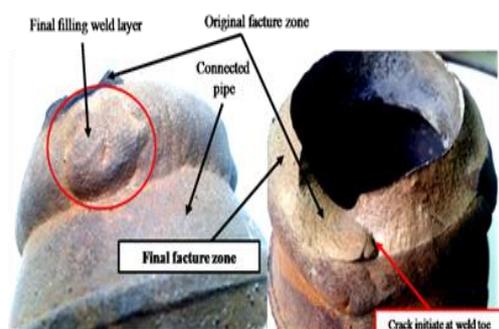
Fig. 2 Enlarged view of fractured connected pipe showing fracture initiation zone.

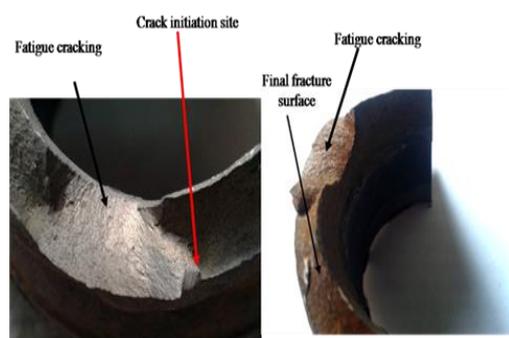
The reinforcement area (final filling weld pass) seems slightly thicker than the remaining weld metal. The detailed characteristics of the damaged part of the flange are illustrated in Fig. 3, displaying the fracture initiation area, fatigue fracture (beach mark zone), and final fracture surface. As shown in Fig. 3, the original fracture surfaces at low magnification and beach marks

were noticed, indicating that the fractures were caused by fatigue and had initiated and propagated through this mechanism [27-31].

Fig. 3 Close-up views of the fractured section of the flange depicting the fracture initiation zone, the fatigue fracture or beach zone, and the final fracture surface.

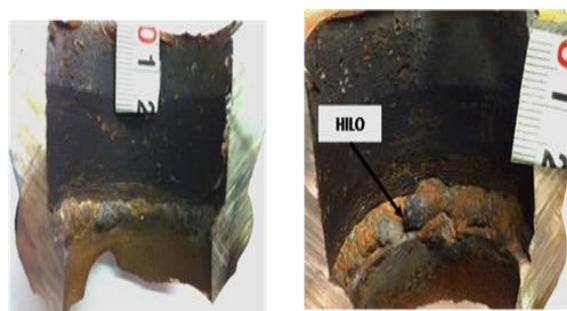
Figure 4 shows the inner surface of the cross-section of the axially welded joint between the flange and the connected pipe. It revealed a non-acceptable High side while the other side is low (HI-LO) by almost (4mm) on the inner surface of the weld joint. Such types of imperfection may disrupt the movement of fluids such as water or steam, resulting in mechanical stress on the welded area. However, examining the flange and linked

Fig. 4 Mismatch fitting of Hi-Lo at the internal surface of the weld connecting steel to flange

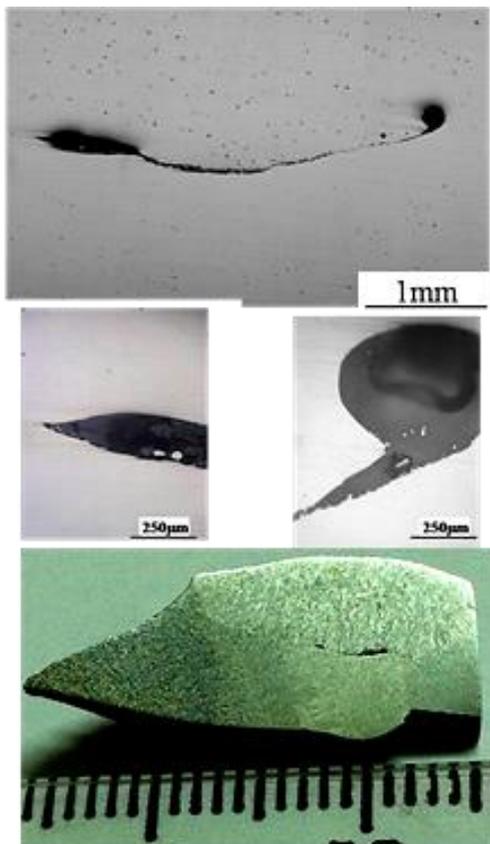
Figure 5 shows the macrostructures of the weld joint's as-polished and etched cross-section near where the fatigue fracture originated (i.e., the final filling weld layer). As shown, revealed several welding defects, including porosity, slag inclusion, and lack of fusion at the boundary line between the initial and final weld passes. These findings provide evidence of the substandard quality of the weld joint. The corresponding microstructures of the specimens can be shown in Figs 6 and 7.

Fig. 5 Macrostructure of the welding cross-section reveals internal flows at the boundary line between inter-passes. (as-polish and etched)

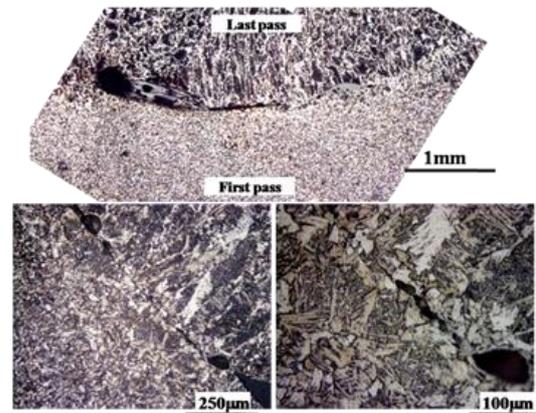
Fig. 6 Microstructures of the cross-section of the weld metal showing several internal defects.

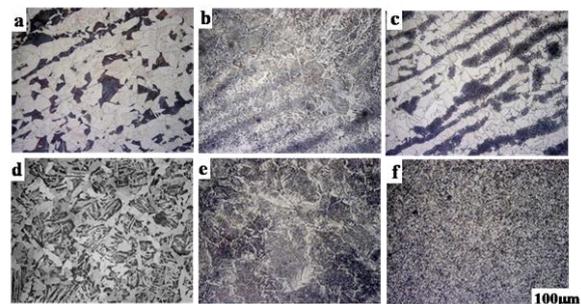
The microstructure of the flange material (ASTM A105 alloy) base metal (BM) reveals ferrite-lamellar pearlite, which can be seen in Figure 7a. No signs of

overheating were observed, such as creep indications or noticeable plastic deformation leading up to the fracture. The heat-affected zones (HAZ) have microstructures that include pearlite-upper bainite and tempered ferrite-pearlite, depicted in Figs. 7b and 7c, correspondingly.

The microstructure of the base metal of the connected pipe shows an acicular ferrite-pearlite structure, as shown in Figure 7d. Figure 7e shows the microstructure of the final layer's weld metal (WM), which contains acicular ferrite, side plate ferrite, and

grain boundary ferrite. The initial layer, known as the root pass, has annealed ferrite-pearlite structures, as seen in Figure 7f. The grain size of the heat-affected zone (HAZ) is coarser near the fusion line and gradually becomes finer as it moves further away from it.

Fig. 7 Microstructures of different areas of weld joint showing: (a). flange (BM), (b), (c) HAZ of the weld joint, (d) BM of welded pipe, (e) final pass (cap pass), and (f) root pass of the weld.

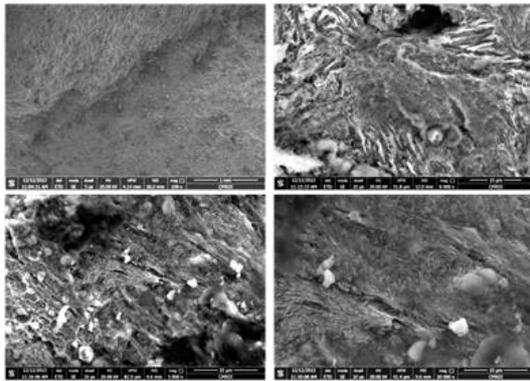
The fracture surface was investigated using a Scanning Electron Microscope (SEM) showed the presence of striation marks, which indicated that the fractures had resulted from fatigue and had progressed over time, as depicted in Fig. 8. An Energy Dispersive Spectroscopy (EDS) analysis equipped with the SEM is used to examine the original fatigue fracture surface, as shown in Fig. 9. The analysis results indicated that harmful elements, such as Cl, S, Ca, K & Na, were absent.

Fig. 8 Scanning electron microscope (SEM) images of the original crack initiation zone showing fatigue striations.

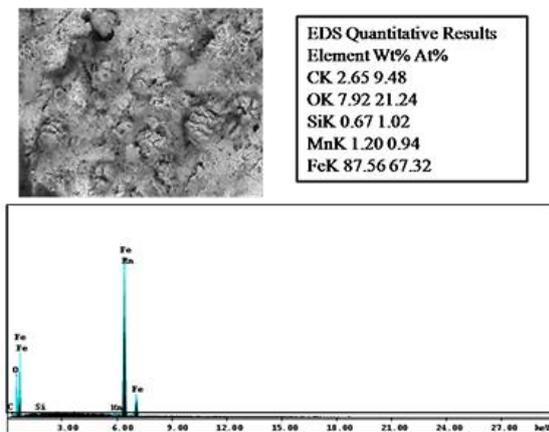
Fig. 9 Results EDS analysis of SEM and at the original fracture surface.
