Evaluation of the reliability and durability of some chemical treatments proposed for consolidation of so called-marble decoration used in 19th century cemetery (Hosh Al Basha), Cairo, Egypt.

Abstract

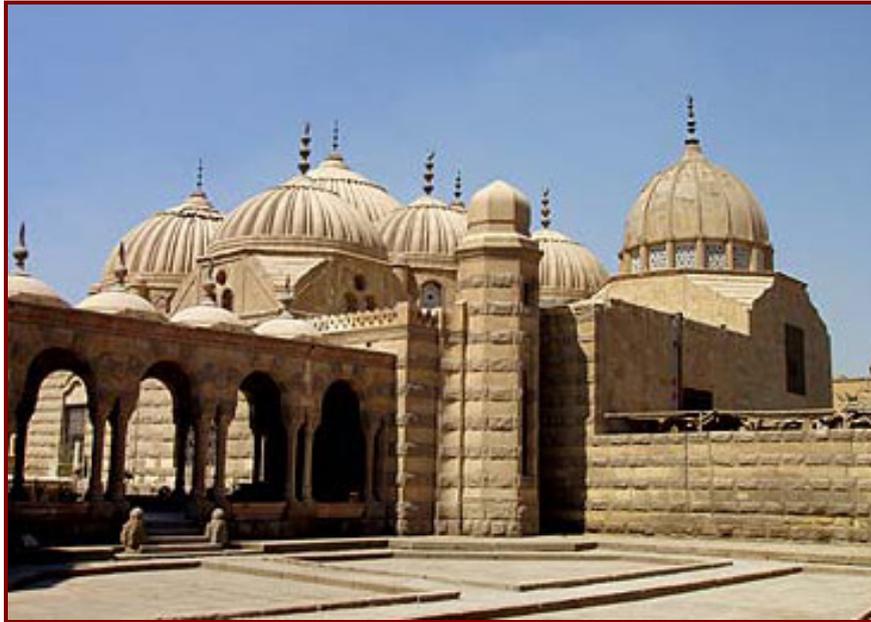
Fig. 1 shows the tomb complex of Hosh Al Basha courtyard in Al-Imam Al-Shafei

Hosh al Basha is an Arabic name meaning, 'courtyard of the Pasha', which was given to the Royal family graveyards and more specifically, the descendents of Mohammed Ali's family. The graveyards were built on a rectangular area located behind the tomb of Al-Imam al-Shafei dating back to the 12th century, south of Cairo Citadel. The graveyard is dating back to 1815 but it was reported that Mohammed Ali bought this courtyard in 1805⁶⁻⁷. At first he built a simple graveyard consists of two domes that was completed later to be six-domed complex [Fig.1]. The tomb complex was built for burial his family members and his distinguished statesmen. The interiors of the main central chambers were richly decorated with

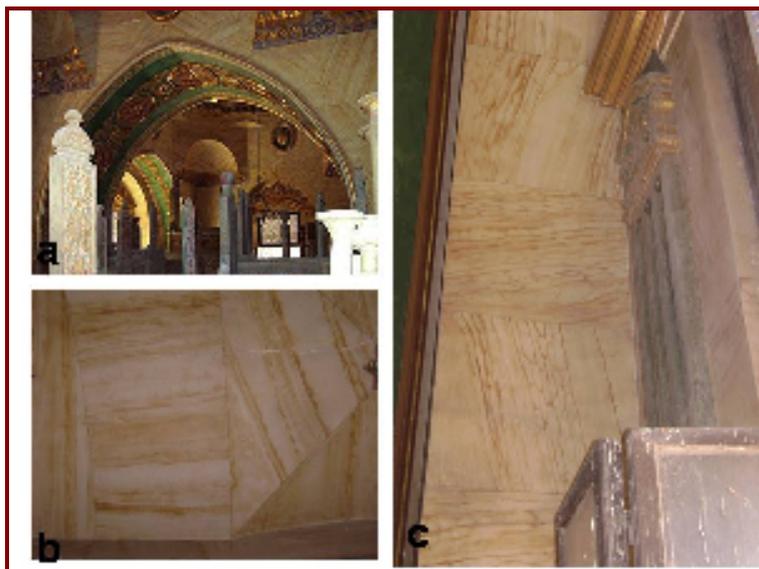
Fig. 2 shows the interiors of the main central chambers decorated with imitated marble occupied the upper parts of walls and ceilings

inscriptions, precious marbles and amazingly detailed colorful paintings. The veined yellow imitated marble stucco is occupied the upper parts of walls and ceilings [Fig. 2a, b, c]. Various deterioration phenomena can be seen within the imitated marble stucco. Cracks in different depths and forms are distributive all over the stucco but they appeared obviously in the lower part of the stucco (about 2 meters high from the ground). Large areas of stucco layer are very fragile and they are completely detached from the background lime stone wall [Fig.3a, b, c]. Powdering of the superficial layer of the stucco and exfoliation of the veined yellow layer from the priming and ground layer is association the previous deterioration phenomena.

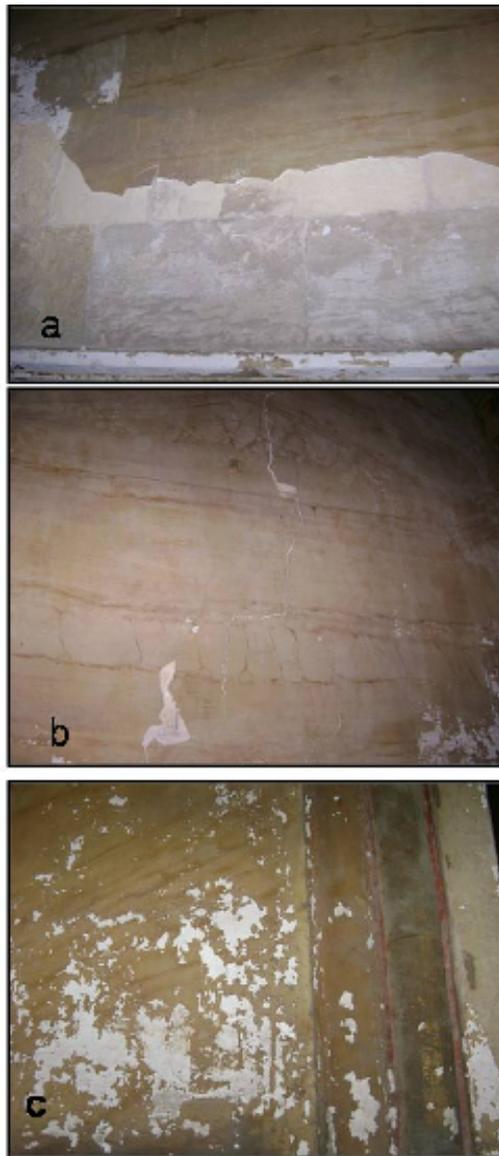
Fig. 3 shows the deterioration phenomena of the imitated marble, (a) shows the missing parts, (b) the arrow points to the crack and (c) shows the exfoliation of the veined layers

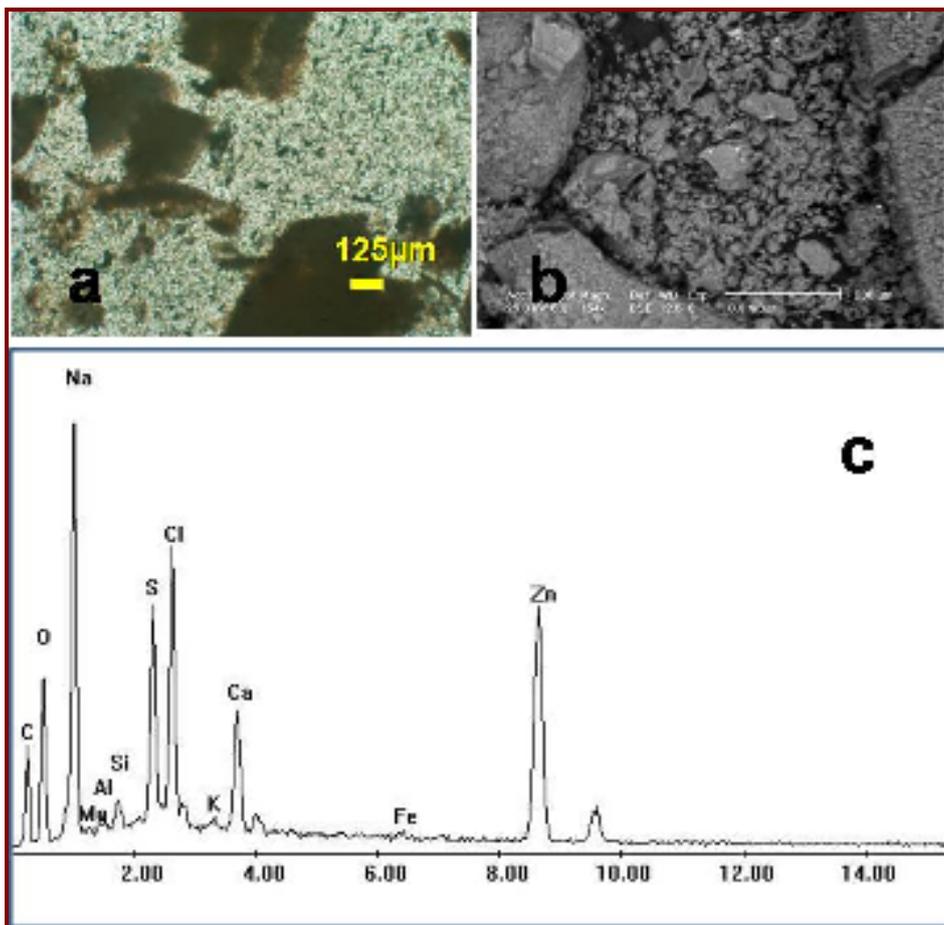
Fig. 4: (a) Photomicrograph of crushed yellow pigments in the yellow veined paint. 20X, (b) SEM image of yellow and brown grains, (c) EDX spot analysis from image (b).

The examination of the thin section of the crushed yellow paint under polarizing light microscope (PLM) displayed the aggregates of opaque brown and yellow particles (Fig.4a) No more physical and optical characteristics were observed most probably due to the well grinding of the used pigments.

The SEM was used both on the paint layer and on the individual yellow and brown pigment particles (grains) that were separated from the prime layer and mounted on a carbon stub. The SEM exhibited disintegrated cracked surface of the paint layer (Fig.4b). The total EDX analysis of the yellow veined layer showed that zinc (Zn), carbon (C) and sodium (Na) are the dominant elements; their values are 20%, 30% and 16% respectively. The value of zinc rise to 36% in some areas that contain brown veins. Small amount of sulfur (S), calcium (Ca) and chlorine (Cl) were recorded. EDX spot measurements were also taken of individual pigment particles of yellow and brown paint (Fig.4c) The gathered data showed that (Zn) is the dominant element besides (C) and (O). Some grains consisting mainly of sulfur (S) and calcium (Ca) representing gypsum were also observed.

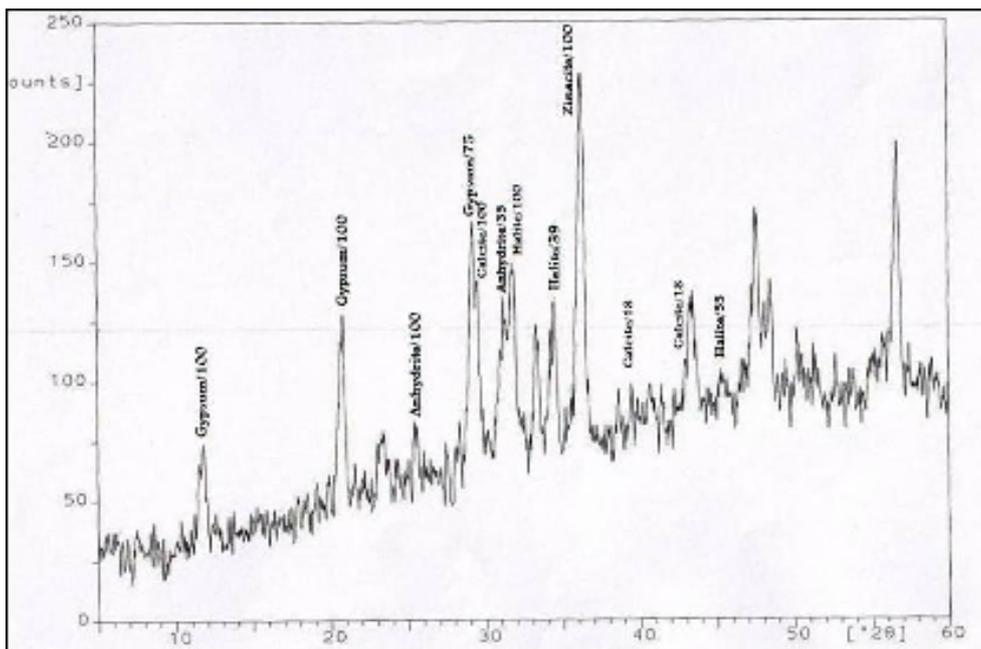
Fig. 5 the XRD patterns of the yellow veined layer

brown color showed that the major mineral is zincite (ZnO) (Fig.5). Gypsum ($\text{CaSO}_4 \cdot 2\text{H}_2\text{O}$), halite (NaCl) and calcite (CaCO_3) are the following minerals in percentage. Anhydrite (CaSO_4) is the minor mineral in this layer. The XRD analysis of the subsurface layer (back ground layer) indicated that the major minerals are gypsum ($\text{CaSO}_4 \cdot 2\text{H}_2\text{O}$). Small amount of zincite (ZnO), anhydrite (CaSO_4) and halite (NaCl) were also detected (fig.6).

The mineralogical compositions of the studied samples showed that the used stucco consists of two main layers. The outer finishing layer, yellow paint veined with brown color, composed mainly of zincite (ZnO). It is called red, orange and yellow zinc oxide mineral that was mined and crushed to produce various color of zinc paints during 1830 to 1850 in Europe and America. Welsh¹¹ reported that The New Jersey Zinc Company not only mined the ore but also manufactured the zinc oxide pigment and the paints at their plant in Newark starting in the late 1840s. In addition, they experimented with manufacturing paints made with the crushed ore, franklinite and zincite, and they successfully marketed them in a variety of colors including orange, stone-color, light brown, brown, dark brown, black, and delicate blue. The historical information about the manufacture of zinc paints indicate that the imitated marble stucco was probably added to the courtyard later after its first construction from 1805 to 1816. Many architectural extensions were added to Hosh Al Basha courtyard during his rule and his successors' rules.

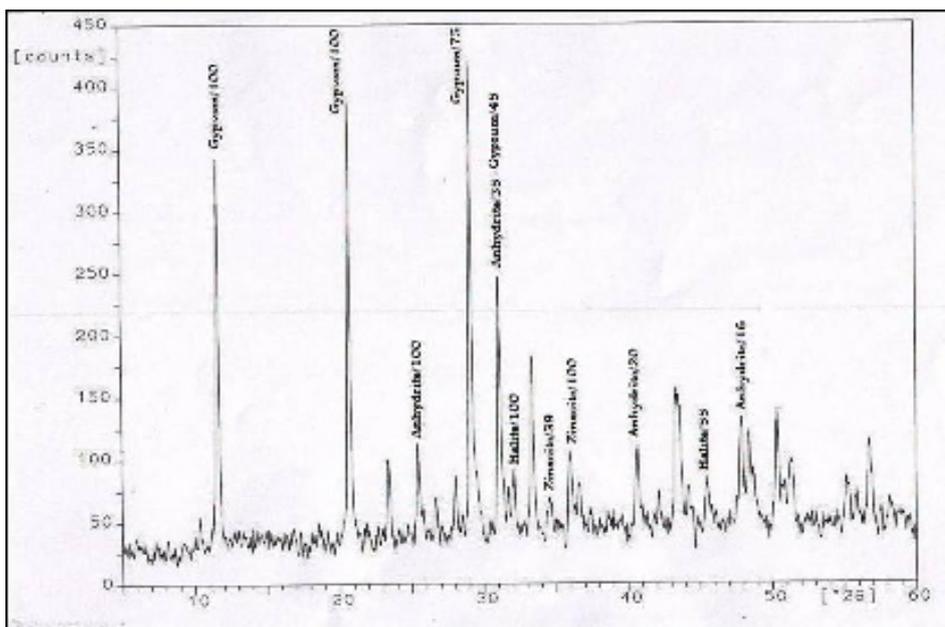
Fig. 6 the XRD patterns of the subsurface layer

The mineral composition of the subsurface layer indicates that gypsum was used as background layer. The anhydrite detected in both layers could be primarily present in the initial material with gypsum or a byproduct of gypsum dehydration. Transformation

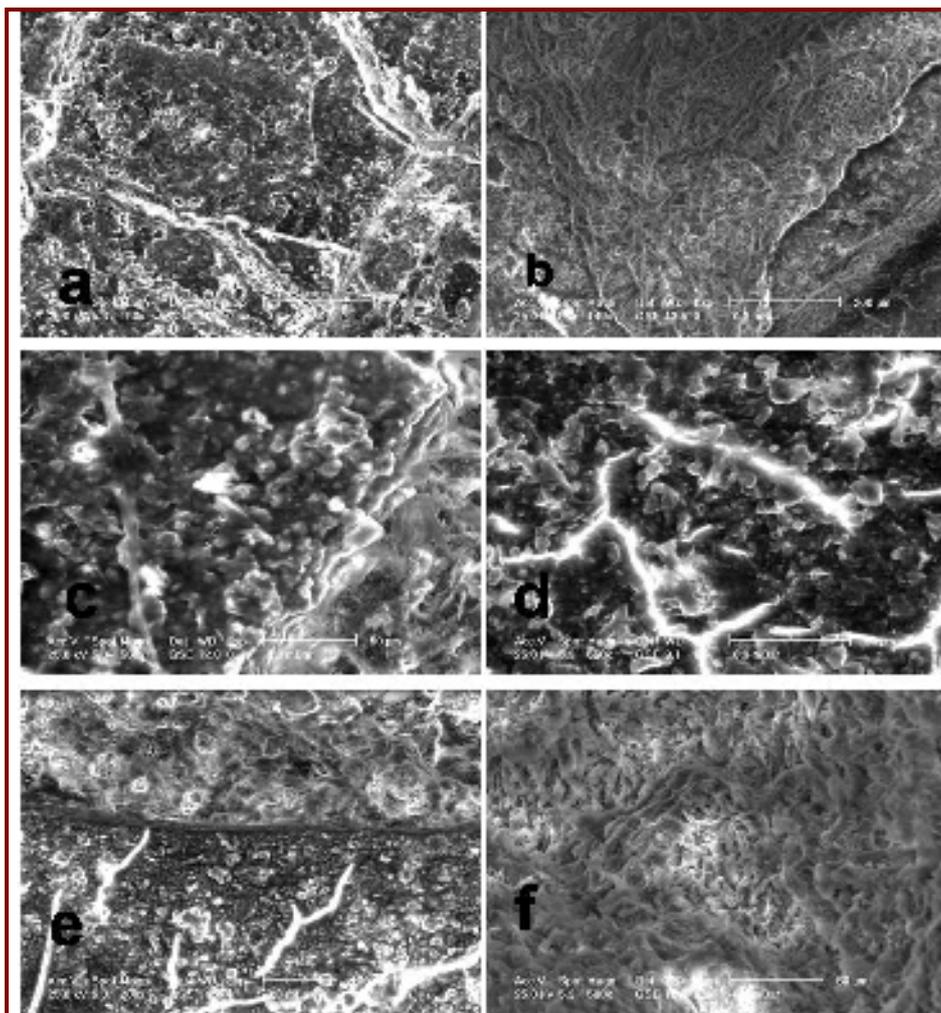
Fig.7 (a) and (c) show the SEM image of the sample treated with Paraloid B 72 before aging under different magnification, (b) and (d) show the SEM image of the sample treated with SILRES® BS OH 100 before aging. Images (e) and (f) show the SEM image of the samples treated with Paraloid B 72 and SILRES® BS OH 100 respectively.

Visual observations indicated that the consolidation treatment changed the color of the samples. When the surfaces of the samples were moistened with consolidant, they darkened, but after drying, the darkness of the surfaces decreased. The SEM examination of the treated samples with both products were performed to study the type of coating, film-forming capacity, adherence to material, continuity of treatments, or cracking. The SEM examination of the samples treated with Paraloid B-72 show that the consolidant filled most of the pores and obscured many of particles (Fig. 7 a, c). No visible cracks are seen in the film coating. The SEM examination of the samples treated with SILRES® BS OH 100 showed a homogeneous coating of the particles more than the coating with Paraloid B-72(Fig.7 b, d). This may be due to the fact that the

chemicals structure of SILRES® BS OH 100 can construct longer chains that lie on the surface of the particles and coating them. After aging no significant changes were observed in the consolidants film which indicate that microstructure of both products are stable under the effect of the artificial thermal aging (fig.7 e, f).

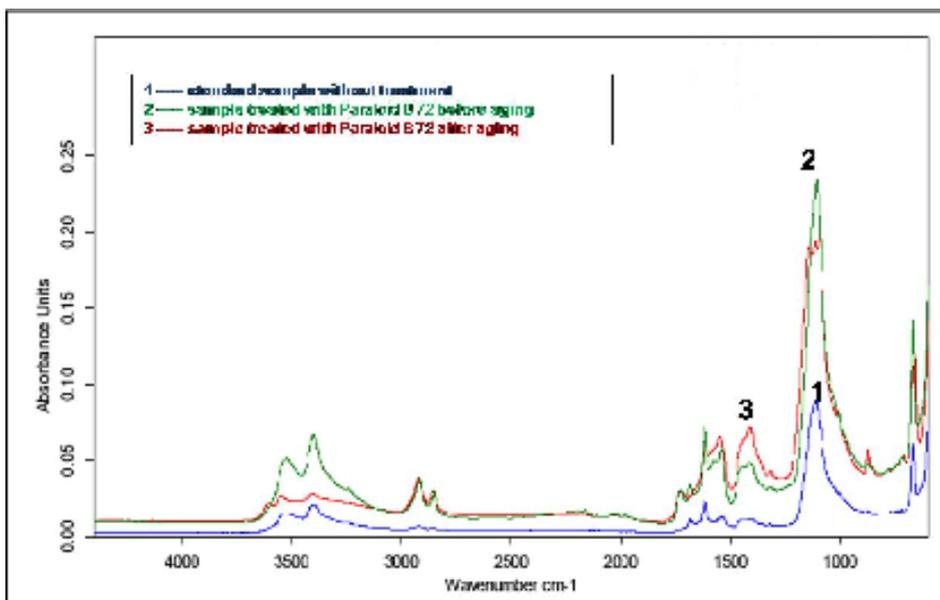
Fig. 8 shows the FTIR- ATR spectra of the sample untreated (1), treated with Paraloid B72 before aging (2) and after aging (3)

The infrared spectra of the sample treated with Paraloid B72 before and after aging show small change of the chemical structure (Fig. 8) and (table 2). The change happened at the main absorption

peak $3000 \sim 3600 \text{ cm}^{-1}$ corresponding to OH group. No remarkable

changes at the 1727 cm^{-1} (corresponding to C =O bond), at 2917 cm^{-1} (corresponding to CH_3), and 2849 cm^{-1} (corresponding to CH_2) were recorded, suggesting the stability of these bonds under the thermal aging. The disappear of the C = C unsaturated bonds, evidenced by the absorption at around 1682 cm^{-1} , is a consequence of the polymerization of the unsaturated bonds under the thermal aging. The intensity increase of the absorption peaks at 1540 cm^{-1} , 1414 cm^{-1} and 1318 cm^{-1} (corresponding to C-H and C-O-C bonds) is most probably a consequence of the polymerization increasing resulting of the condensation under the thermal aging. The modification and decreasing observed at the $1000 - 1200 \text{ cm}^{-1}$ area is most probably due to the chain-scission of Si - O - C and Si - O - Si bonds. In general, the Paraloid B72 showed good stability towards the thermal aging because of the absence of new cross-linking (new compound)¹⁷.

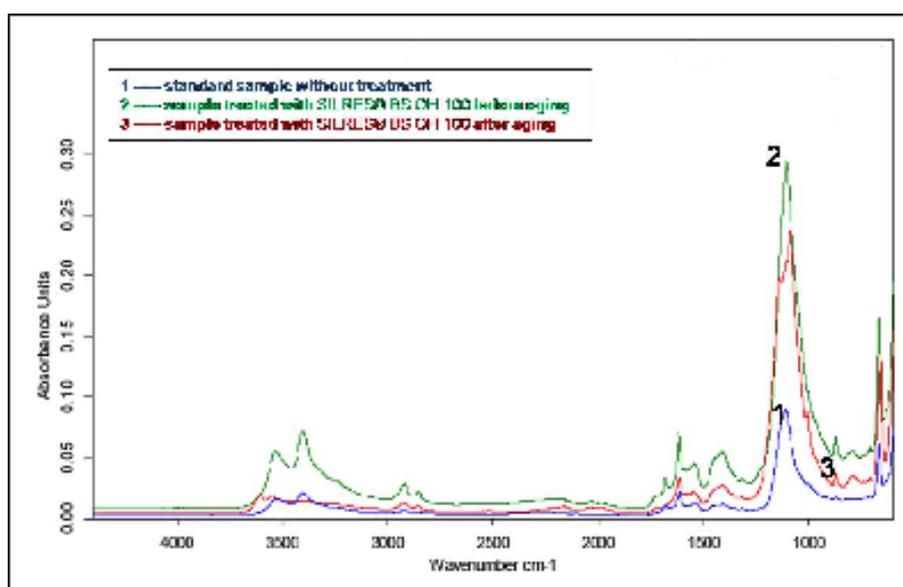
Fig. 9 shows the FTIR- ATR spectra of the sample untreated (1), treated with SILRES® BS OH 100 before aging (2) and after thermal aging (3)

The FTIR spectra of the sample treated with SILRES® BS OH 100 show significant changes in all major signals which all decrease in their intensity (Fig.9) (table2). Considering the attribution of the typical absorption bands and their variation during degradation it appears that the major chemical groups CH₃ (2921cm⁻¹), CH₂ (2851 cm⁻¹), Si – CH₃ (874 cm⁻¹and 797 cm⁻¹) and Si – O – Si, Si – O – C, Si – CH₃ (1000 – 1200 cm⁻¹) are affected by the thermal degradation. As a consequence, one can conclude that the environmental stability of SILRES® BS OH 100 is somewhat lower as compared to this of Paraloid B72.
