6th International Conference
On Civil & Architecture
Engineering

GUIDELINES FOR MAINTENANCE OF AIRPORT PAVEMENTS

CASE STUDY: ASWAN INTERNATIONAL AIRPORT

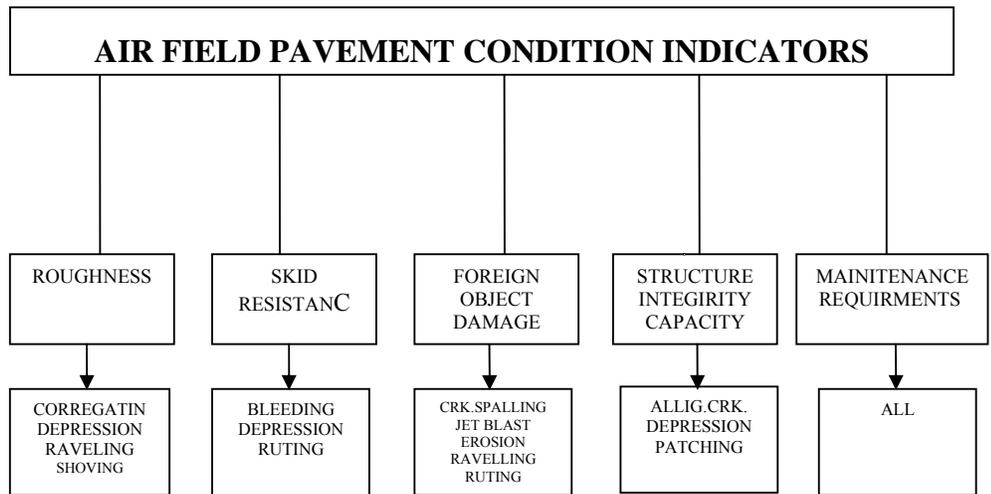
Figure (1): Relation between Pavement Condition Indicators and Distress Types for Asphalt Airfield Pavement [2].

Aviation communities introduced new generations of aircraft having different weights, and performance. Like these generations raise the demand of developing a decision support system to keep all airfields in good conditions by evaluating airfield pavements for purpose of maintenance. The first step in determining the maintenance and rehabilitation (M&R) of pavements is an accurate and comprehensive evaluation of their existing condition. The condition of an airfield pavement can be evaluated in terms of factors called condition indicators. Comprehensive pavement condition evaluation requires the measurement of these condition indicators which include operational surface indicators as roughness, skid resistance and potential for foreign object damage (FOD). Structural indicators like structural integrity and load carrying capacity can be also used as condition indicators. Figure (1) presents the major pavement condition indicators for airfield pavements. The figure also shows how the various distresses types in asphalt pavements relate to the various pavement condition indicators [1].

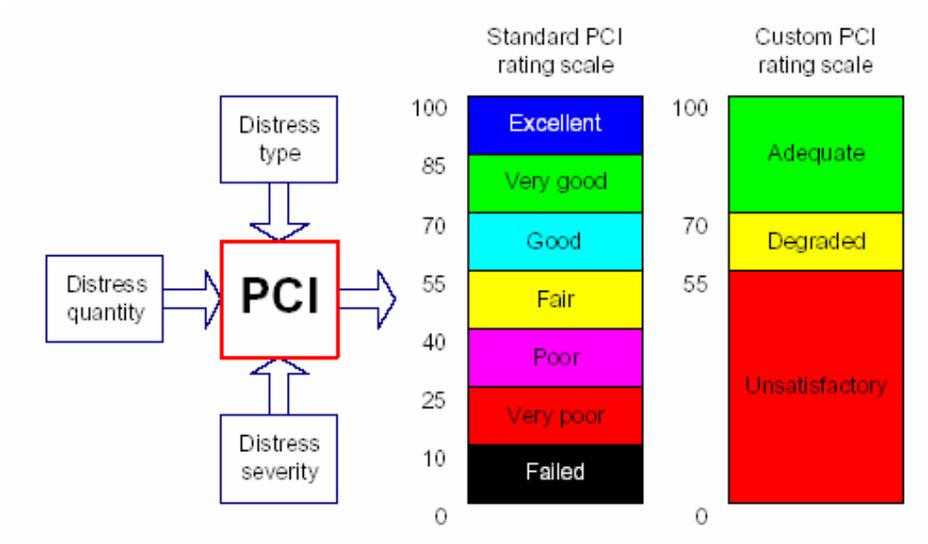
Figure (2): Pavement Condition Index Numerical Value versus Condition Rating [16].

estimated density and severity of each distress type from which the PCI can be determined. The PCI is a numerical indicator based on a scale of 0 to 100 and is determined by measuring pavement surface distress that reflects the surface condition of the pavement. Pavement condition ratings (from excellent to failed) are assigned to different levels of numerical PCI values. These ratings and their respective PCI value definitions are shown in Figure (2). The distress types, distress severities, methods of survey, and PCI calculations are described in references [5,6]. Structural Condition Index (SCI), also known as PCI_{STR} , is the PCI obtained from considering only those distresses caused by structural deficiencies [7]. Because the PCI includes deducts due to non-structural deficiencies, it is difficult to judge the required overlay thickness based on a low PCI alone. In fact if most deficiencies are non-structural, the minimum recommended overlay thickness of 2 inches is typically adequate. The minimum acceptable value for the SCI is 35 [7], while Navy and Army have used a minimum SCI value of 50 [8, 9]. A Foreign Object Damage (FOD) Index can be determined using the PCI survey data which is one of the primary factors for determining the serviceability of a pavement area. The FOD Index is determined from the PCI calculated by considering only the distresses/severity levels capable of producing FOD the FOD Index = $(100 - PCIFOD)$. Figure (3) show the FOD Potential Rating Scale. The distresses cause the FOD includes Alligator Cracking, Block Cracking, Jet Blast Erosion, Joint Reflection Cracking, Longitudinal and Transverse Cracking, Oil Spillage, Patching, Raveling and Weathering, Shoving, and Slippage Cracking [10].

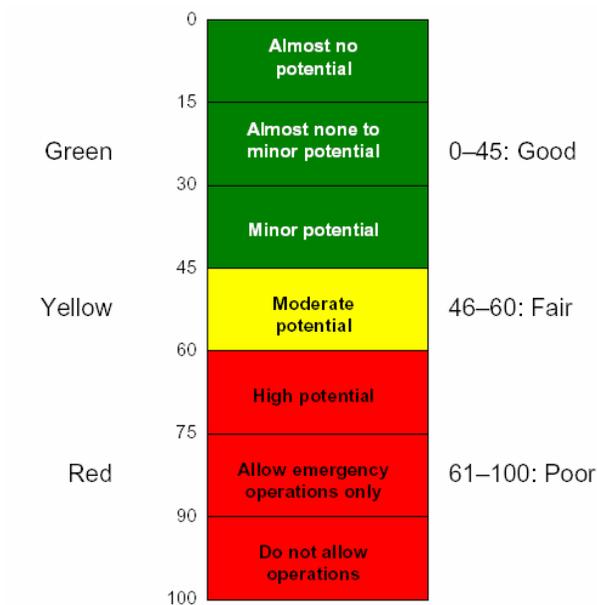
Figure (3): FOD Potential Rating Scale.

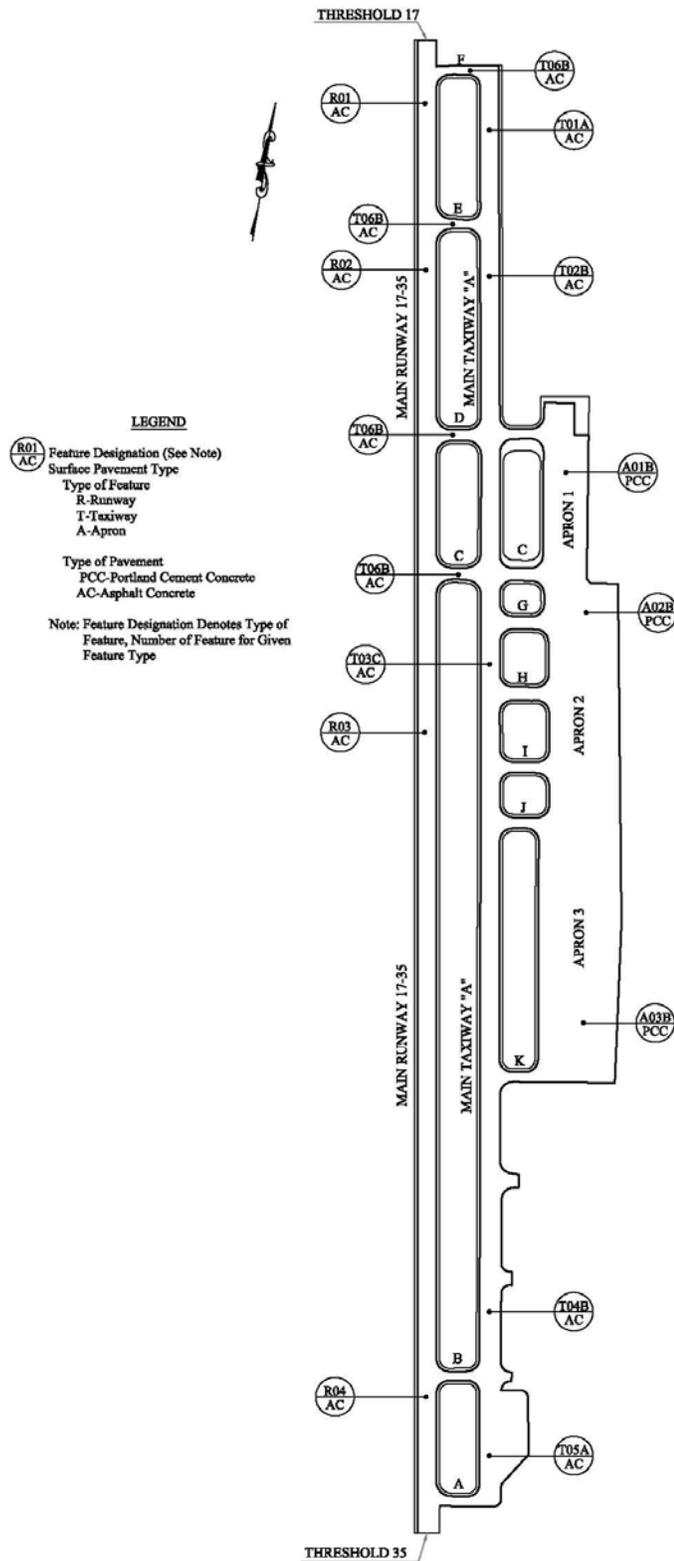
This section presents the feature identification of Aswan International Airport, as shown in Figure (4), as a case study to perform the visual inspection of pavement condition. According to the normal traffic types using the airfield and pavement type and construction, the main runway can be divided into 4 features paved using Polymer Modified Asphalt Concrete Pavement (PMA) as follows:

Figure (4): Feature Identification for Aswan Airfield Pavements.

- Feature R01: This section starts from distance 0 to 200 m measured from the 17 Threshold. A total of 1 sample was inspected to represent the condition of this feature. The major distress types found in this feature are depression, longitudinal and transverse cracking, raveling and weathering.

- Feature R02: This section starts from distance 200 to 600 m. A total of 3 samples were inspected to represent the condition of this feature. The major distress types observed in this feature are longitudinal and transverse cracking, depression, and block cracking.

- Feature R03: This section starts from distance 600 to 2800 m (runway interior). A total of 5 samples were inspected to represent the condition of this feature. The major distress types affecting this feature are longitudinal and transverse cracking, depression, and block cracking.

- Feature R04: This section starts from distance 2800 to 3402 m (35 touchdown zone). A total of 2 samples were inspected to represent the condition of this feature. The major distress types found in this feature are longitudinal and transverse cracking and depression.

According to the normal traffic types using the airfield and pavement type and construction, the taxiways could be divided into 6 features paved using Asphalt Concrete Pavement (AC) as follows:

- Features T01A-T05A: Includes the whole length of the parallel taxiway “A”. This taxiway is temporarily used as a runway. A total of 11 samples were inspected to represent the condition of all this features. The major distress types affecting this feature are longitudinal and transverse cracking, raveling and weathering, and block cracking.
- Feature T06B: Includes all connecting taxiways “C-F”. A total of 4 samples were inspected to represent the condition of this feature. The major distress types affecting this feature are depression, polished aggregate, raveling and weathering, bleeding, and longitudinal and transverse cracking.

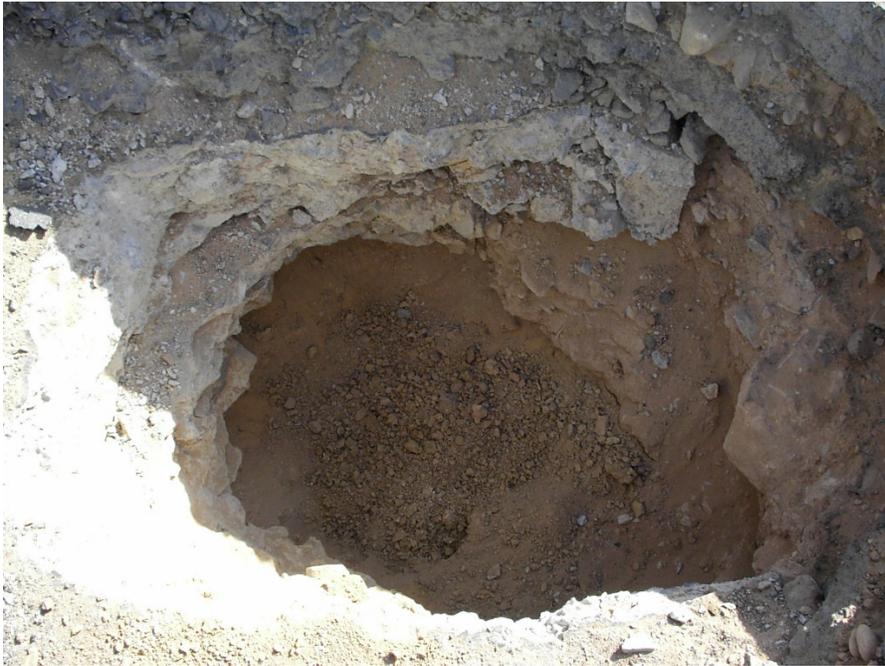
For the main runway, major rehabilitation work of this runway was carried out in 2004 the work consisting of milling the top 10 cm of the old pavement and adding AC layers with 13.5 cm total thickness. Figure (5) presents an open pit shows the different structural layers of main runway. These layers are 7cm macadam layer (bituminous gravel), old asphalt layers, old concrete pavement (tow layer), and prepared subgrade with $\text{CBR} \geq 20\%$. On the other hand, for main taxiway, major rehabilitation work was carried out in 2000. The work consisting of milling the top 5 cm of the old pavement and adding AC layers with 12 cm total thickness. Figure (6) presents an open pit shows the different structural layers of the main taxiway which consists of 5 cm HMA surface course, 7 cm macadam layer, old Asphalt layers, old Concrete pavement, prepared subgrade with $\text{CBR} \geq 20\%$.

Figure (5): Pavement Layers for Main Runway 17-35 of Aswan Airport.

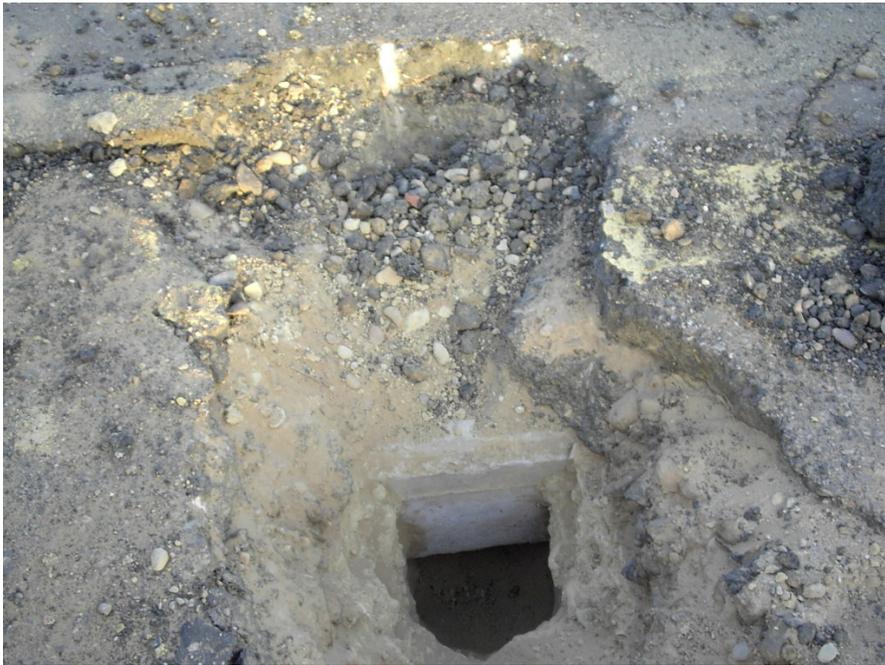
Figure (6): Pavement Layers for Main Taxiway of Aswan Airport.

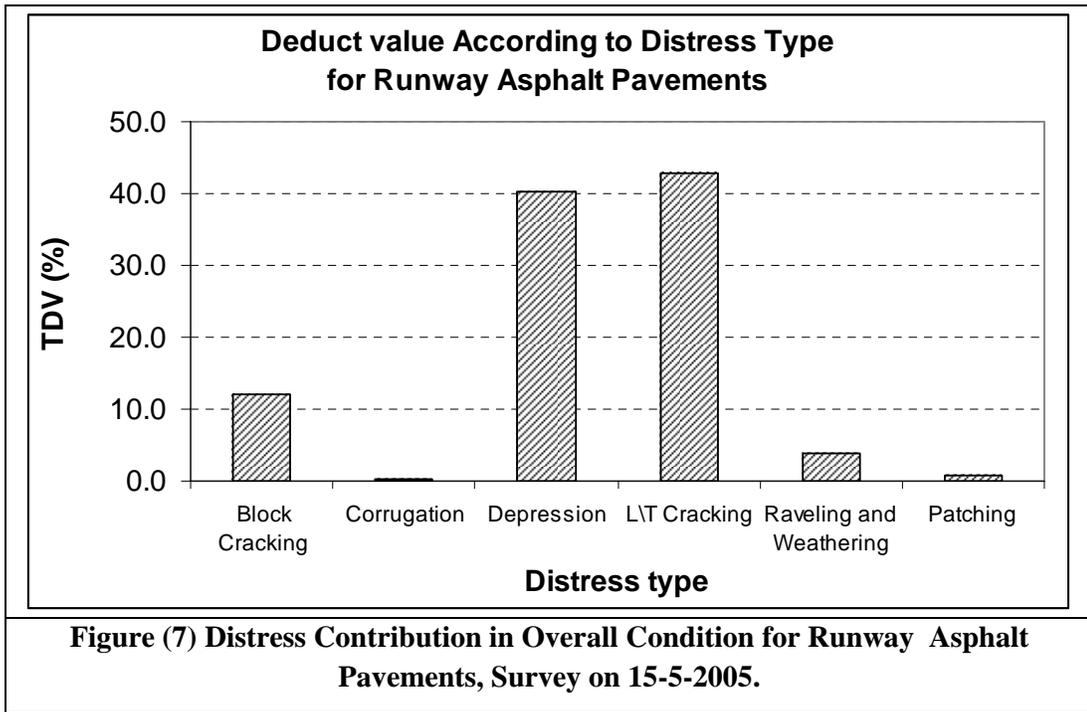
- Feature R01: from Figure (7) the higher deduct point is 61.34% and 18.55% for depression and longitudinal and transverse cracking respectively so, the depression is the most serious distress appears in this feature, main cause of these distresses is “others”.

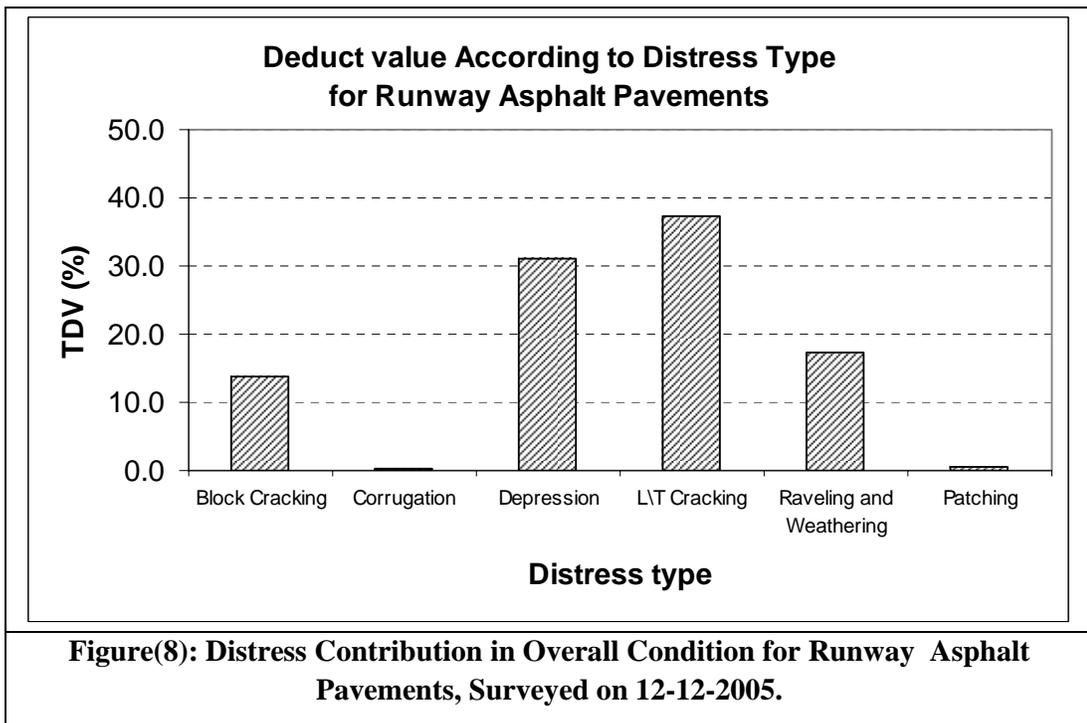
- Feature R01: from Figure (8) the higher deduct point is 42.49% and 27.78% for depression and longitudinal and transverse cracking respectively so, the depression is still the most serious distress appears in this feature, Main cause of these distresses is “Climatic/Durability”.

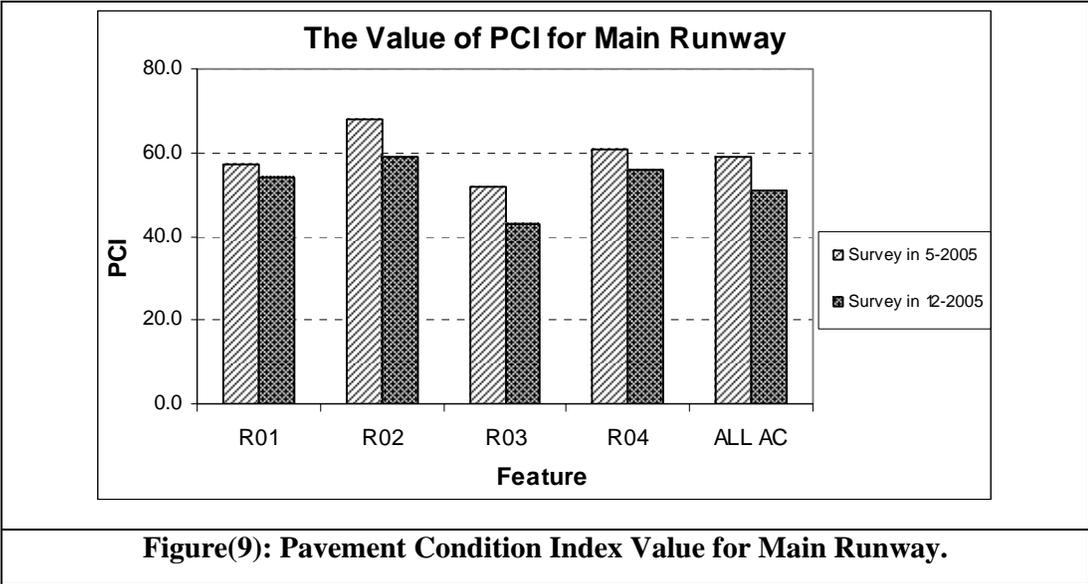
For the whole Runway: the average PCI of the whole area dropped from 59% in May 2005 to 51% in December 2005 see Figure (9) the most influence distresses are caused by “Climatic/Durability” and “construction materials” had almost the same share in the contribution in the causes of the observed distresses. In December 2005 “climatic/durability” had a share of almost 70% indicating a rapid drop in condition due to the environmental effects on the pavement surface during the same period, the FOD index increased from 26 to 36 indicating a rapid increase in the potential of foreign object damage to aircrafts using this runway if opened to air traffic (overall condition rating changed from “almost none to minor FOD potential” to “minor FOD potential” within 6 months) as shown in Figure (10). Also from Figure (11) we see that there is no change in the values of SCI it means that most of the increased distresses is related to weathering. Figure (12) show summary of distress distribution by quantity for all features.

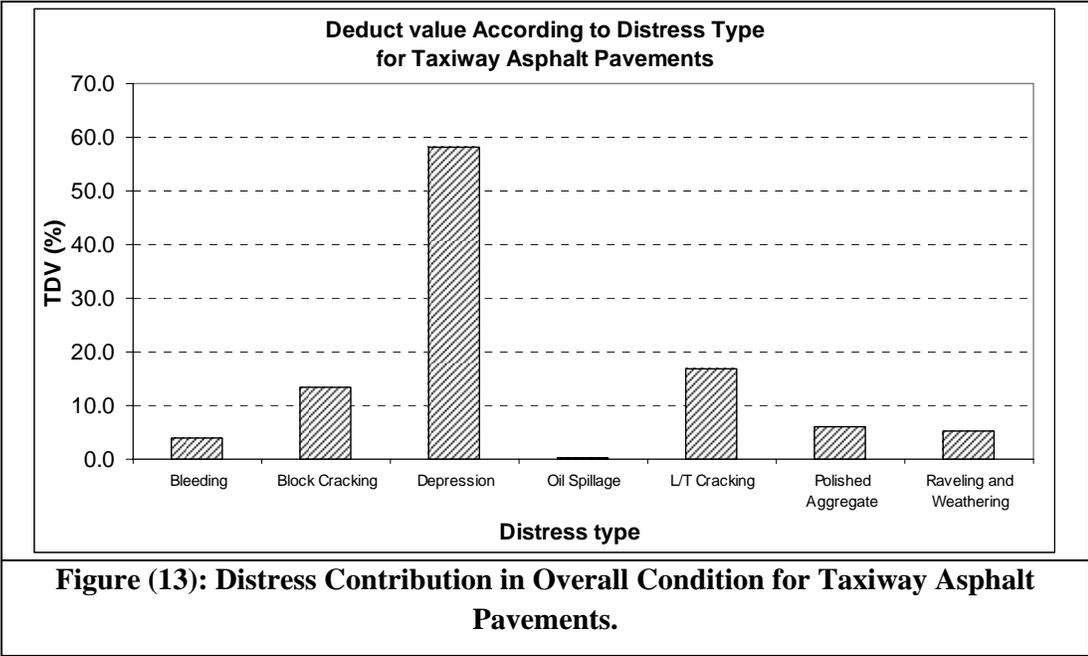
The Survey was conducted once on taxiways in May 2005. The results of this survey are also presented in Tables (1-3). The tables show that, the dominant distresses on Feature T01A are depression, and polished aggregate. Main cause of these distresses is “others”. For Feature T02B the dominant distress is depression. Main cause of these distresses is “others”. For Feature T03C, Feature T04B, Feature T05A, and Feature T06B, the dominant distresses are (depression, and longitudinal and transverse cracking), (block cracking, and depression), (depression, block cracking and longitudinal and transverse cracking), and (depression), respectively. The main causes of these distresses are climatic/durability for the first three features and other for the last feature as shown in Figure (13).
