## A Proposal to Rehabilitate Ouda Pasha Archaeological Agency in Historic Cairo Based on the Building's Data and the Needs of its Surrounding Urban

Ouda Pasha Agency (in Arabic: *Wikala*) is considered as one of the few remaining Ottoman agencies in Cairo. It has archaeological and architectural values. However, it did not receive enough attention for its protection and preservation despite the rehabilitation works on archaeological buildings in its urban. The Agency suffers from collapse of some of its parts as a result of lack of archaeological awareness, neglect and improper use which threatens the disappearance of its

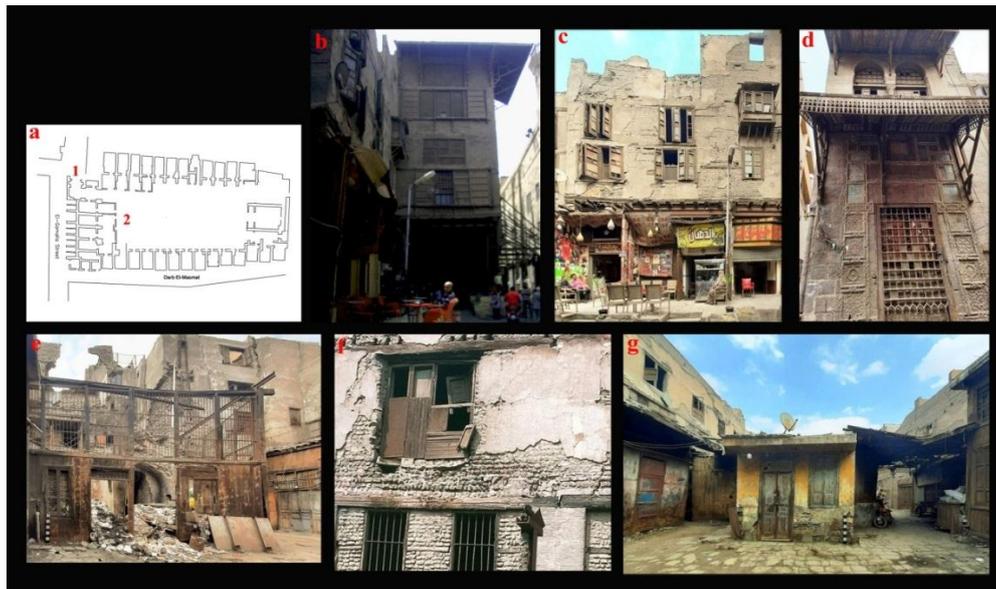
**Fig. 1.** (a) Plan showing the location of the documented spaces, (b) Main elevation Facade, (c) Residential Quarter Facade, (d) Sabil Facade, From point 2 (e) The palace on the western side of the agency, (f) Structural and architectural problems in the residential quarter located in the southern and eastern side, (g) The place of the small mosque.

The first palace was at the top of the entrance block on the western side. It consisted of five rooms, a bathroom and a kitchen, overlooking the courtyard. The second palace was above the first, and it consisted of two *iwans*, a *durqua'a* and two side spaces. The architecture did not neglect the work of three skylights to provide light and ventilation for the living units on those two sides [5], [1] (Figs. 1, 2).

This is in addition to some other deterioration phenomena, such as: a. the fall of layers of mortar, b. the appearance of moisture and salt on the surface of the walls, worn out stone floors, c. deterioration of the doors and *mashrabiya*s, the fall of most of the layers of internal and external paint layers, d. the accumulation of dust and waste in large quantities inside and around the agency, e. random electrical connections, f. Improper crafts such as carpenters and metal works, g. the presence of rust and corrosion of the metals used to cover the window openings. This is in addition to the high street level, which led to the extinction of a large part of the main entrance (Figs. 1, 2).

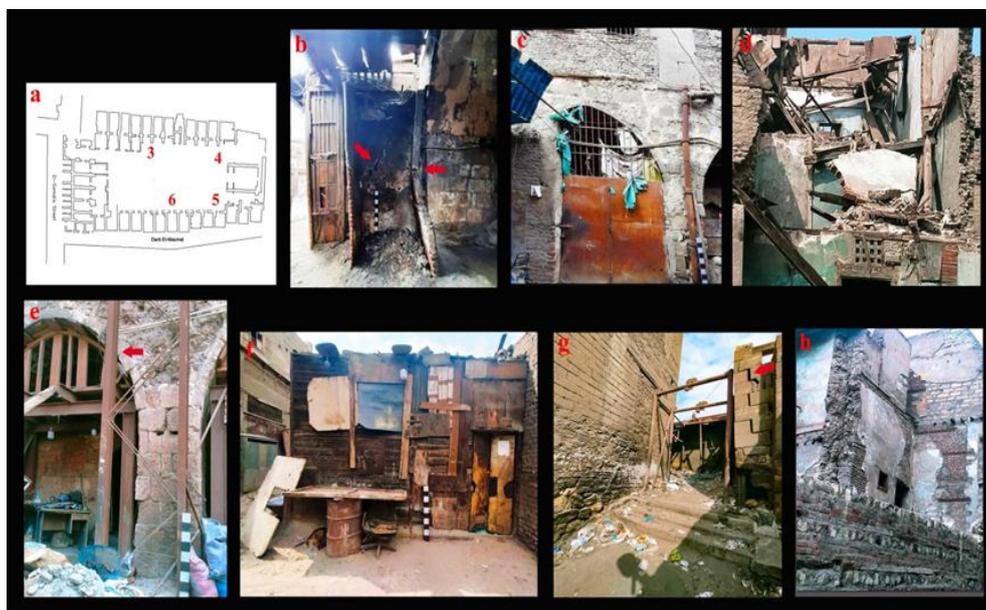
**Fig. 2.** (a) Plan showing the location of the documented spaces, (b) Point 3. shows tendencies, cracks and separation in the wall of one of the entrances, (c) Point 4. internal spaces used as workshops, (d) Point 4. illustrates the serious structural and architectural problems, (e) Point 5. support and reinforcement using metal beams, (f) Point 6. some workshop was improperly added to the courtyard, (g) Back facade showing steel shores and cracks that follow the mortar direction, (h) The back facade shows structural and architectural damage.

The agency suffers from structural and architectural deterioration phenomena as a result of the lack of conservation works and the lack of continuous monitoring and follow-up [6]. These phenomena are represented in: a. the demolition of many of its parts in the lower and upper floors, leaving only the northern and western facades, b. the appearance of vertical and inclined cracks in the remaining parts of the building, c. the separation of most of the architectural blocks, d. all internal stairs on the upper floors are completely demolished, e. The deterioration, collapse and fall of wooden ceilings as a result of fire more than once, f. the slope of the lintel above the entrance, g. using steel reinforcement of most parts of the agency from the main facade, the interior parts and most of the buildings of the ground floor for a long time without follow-up or evaluation of its effectiveness, the construction of modern buildings in the courtyard disproportionate to the value of the building and used inappropriately.

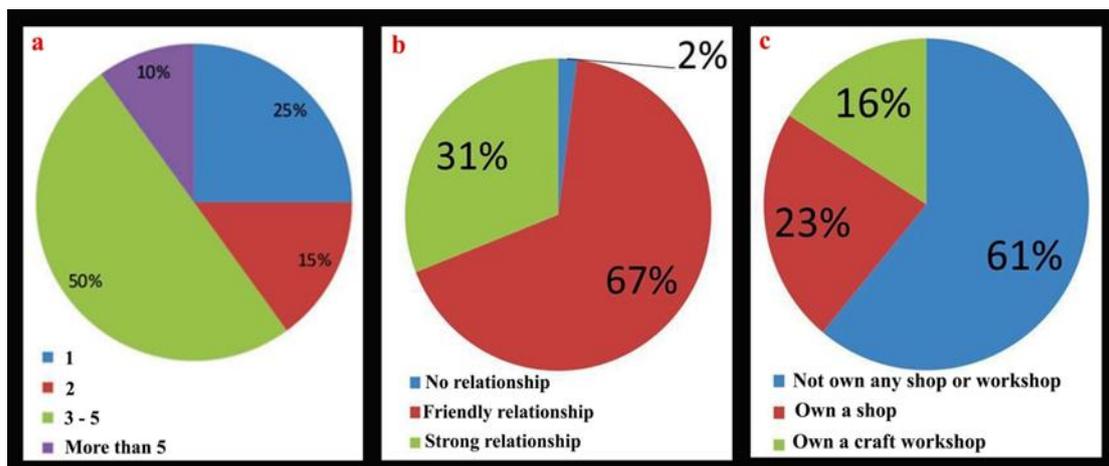
Fig. 3. Diagrams showing (a) The average number of family members for the area's population, (b) Social relations among the inhabitants of the area, (c) Ownership by residents of shops and craft workshops

**Social Characteristics:** By analyzing the results of the questionnaires, it was found that 53% of the population had resided in the area since their birth and 47% of them have moved to the area recently. Among the sample of families covered by the survey, it is found that about half of the families consisted of 3-5 members and children represent about 37% of the total population. The *Timbukshia* region is also characterized by its social relations with 67% of its residents having friendly relations to each other (Fig. 3. a, b).

Thirty percent of the population are employees with a fixed income. This sample includes workers in local activities, 30% of the pensioners, while 40% of them have different incomes to work in crafts and trade and the class of the wealthy or those with high incomes does not appear in the region (Fig. 3. c).

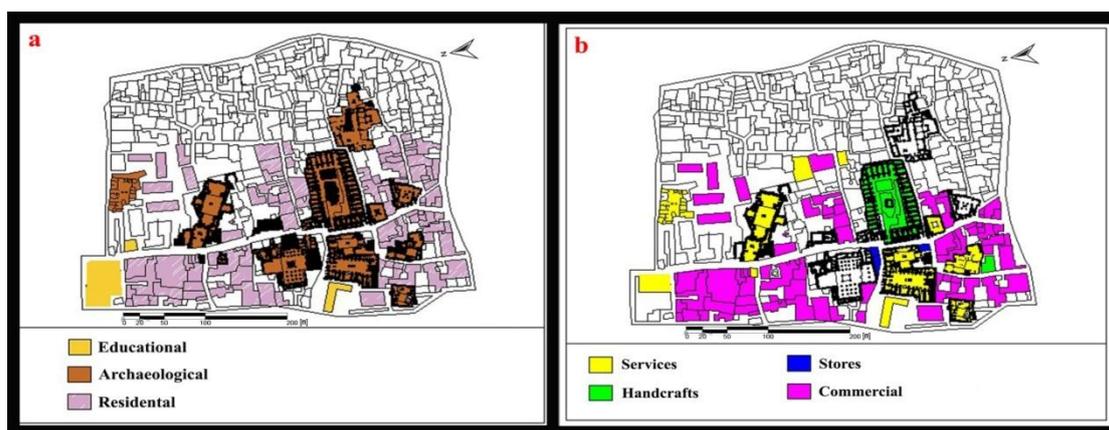
Fig. 4. Maps showing (a) The prevailing uses in the Timbukshia region, (b) Uses of the ground floor

**Archaeological Buildings:** The proportion of archaeological buildings (Fig. 4. a) represents about 20% of the built area in the *Timbukshia* region, and the rest is non-archaeological. The archaeological buildings in the urban of the agency date back to different historical periods (Fatimid, Mamluk and Ottoman eras) and their uses vary between mosques, schools, agencies, *sabils* and shrines. Some of these buildings were reused such as the agency of Bazara'a [10] which was reused as an international center for traditional and artistic crafts, as well as hosting a group of distinguished artists in this field to hold workshops and benefit from their artistic expertise. It was also used as an administrative office of the Ministry of Tourism and Antiquities.

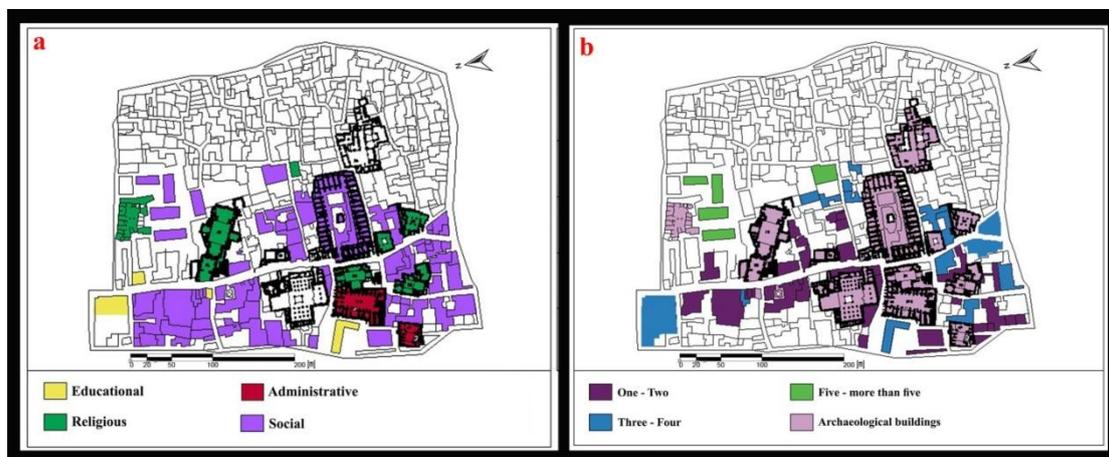
Fig. 5. Maps showing (a) The nature of public services in the Timbukshia region, (b) The heights of the buildings

**Characteristics of Services:** With regard to the distribution of services (Fig. 5. a), it is noted that most of the region's needs of public services such as health, cultural and recreational services, transportation and accommodation services are located outside it, with the availability of some religious and educational buildings. It is also noted that there was a lack of water and sewage networks, which represents a danger in preventing disasters that may occur such as fires, especially with the collecting of garbage in some ancient buildings and spaces [10], [9].

**Building Heights:** The majority of buildings consist of only a ground floor or two floors (Fig. 5. b). These buildings include old agencies and some small factories. While the heights of some modern buildings reach 3-5 floors or more, which are inappropriate heights that negatively affect the stability of ancient buildings and the general nature of the historical area.

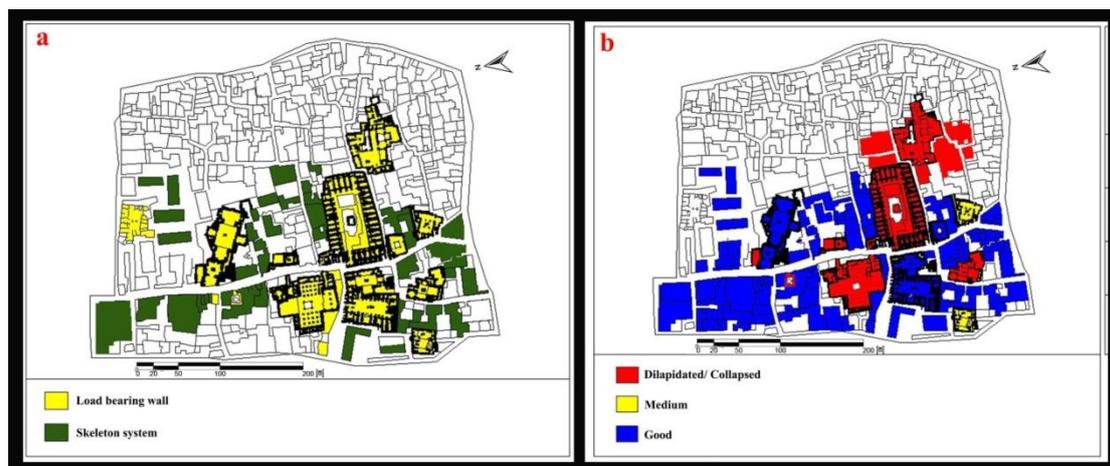
Fig. 6. Maps showing (a) The structural system in the Timbukshia region, (b) Status of the buildings

**Structural System and Building Status:** The structural system in the region varies according to the age of the building. The archaeological buildings are built with the load-bearing walls system while the modern buildings are built with the skeleton system (Fig. 6. a). Their status vary according to the same consideration. Most of the archaeological buildings are in a degraded or dilapidated condition while the modern buildings are in good structural condition (Fig. 6. b).

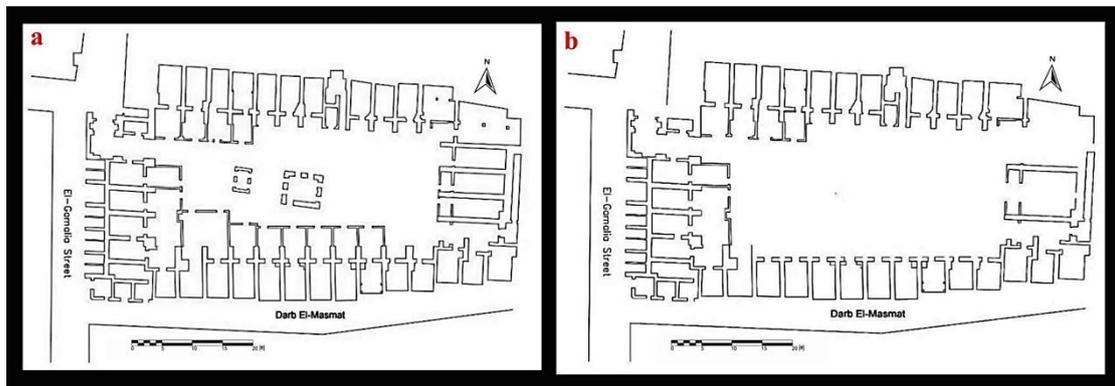
**Fig. 7. The horizontal plan of the ground floor (a) Before the demolition and the effect of deterioration factors, (b) The current situation after demolition**

**B. Suggested Use Requirements:** The proposed use requires the reconstruction of the dilapidated parts and the guidance to complete the missing parts of the agency carrying out the necessary structural and architectural restoration works for the existing spaces. It requires making plans to reuse the ground (Figs. 7, 9), first (Figs. 8, 9) and second (Fig.

**Ground Floor:** shops and commercial stores, a cafeteria, and a multi-purpose hall.

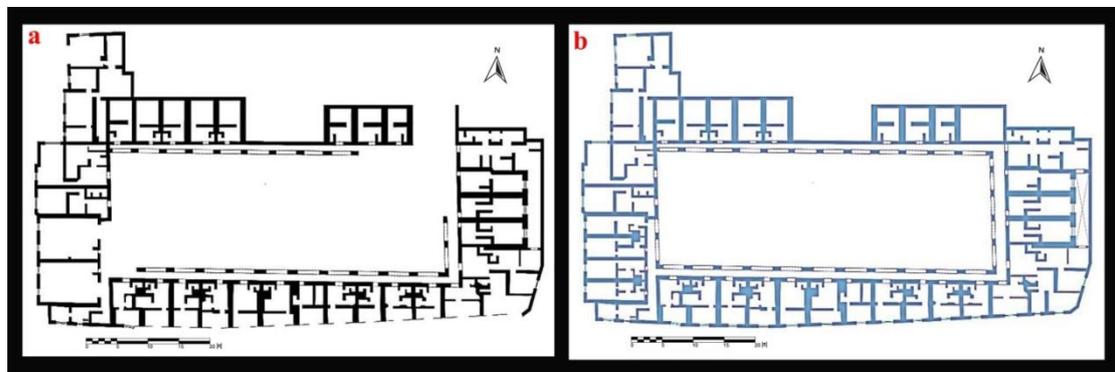
**Fig. 8. The horizontal plan of the first floor (a) The current situation after demolition with the effect of deterioration factors, (b) Proposal after reconstruction work**

**First Floor:** exhibition of traditional handicraft products, bedrooms with their services.

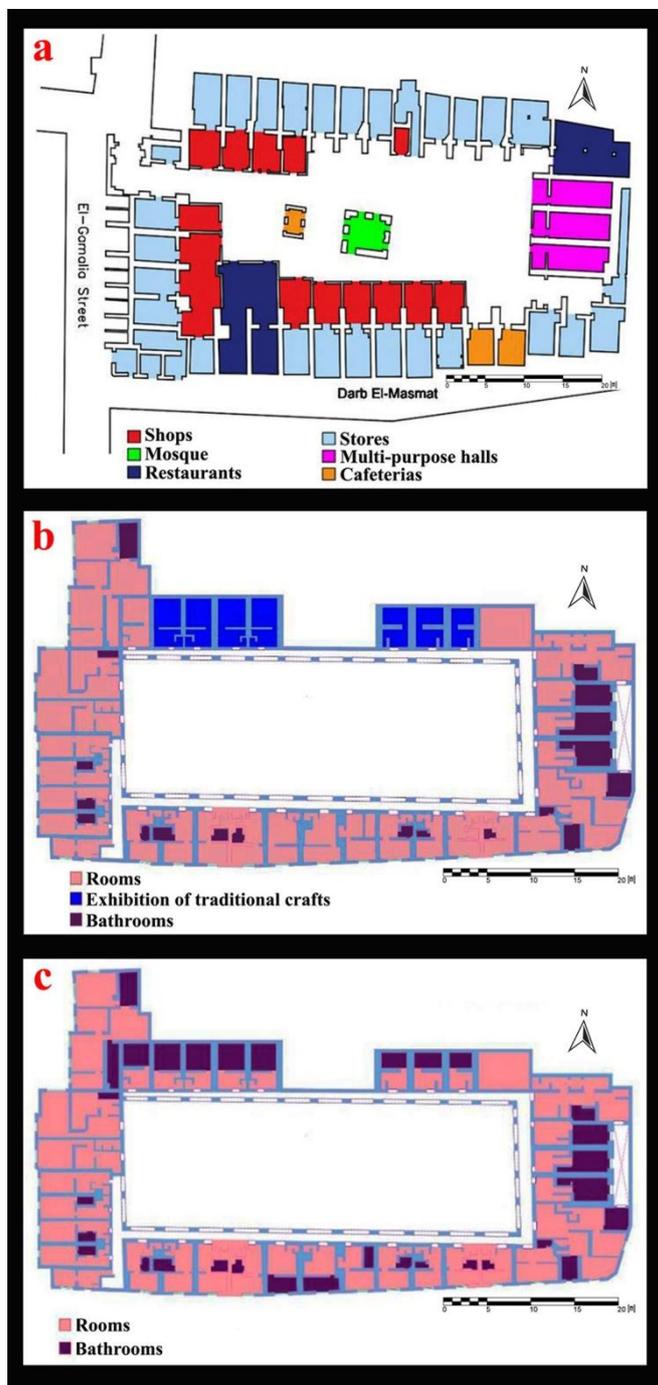
Fig. 9. The proposed plans after reuse (a) Ground floor, (b) First floor, (c) Second floor

**Second Floor:** bedrooms with their services.

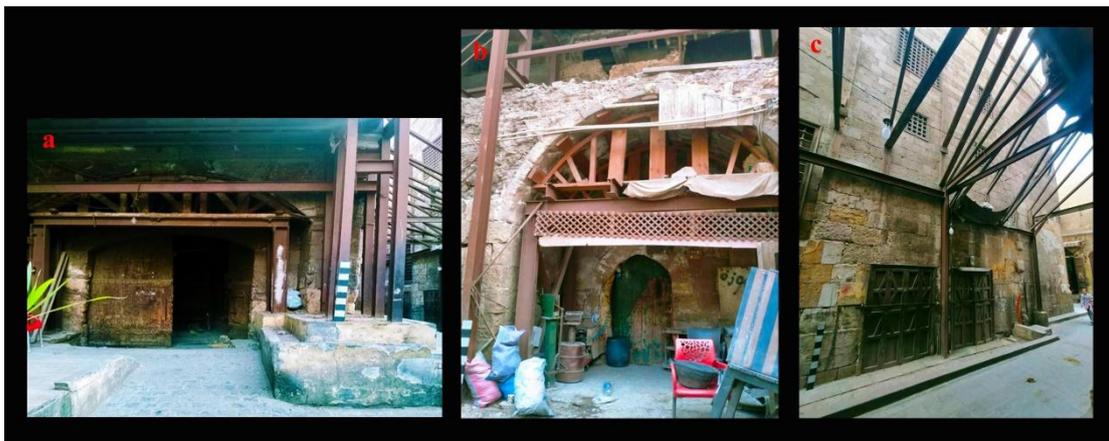
**Fig. 10. Current Acting Steel Works (a) The main entrance, (b) Interior stores, (c) Northwest Facade**

Metal or wooden shores are used in such works, whether in the temporary strengthening of the building as a whole, or of a particular element such as columns or arches [21]. From the visit to the site and the monitoring work that was carried out, it is noted that the shores and reinforcement works (Fig. 10) for some parts of the agency have been implemented for a long period without follow-up and continuous evaluation of their condition. As a result, these shores suffer from deterioration factors that led to the damage of their parts, such as the deterioration of wood panels adjacent to the building, the corrosion of the metal pillars, the corrosion of the metal

bases and other metal parts that make up the shore.

Among the parts that are currently shored in the building are the entrance, the entire

northwest facade overlooking *Habs Al-Rahba* Street and parts of the shore resting on the *Jamal Al-Din* archaeological Mosque, parts of the southwestern facade, some internal shops and the remaining external shops.

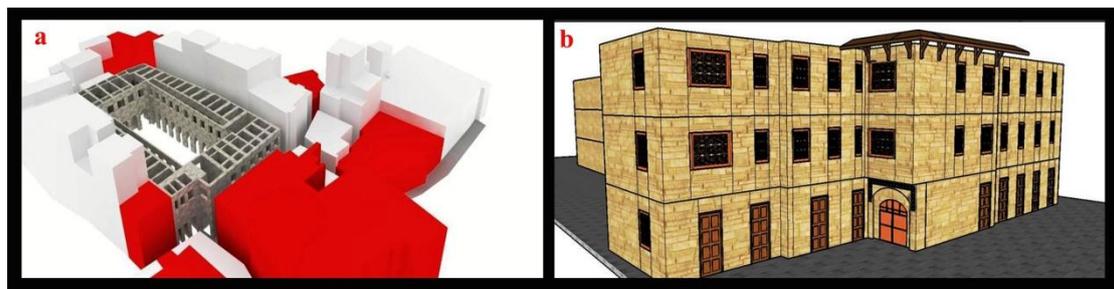
**Fig. 11. Imaginary drawing of Ouda Pasha Agency after rehabilitation (a) The Agency within its urban, (b) The Front facade of the building**

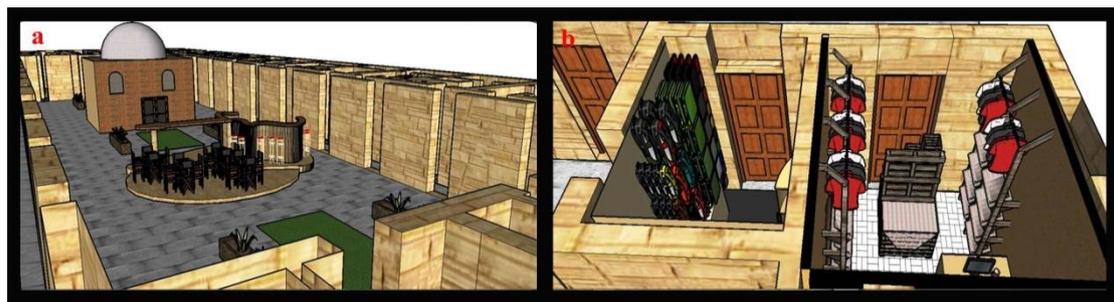
**Fig. 12. Imaginary drawing of Ouda Pasha Agency from inside after rehabilitation, a. The open courtyard, b. Some interior spaces**
