EFFECT OF BED SCOUR AND PILE REFUSAL ON THE BEHAVIOR OF PILES IN WATER COURSES IN EGYPT

Y. B. M. Heza

Construction Research Institute, National Water Research Center, Cairo, Egypt

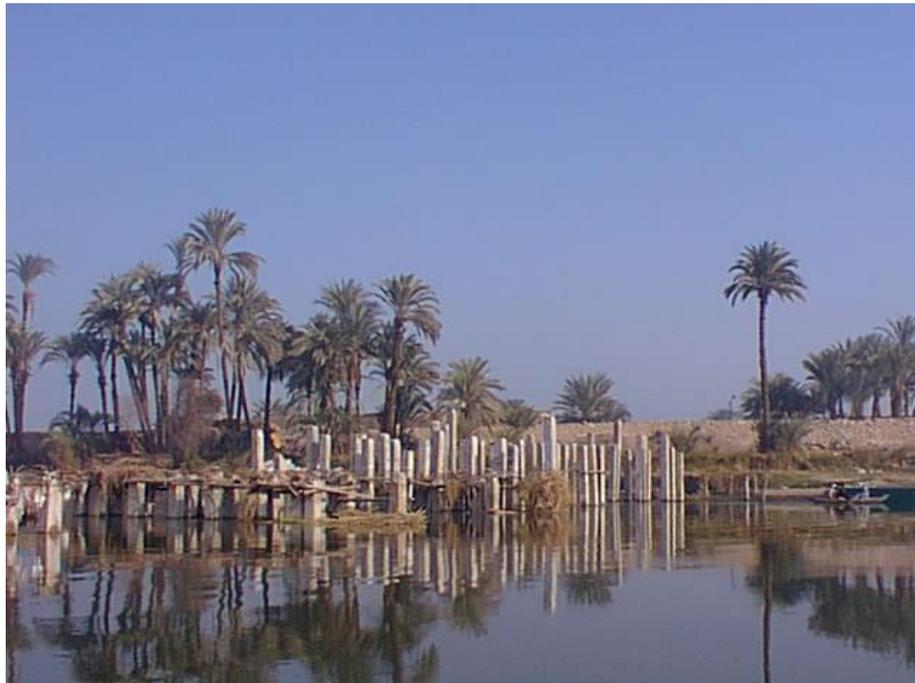
Fig.1 Driven piles of the bridge in Upper Egypt

Three sites have been investigated by the author. The first site is the bridge located in Upper Egypt on major canal as shown in figure (1). The soil consisted of a layer of silty clay followed by poorly graded medium to coarse sand with a lens of gravelly sand. The problem reported in this site is the refusal of the piles at a depth shallower than the required by the design and the presence of scour of about 2.73 m from the original bed level. The second site is on a branch canal in the North West of Egypt. The soil at the site is mainly cemented sand and the pile penetration depth was shorter by 8 m because of refusal. The piles are shown in figure (2). The third site is of a bridge on a major canal in the North East of Egypt. The soil is mainly silty clay followed by sandy soil. The problem at the site is the refusal of the piles at a depth shallower than the required by design. Figure (3) shows the piles at the site and the platform used to construct the piles. A full assessment of the sites required to avoid the risk of failure. In this paper, the assessment of the case study

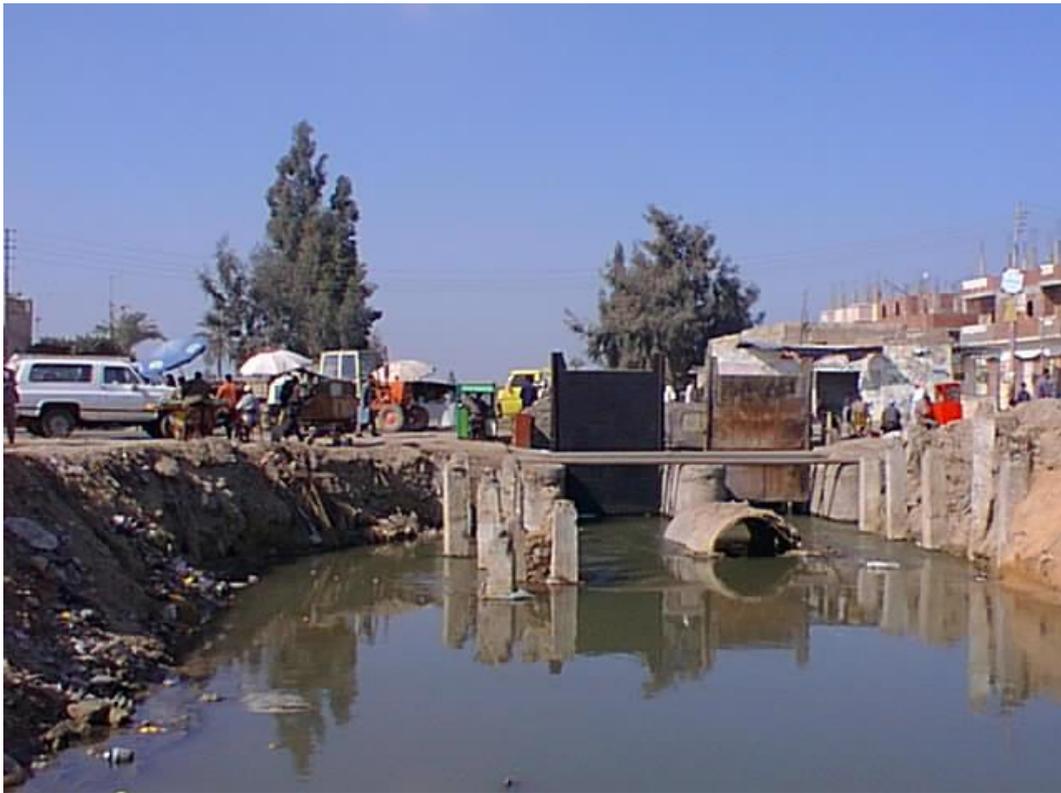
Fig. 2 Driven piles of the bridge in North West of Egypt

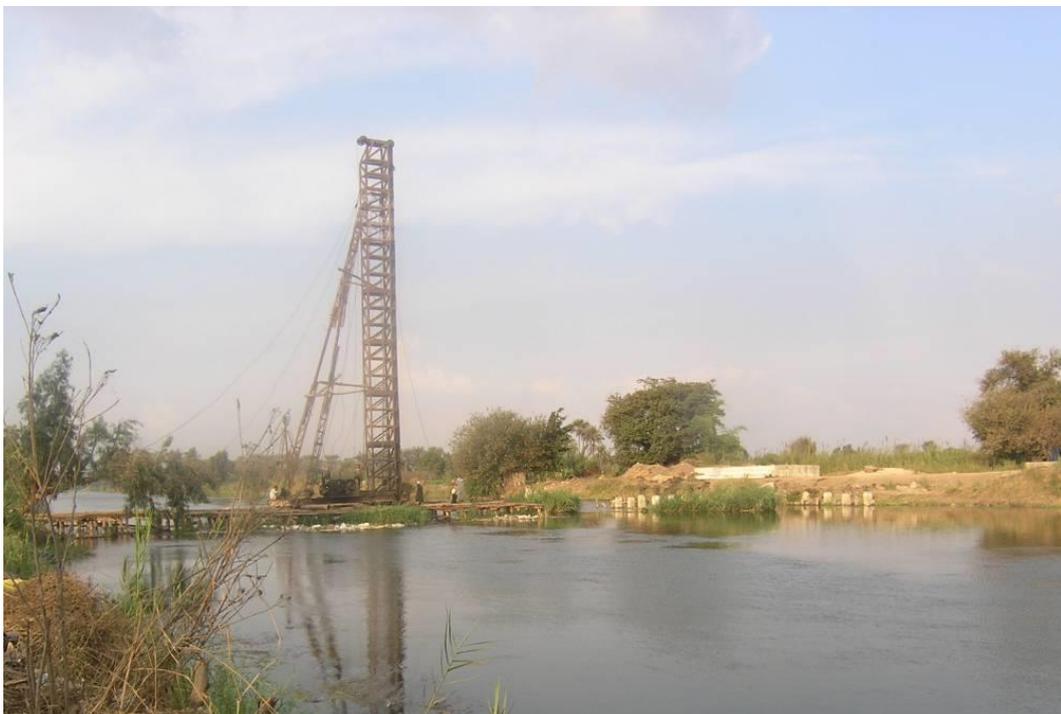
Fig. 3 Driven piles of the bridge in the North East of Egypt

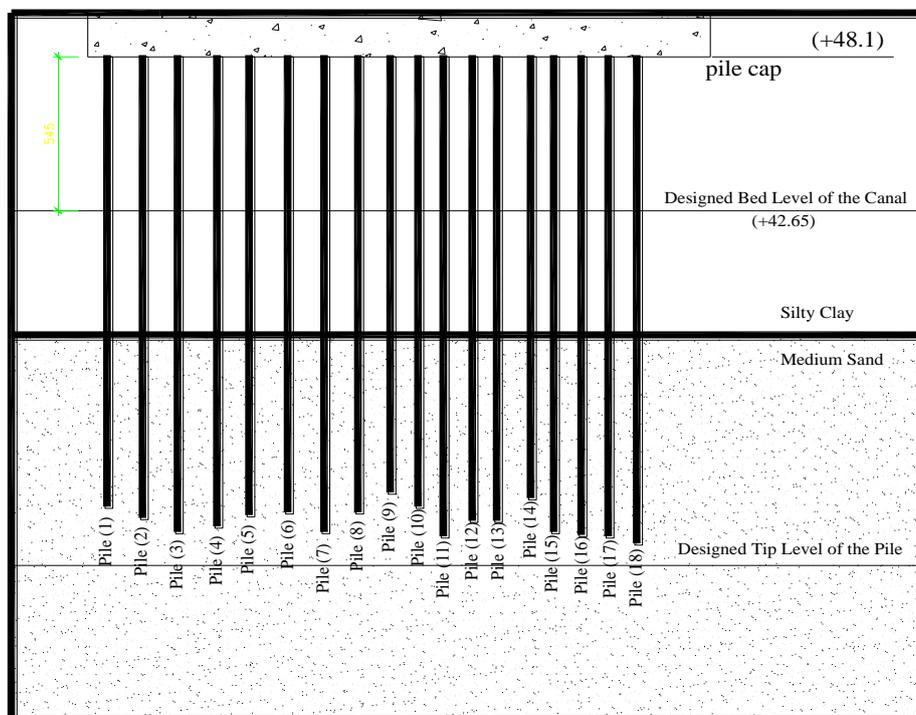
Fig. 4 The embedded length of the driven piles of support no. 2

During construction, most of the piles did not reach to the required toe level as indicted in figures 4 to 9. Consequently, these piles do not satisfy the required embedment length. In addition to that, the observed scour depth in the cross section of the canal at the bridge site after driving the piles ranged from zero to 2.73 m. To investigate the problem, an extensive program of field and laboratory work and numerical analysis were conducted.

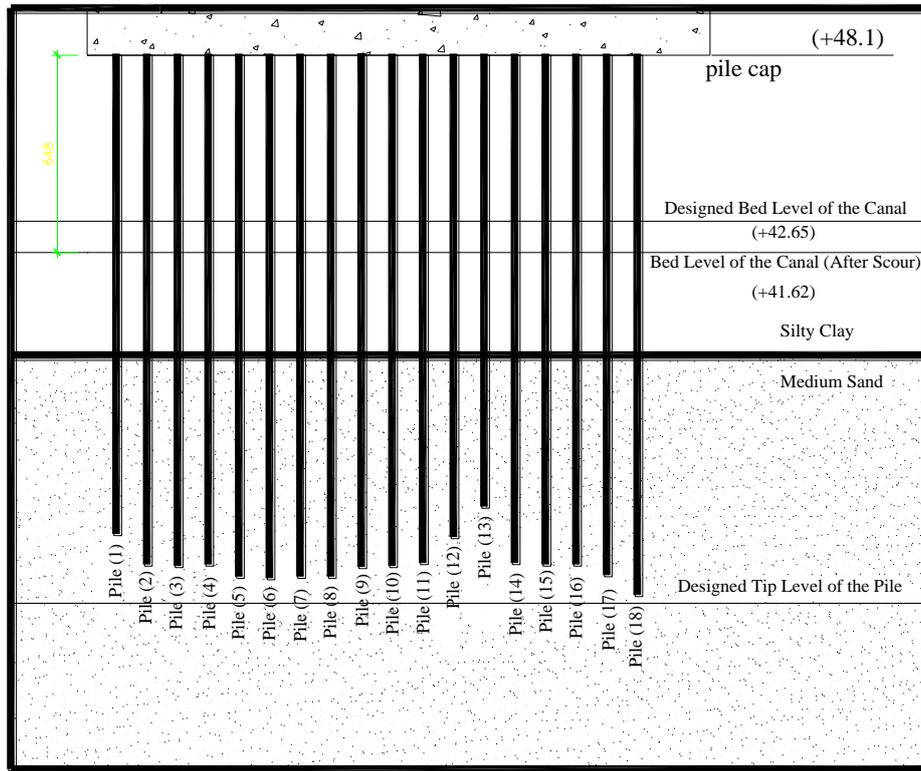
Fig. 5 The embedded length of the driven piles of support no. 3

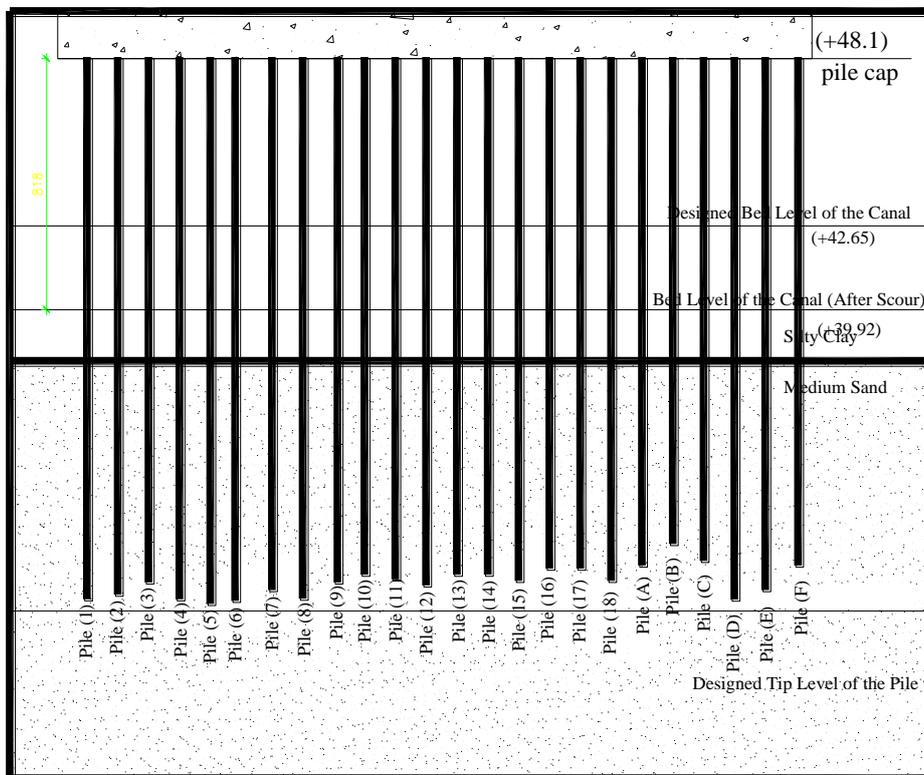
Fig. 6 The embedded length of the driven piles of support no. 4

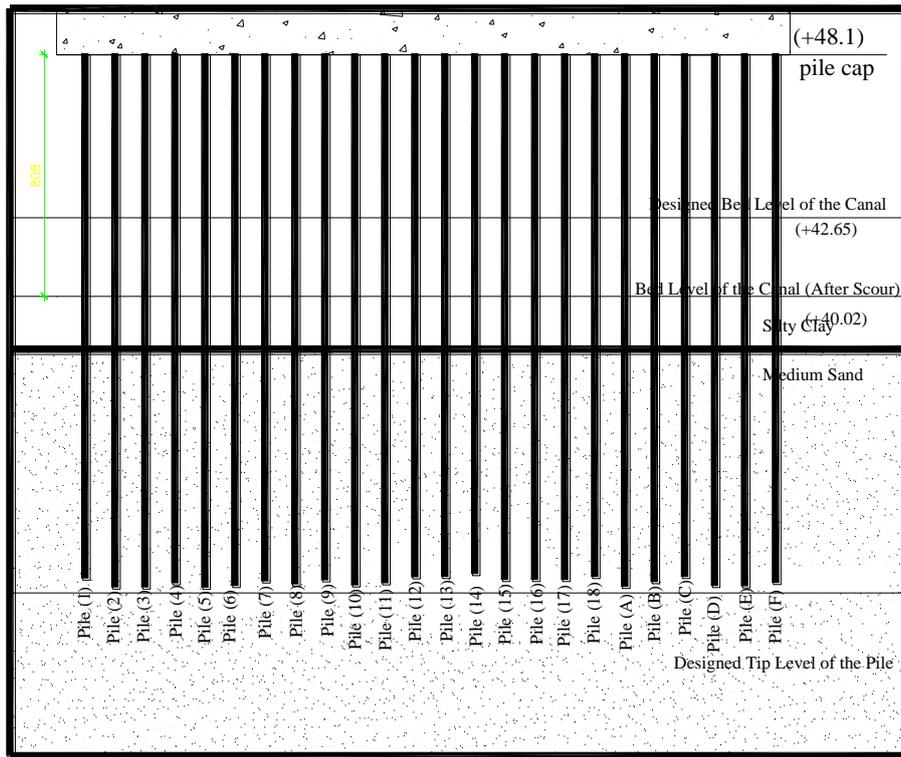
Fig. 7 The embedded length of the driven piles of support no. 5

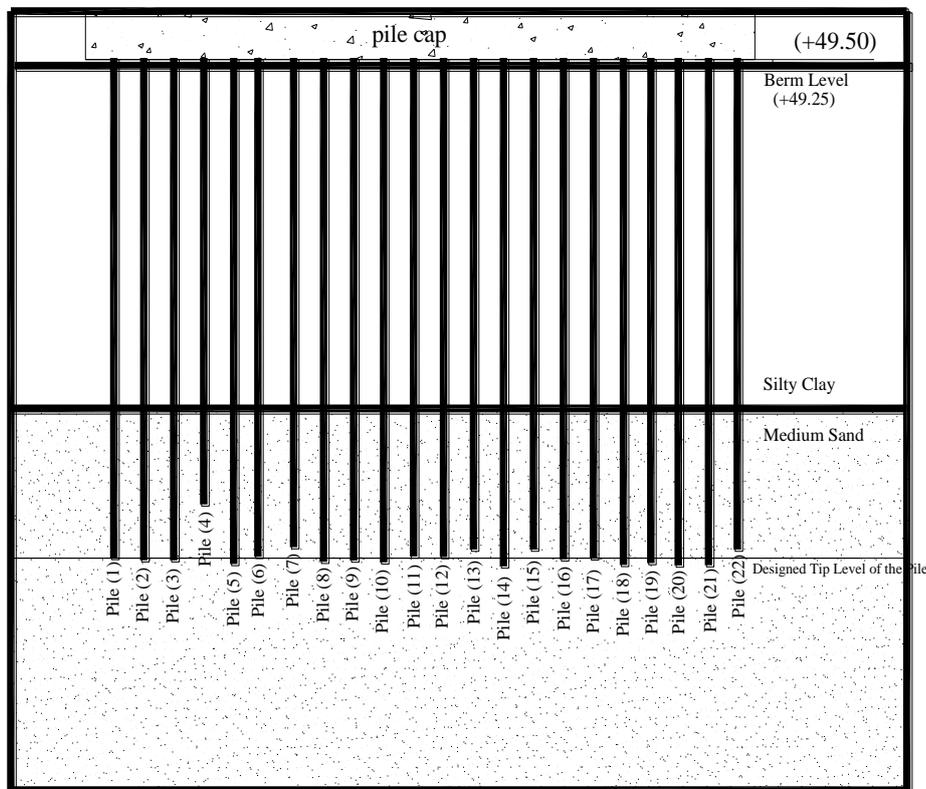
Fig. 8 The embedded length of the driven piles of support no. 6

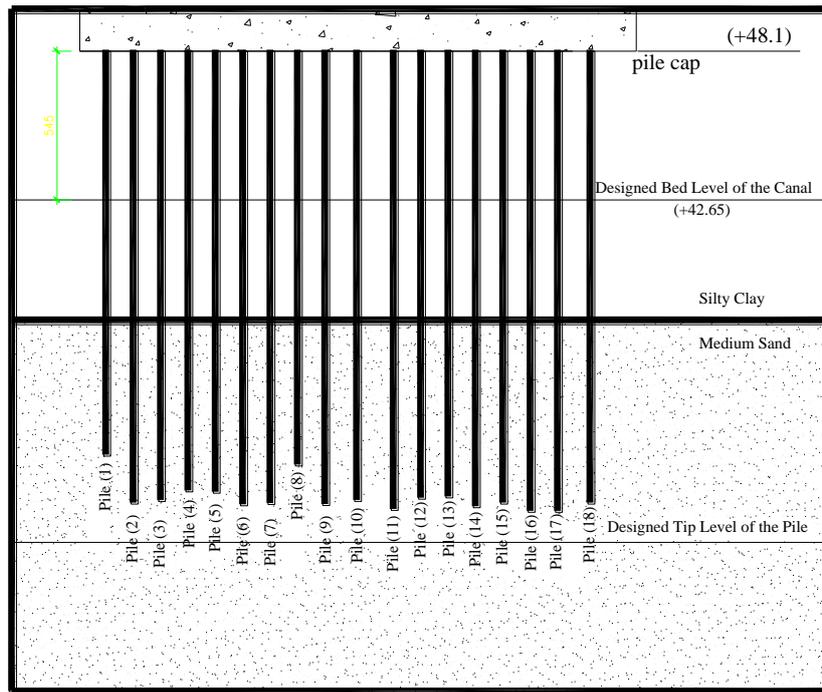
Fig. 9 The embedded length of the driven piles of support no. 7

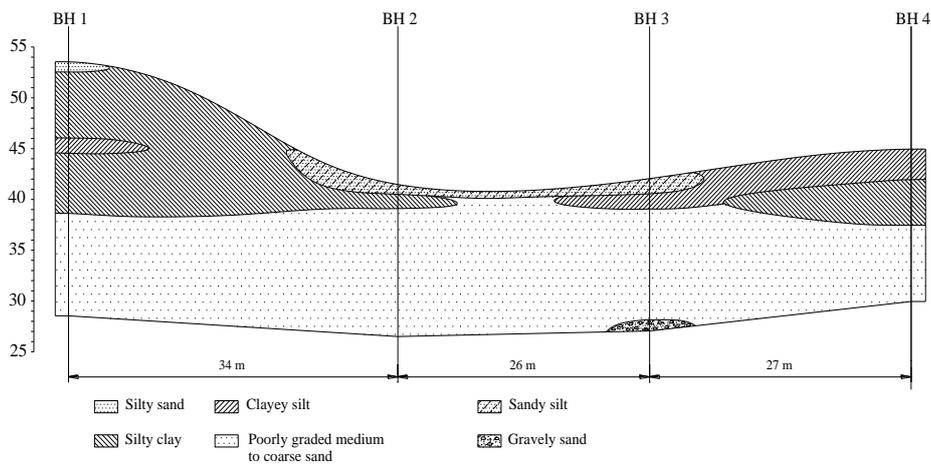
Fig. 10 Lithological section of soil stratification at cross section of the canal

were conducted and soil samples were extracted. Laboratory tests were carried out to define the required physical, mechanical, and chemical soil prosperities. From the field and laboratory tests, it can be shown that the soil deposit consists mainly of two layers. The top layer is either silty clay or clayey silt with a thickness ranging from 1.0 m to 13.0 m. The second layer is poorly graded sand till the end of the borehole. A lens of gravelly sand with a thickness of 1.10 m existed in the third borehole. Figure (10) shows the letheological section across the canal at the bridge site. By examining the results of the field and laboratory tests, it was found that the soil layer at the design pile toe level is very dense which explains the refusal happening while driving the piles. This shows the necessity for accurate geotechnical investigation prior to the design of such structure. Driven piles are not suitable in such a deposit.

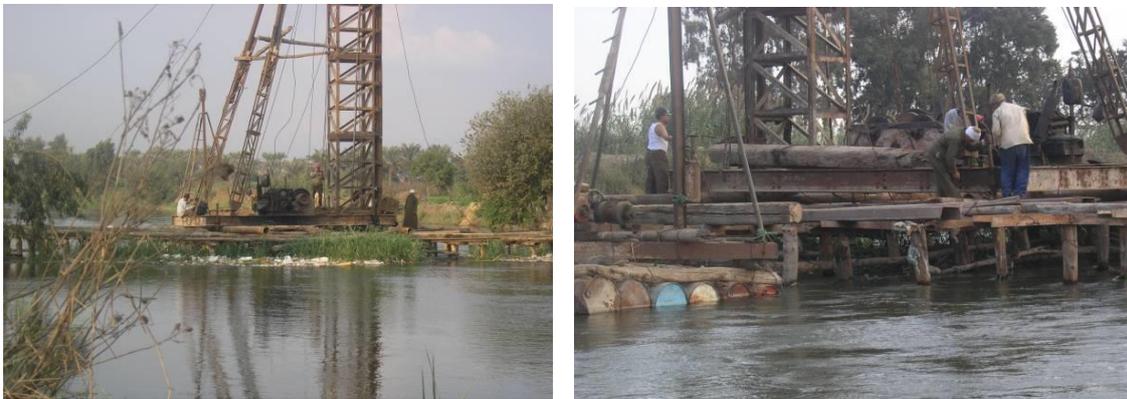
The field investigation also showed that a platform of steel beams and wooden logs built on wooden piles was used for the pile driving machine in the presence of water as shown in figure (11). The presence of the platform lead to the contraction of the water course cross section and the contraction gets worse by driving the reinforced concrete piles which in turn lead to a higher water velocity causing scour around the driven piles. Therefore, the stability of the piles became questionable because of the shorter embedment length due to the refusal of the piles and the scour around them. To assess the safety of the driven piles, a stability analysis was conducted.

Fig. 11 Platform setup used to drive piles of bridges across water courses

It is recommended to use a different method while constructing bridges across water courses to avoid the contraction of the water course due to the pile installation and consequently avoid the scour problem which destabilize the structures. Thorough technical investigations are highly recommended to be conducted before construction.

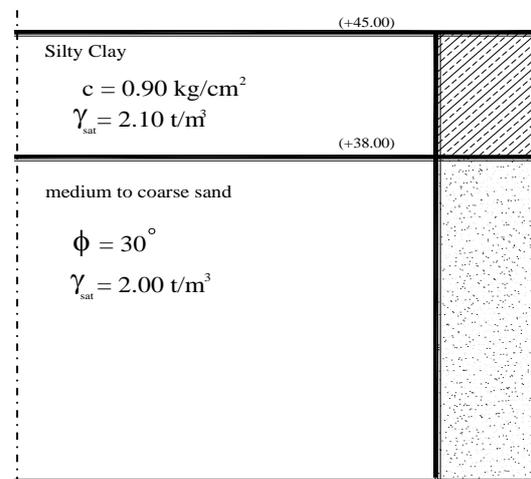
The vertical load carrying capacity of each pile was estimated based on the embedded length of the pile using the Egyptian code for soil mechanics and foundation design and construction (Ministry of Housing and Infrastructures, 2008). The soil profile and characteristics are indicated in figure (12). The load carrying capacity was estimated using the smallest pile length in each pile group.

Fig. 12 Soil profile and soil characteristics at the site

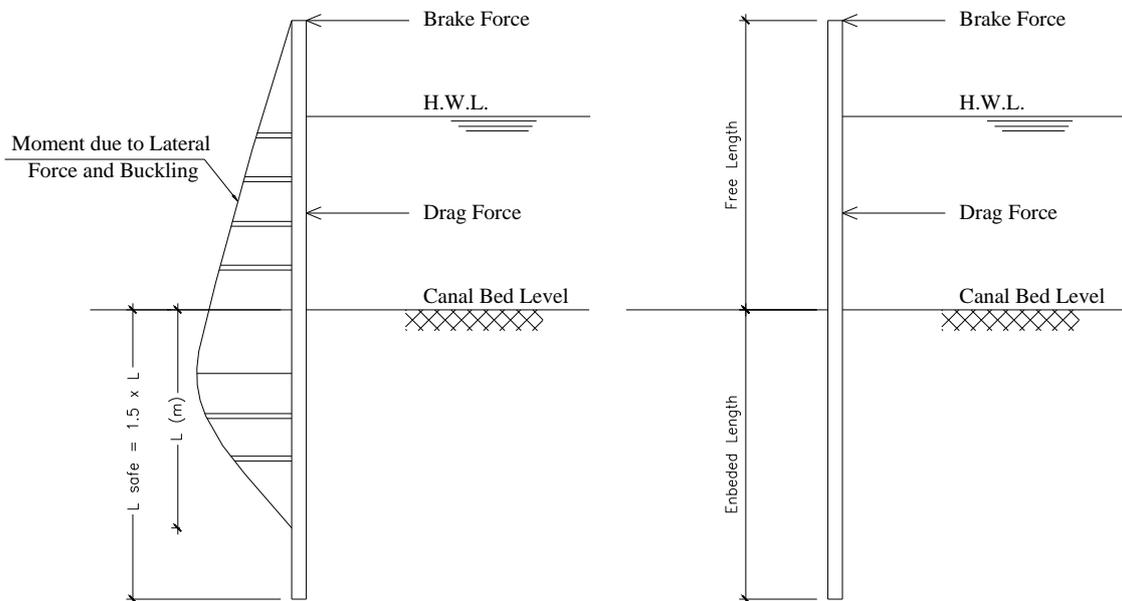
The lateral loads due to the drag and brake forces were calculated considering a drag force of 2.1 ton at half of the water depth and brake force of 1.75 ton at the pile head. Figure (13) indicates the schematic diagram of the lateral forces applied on the piles. The scour increased the moment due to the lateral loads on the piles. Table (5) shows the free length of the pile and the resulting moment on each pile for each support after the scour has taken place. The maximum normal stresses on the pile cross section due to normal load and bending moment were calculated for each pile before and after the scour. It was found that despite of increasing the moment because of the scour, the normal stresses were within the allowable limit and that the effect of the scour on the normal stresses on the pile cross section is limited.

Fig. 13 Schematic diagram of the force inserted on the pile under investigation
