POST-OCCUPANCY EVALUATION (POE) OF JEDDAH RUSH HOUSING PROJECT

Hisham Mortada

Dept of Architecture College of Environmental Design King Abdul Aziz University Jeddah, Saudi Arabia

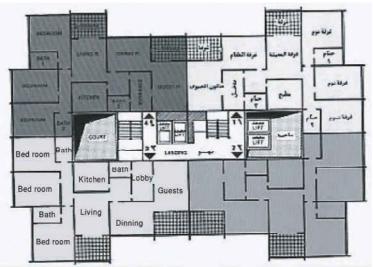
Fig. 8. Typical plan of a residential floor Source: Adopted and developed from [16]

Each apartment covers an area of 220 m^2 and includes 3 bedrooms, a guest room, a living room, a kitchen, 3 bathrooms, and 2 balconies. Pre-fabrication was used in the construction of the entire project mainly to achieve rapidity and high quality construction [8 and 15] (Figs. 5-8).

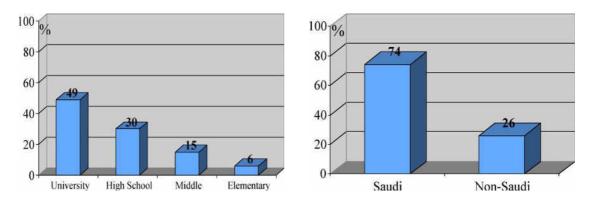
The survey has found that the householders of most units of the project were educated. Indeed, about half of them had a university education (Fig. 10). This means that those residents had enough knowledge of the meaning of responsibility toward their community and proper behavior.

Although the project was built for Saudi families, the survey has found that 74% of inhabitants were Saudi while 26% were non-Saudi (Fig. 11). This diversity in nationalities, thus in cultural backgrounds and daily lifestyles, should have an impact on the social integration among residents.

Fig. 10. Level of education among residents

Fig. 11. Ethnic distribution of residents

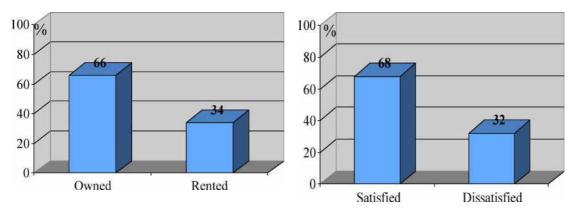
Fig. 12. Type of tenancy

The project was constructed to shelter Saudi families who did not own a house due to their limited income. However, the survey found that some Saudi owners (34%) have rented their apartments to other families (Fig. 12). This has in turn affected the project in terms of maintenance and social relationships. As the renters usually stayed in the complex for 2-3 years, they were not keen in participating in the maintenance or cleanness of the property, thus creating conflicts with neighbors.

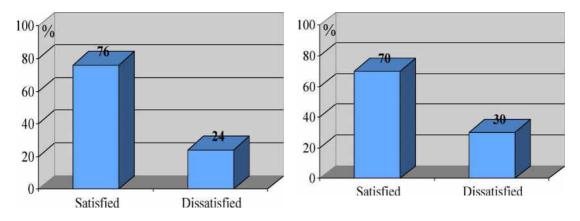
Unexpectedly, 78% of respondents said that the architectural design of their housing units suited their traditional Arabian customs (Fig. 14). They felt that the spatial arrangement of the unit was made with local norms in mind.

70% of those answered the questioners thought privacy inside their apartment was achieved by the design. Yet, 30% claimed that the closeness of the residential towers encouraged visual intrusion into their apartments from neighboring buildings (Fig. 15).

Fig. 14. Satisfaction with the suitability of the apartment design to local customs

Fig. 15. Satisfaction with privacy inside the apartment

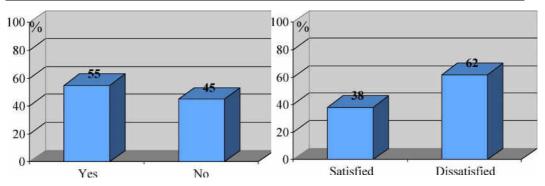
Regardless of the positive answers of above, the survey has found that 55% of residents have modified the unit layout in order to suite their needs (Fig. 16). This in fact violates the Supervision Committee's rule that prevents any modification to the layout of the unit.

Fig. 16. Modification made to the unit layout

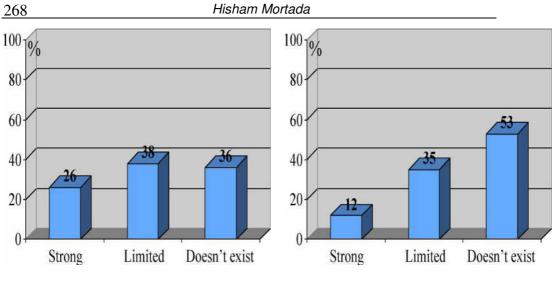
The survey has found that 74% of residents had negative impression on their relationship with neighbors in the same tower. While 38% of the respondents said that their relationship with their neighbors was limited, 36% did not have any neighborly relation at all (Fig. 20). However, 36% believed that they had a strong contact with neighbors.

More than half (53%) of residents did not have any social connection with residents of the other towers of the complex. Only 35% had a limited relationship while 12% had a strong contact (Fig. 21).

Fig. 20. Social relationship with neighbors in the same buildings

Fig. 21. Social relationship with other residents of the project

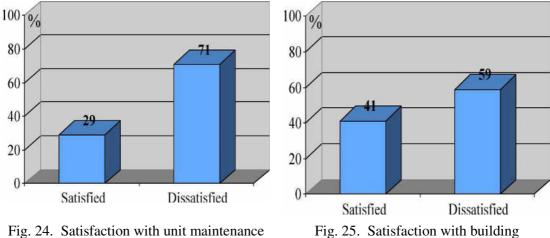
As previously discussed, the maintenance of the towers of Jeddah Rush Housing Project was the duty of the Supervision Committee. This maintenance included repairing any damages that might have occurred outside the unit. Only 41% of residents were satisfied with this maintenance while 59% were dissatisfied (Fig. 25).

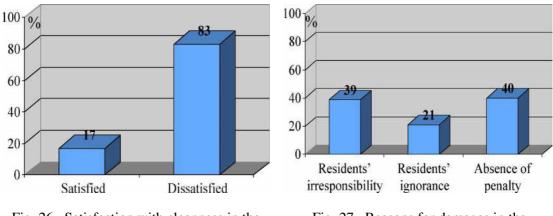
There was a negative reaction toward the level of cleanness of the project. A high rate of 83% of residents thought that public spaces such as parking garages, staircases, walkways and lobbies were unclean (Fig. 26). 17%, however, thought differently.

that absence of penalty was the main reason for damages in the building or complex, 39% believed that residents' irresponsible behavior was the reason. 21% said residents' ignorance (Fig. 27).

Fig. 26. Satisfaction with cleanness in the complex

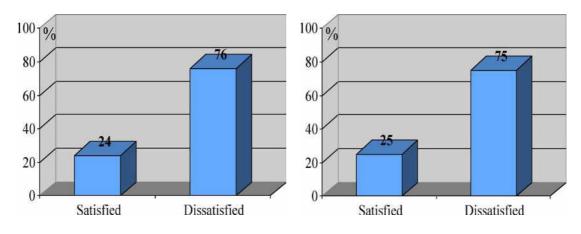
The survey has found that 76% of inhabitants were dissatisfied with the level of security in the parking garages (Fig. 28). Nonetheless, 24% were satisfied.

A high rate of 75% of respondents was unhappy with the security of the project. As discussed in the following section of this study, there were several reasons for this dissatisfaction. Yet, 25% were satisfied (Fig. 29).

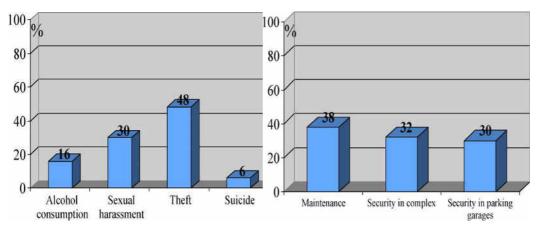
38% of residents thought that maintenance was the most issue affecting their life in the complex. While 32% believed that security in the complex was the issue, 30% said that they have been affected by the security of the parking garages (Fig. 31).

Fig. 31. Most issues affecting the life of residence in the complex

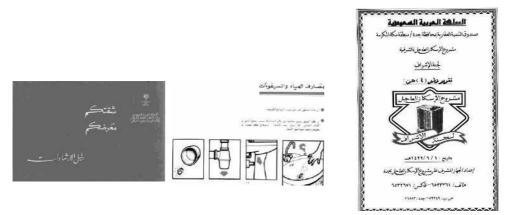
Fig. 42. Maintenance instruction manual and a newsletter regularly published by the Supervision Committee Source: [20 and 21]

In a rare move and as the leak of water between units became severe, the Committee decided to repair the plumbing pipes of most affected apartments on its own expense. Nonetheless, such an attempt did not succeed. Residents were not corporative to allow maintenance labors to enter their units. Some were not in their apartments most of the time while others complained about the inconvenience of the time of the maintenance or gave excuses such as a presence of a guest, etc. As a result, the maintenance groups made several changes in their schedule, but that did not work either. This had worsened the plumbing situation in the project [15].

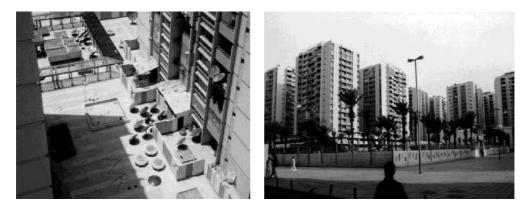
Fig. 45. Deserted plazas and playgrounds
