**ICCAE-10-2014**

**INVESTIGATING MEASURES TO INCREASE THE LIFESPAN OF  
CONCRETE COASTAL STRUCTURES IN THE NILE DELTA**

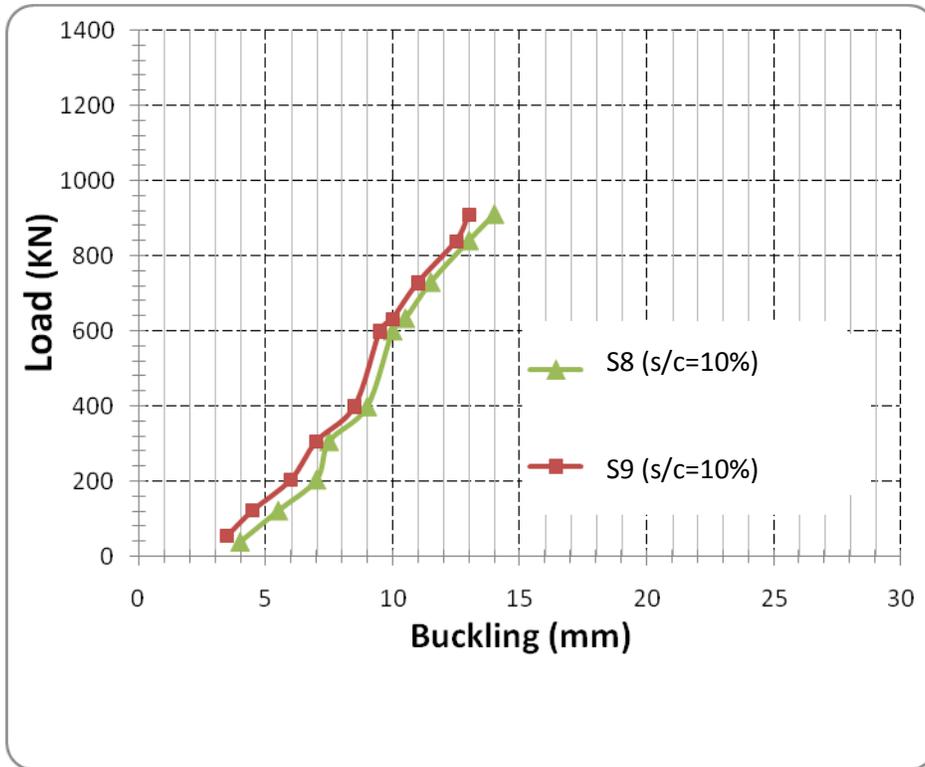
**Figure (1) Relation between load and buckling (Unenhanced)**

Figures (1) to (3) represent the relation between the loads and buckling for the unenhanced specimens and enhanced specimens with 40 mm cover or with CFRP sheets, respectively. Figures (4) to (6) represent the relation between the loads and strain of steel for the unenhanced and enhanced specimens with 40 mm cover or with CFRP sheets, respectively. Figures (7) to (9) represent the relation between the loads and strain of concrete for the unenhanced and enhanced specimens with 40 mm cover or with CFRP sheets, respectively.

Although the curves are self-explanatory curves, a comparison to the values of buckling, strain of steel and strain of concrete of the unenhanced specimens, enhanced specimens with 40 mm cover and enhanced specimens with CFRP sheets is given in table (2). It is to be noted that these values are a load of 400 KN (i.e. average load). The table also provides the enhancement percentage due to the provided extra concrete cover or the addition of CFRP.

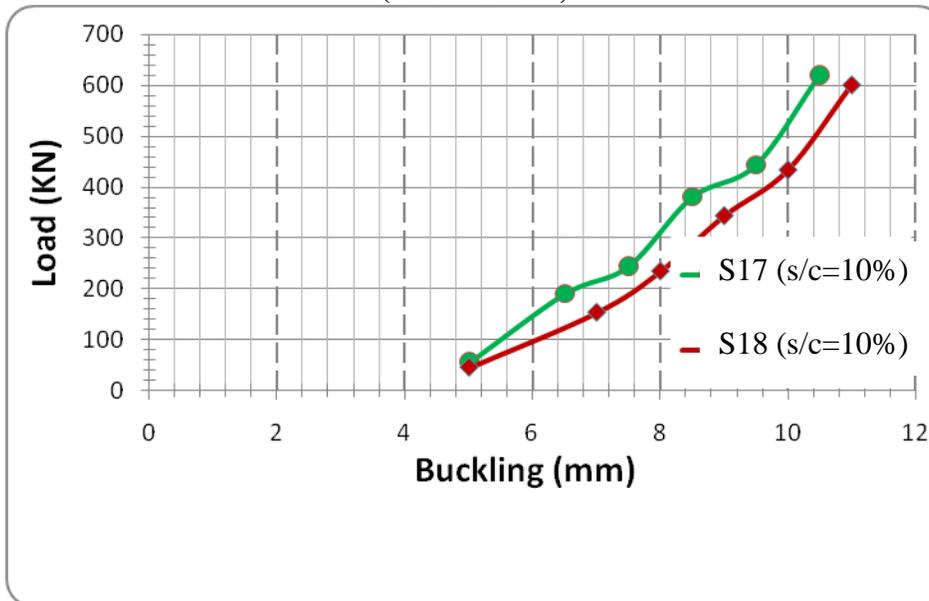
**Figure (2) Relation between load and buckling (Enhanced specimens with 40 mm cover)**

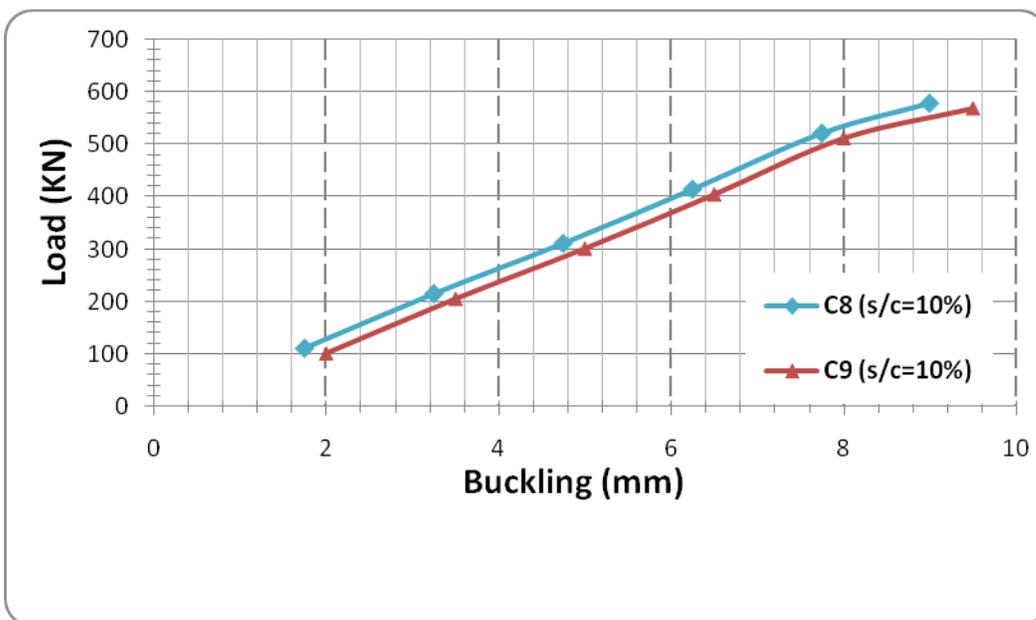
**Figure (3) Relation between load and buckling  
(Enhanced specimens with CFRP)**

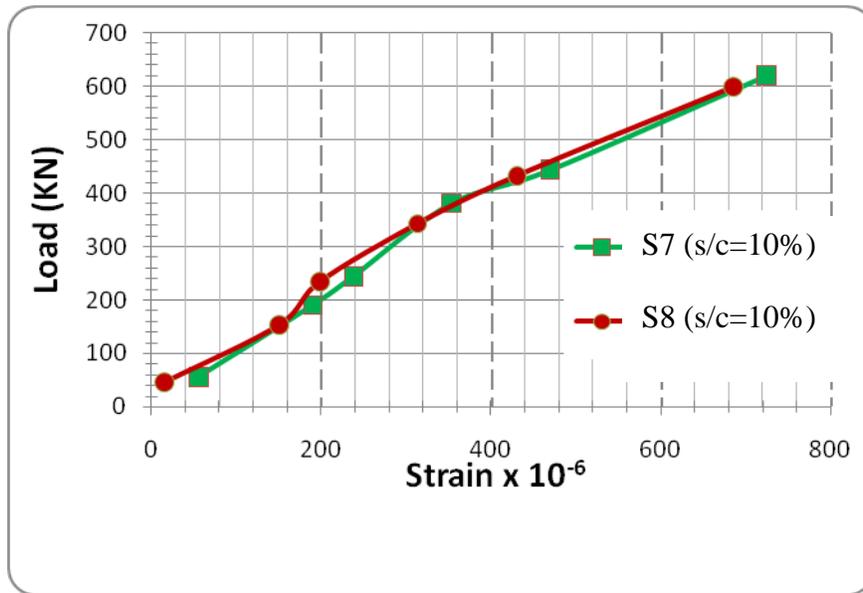
**Figure (4) Relation between load and strain of steel (Unenhanced specimens)**

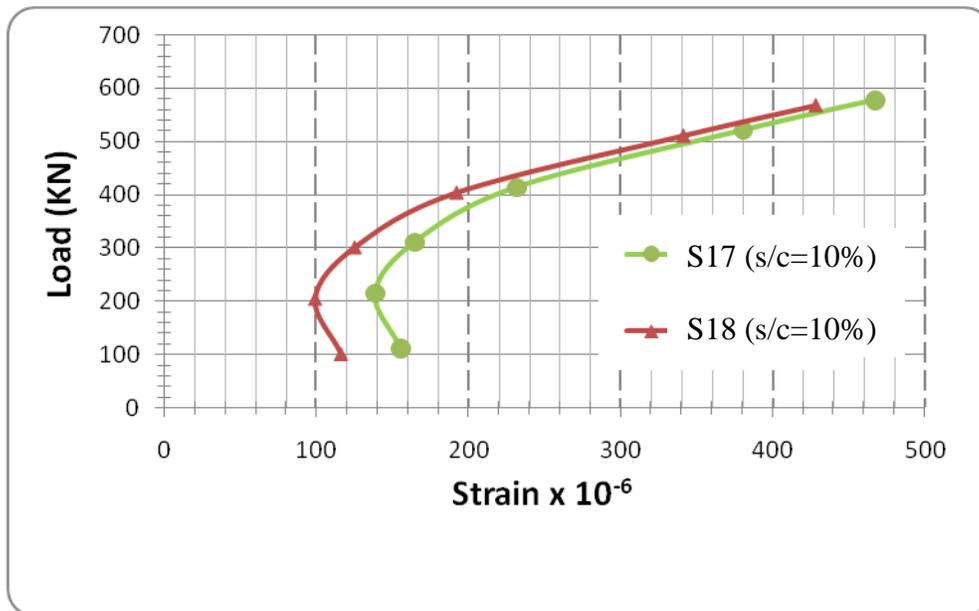
**Figure (5) Relation between load and strain of steel (Enhanced specimens with 40 mm cover)**

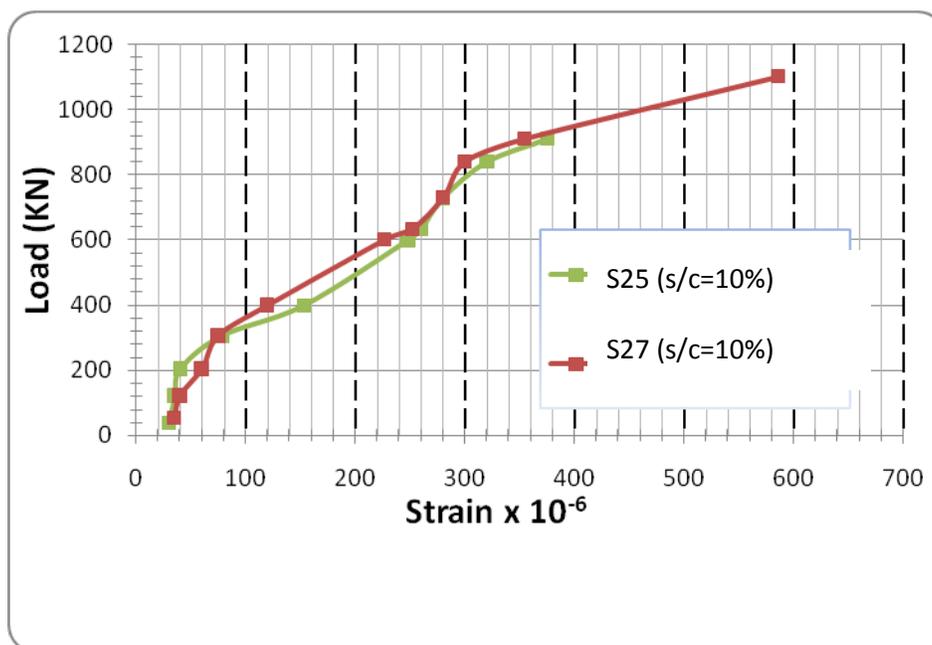
**Figure (6) Relation between load and strain of steel  
(Enhanced with CFRP sheets)**

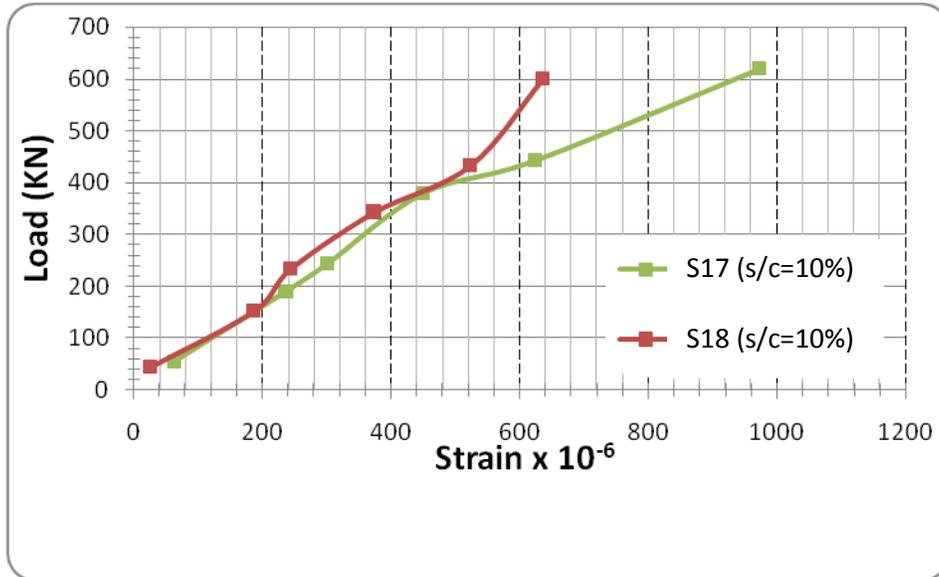
**Figure (7) Relation between load and strain of concrete (Unenhanced)**

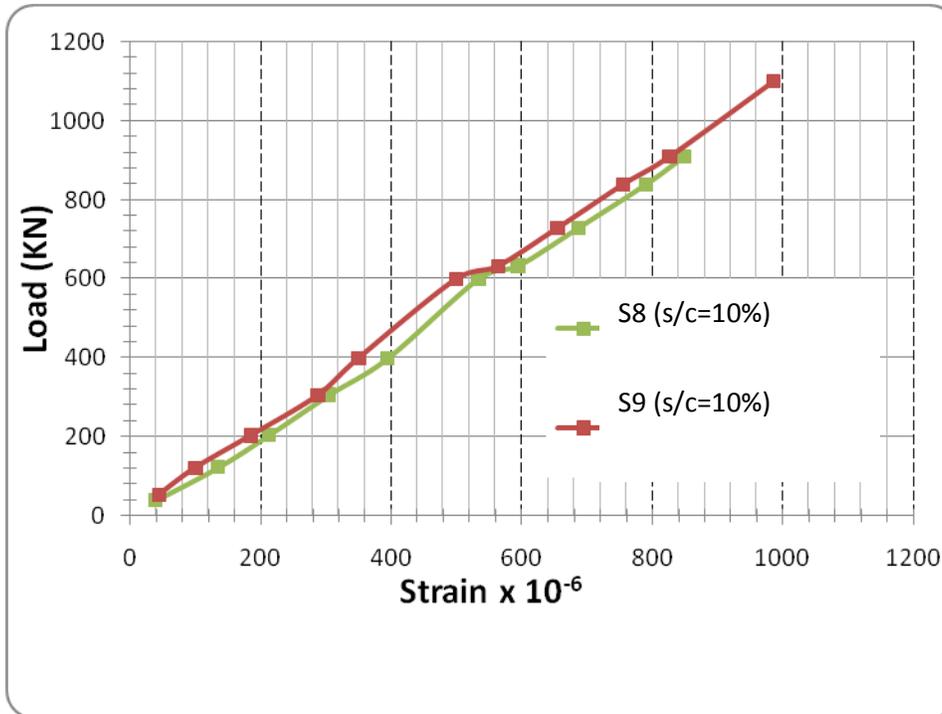
**Figure (8) Relation between load and strain of concrete (Enhanced with 40 mm cover)**

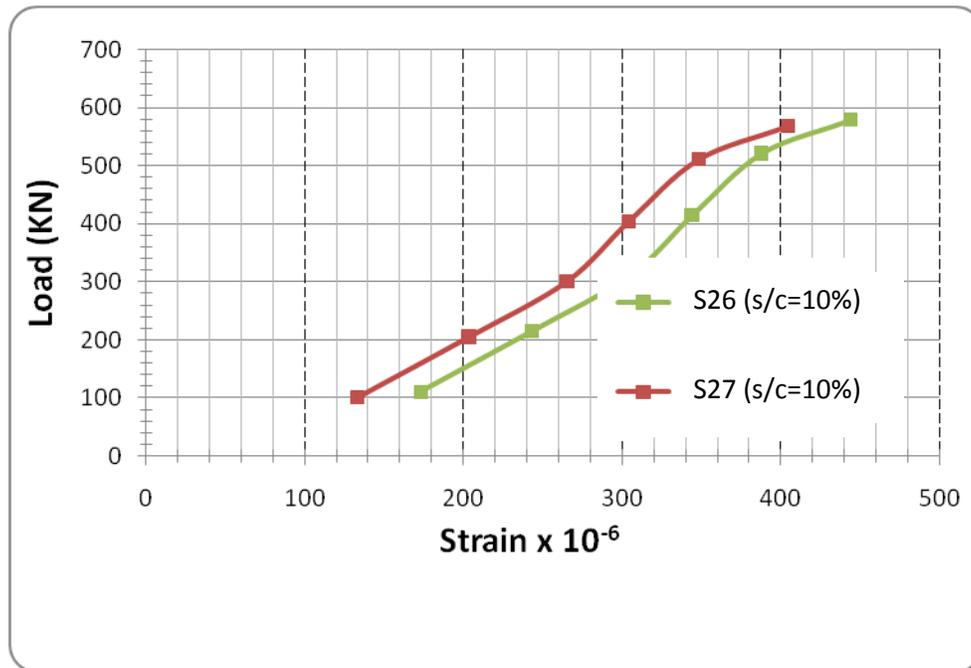
Figure (9) Relation between load and strain of concrete (Enhanced specimens with CFRP)

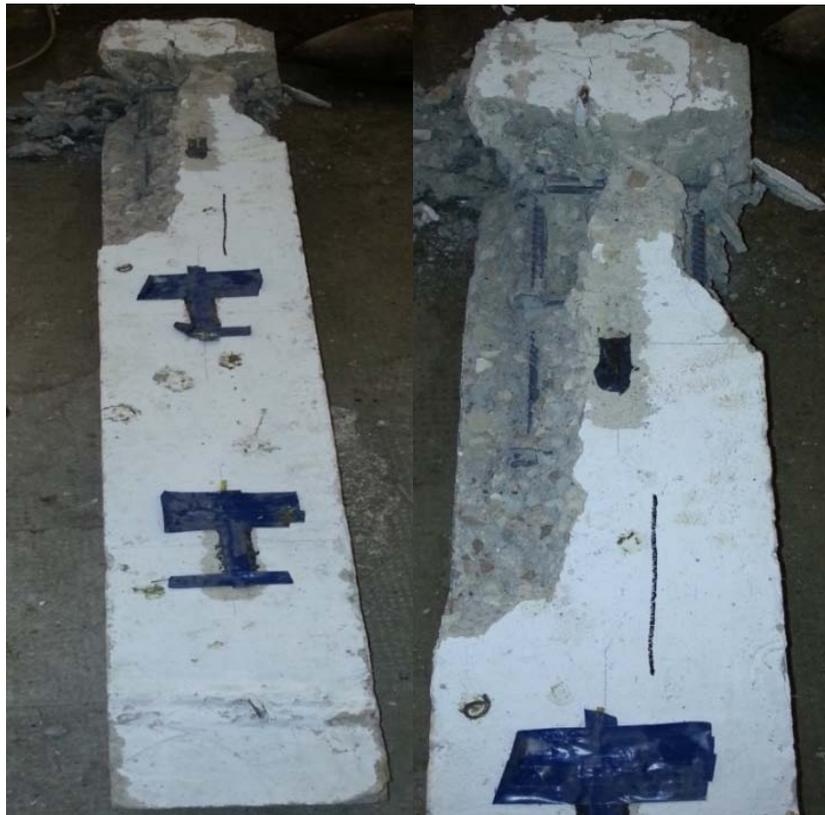
**Photo (11) Mode of Failure for one of the unenhanced specimens**

Also, photos (11) and (12) are given to illustrate the failure modes of unenhanced and enhanced specimens, respectively.

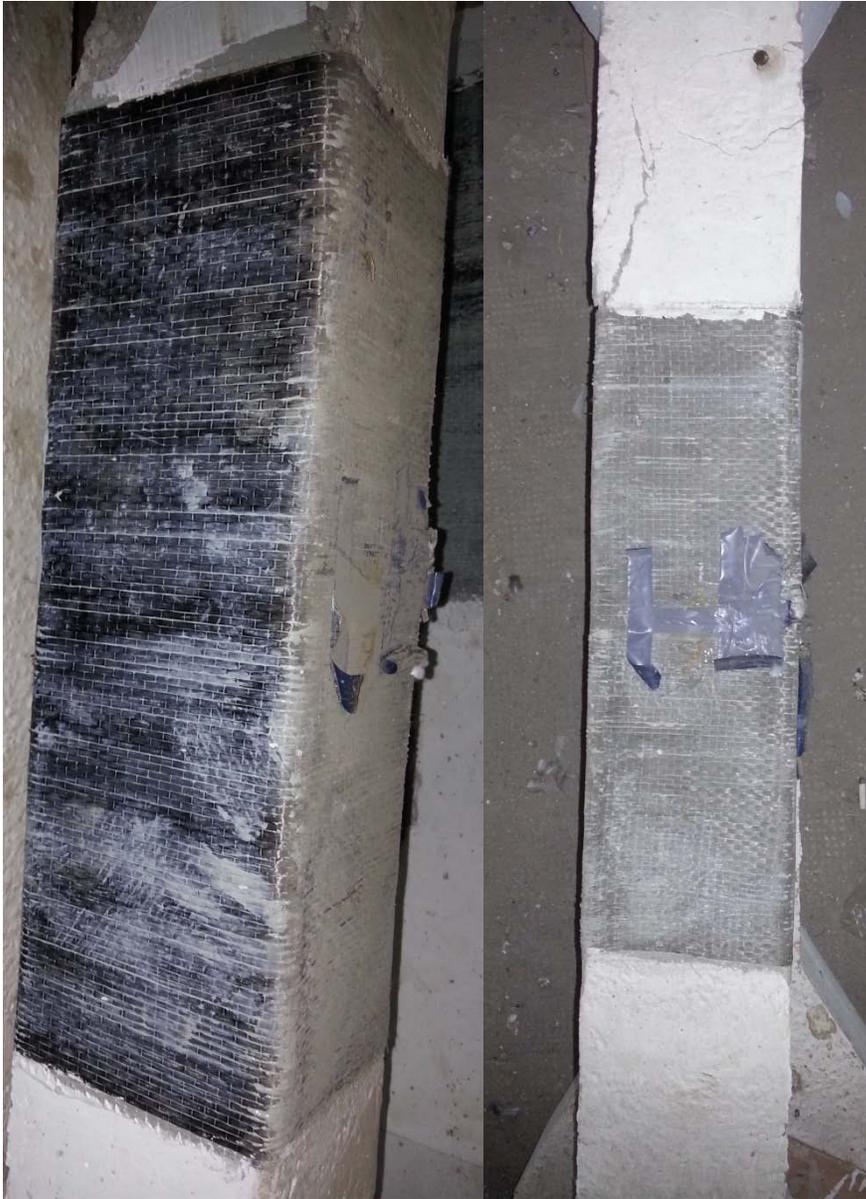
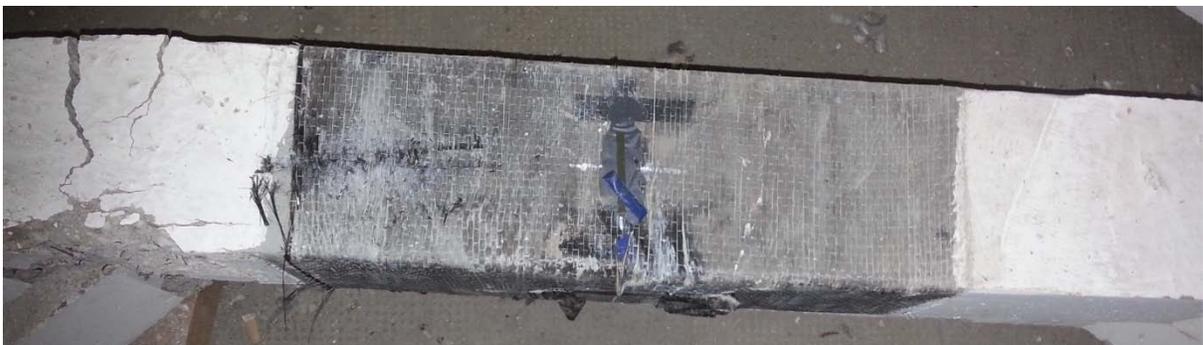
**Photo (12) Mode of Failure for one of the enhanced specimens)**
