Evaluation Study of The Fustat Excavations Site Between The Past, Present And Expected Future

Department of Architectural Conservation and Preservation of Buildings and Archaeological Sites, Faculty of Archaeology, Cairo University, Giza, Egypt.

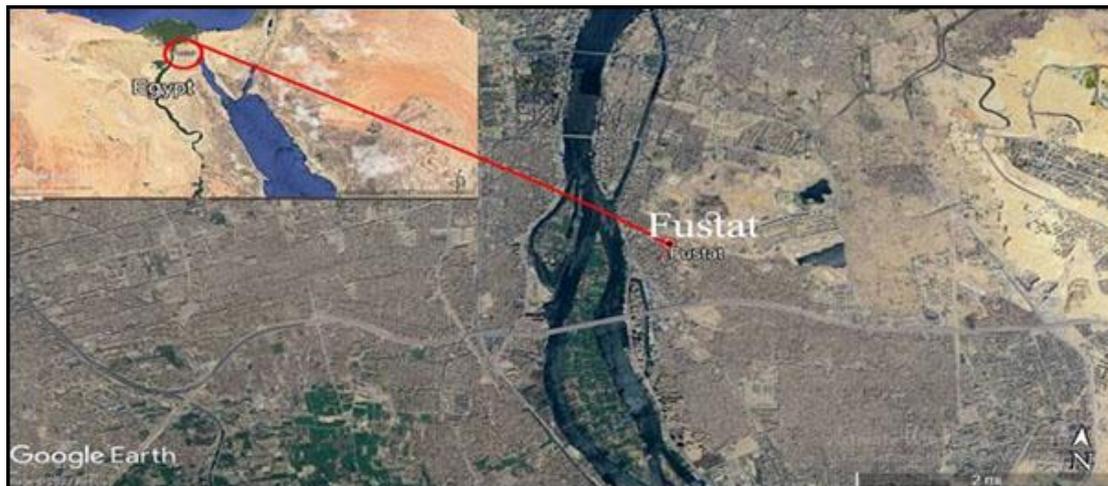
Fig. 1. Aerial photo shows the location of the Fustat archaeological site and the Fustat excavations site within its borders in Egypt (Google earth pro, 9- 1- 2023)

Visiting the Fustat excavations site reflects mixed impressions between an ancient city that was famous for its civilization and history, and some ruins that disappeared due to natural and human factors. The Fustat excavations site is considered part of the Fustat archaeological site (Fig. 1) that includes many archaeological sites, such as the Synagogue of Ben Ezra, the Mosque of 'Amr ibn al-'As, the excavated remains of the old city of al-Fustat, the Nilometer on Al-Roda island, the Al-Manesterley Palace, and Mohammad Ali Palace in Al-Manyal [1].

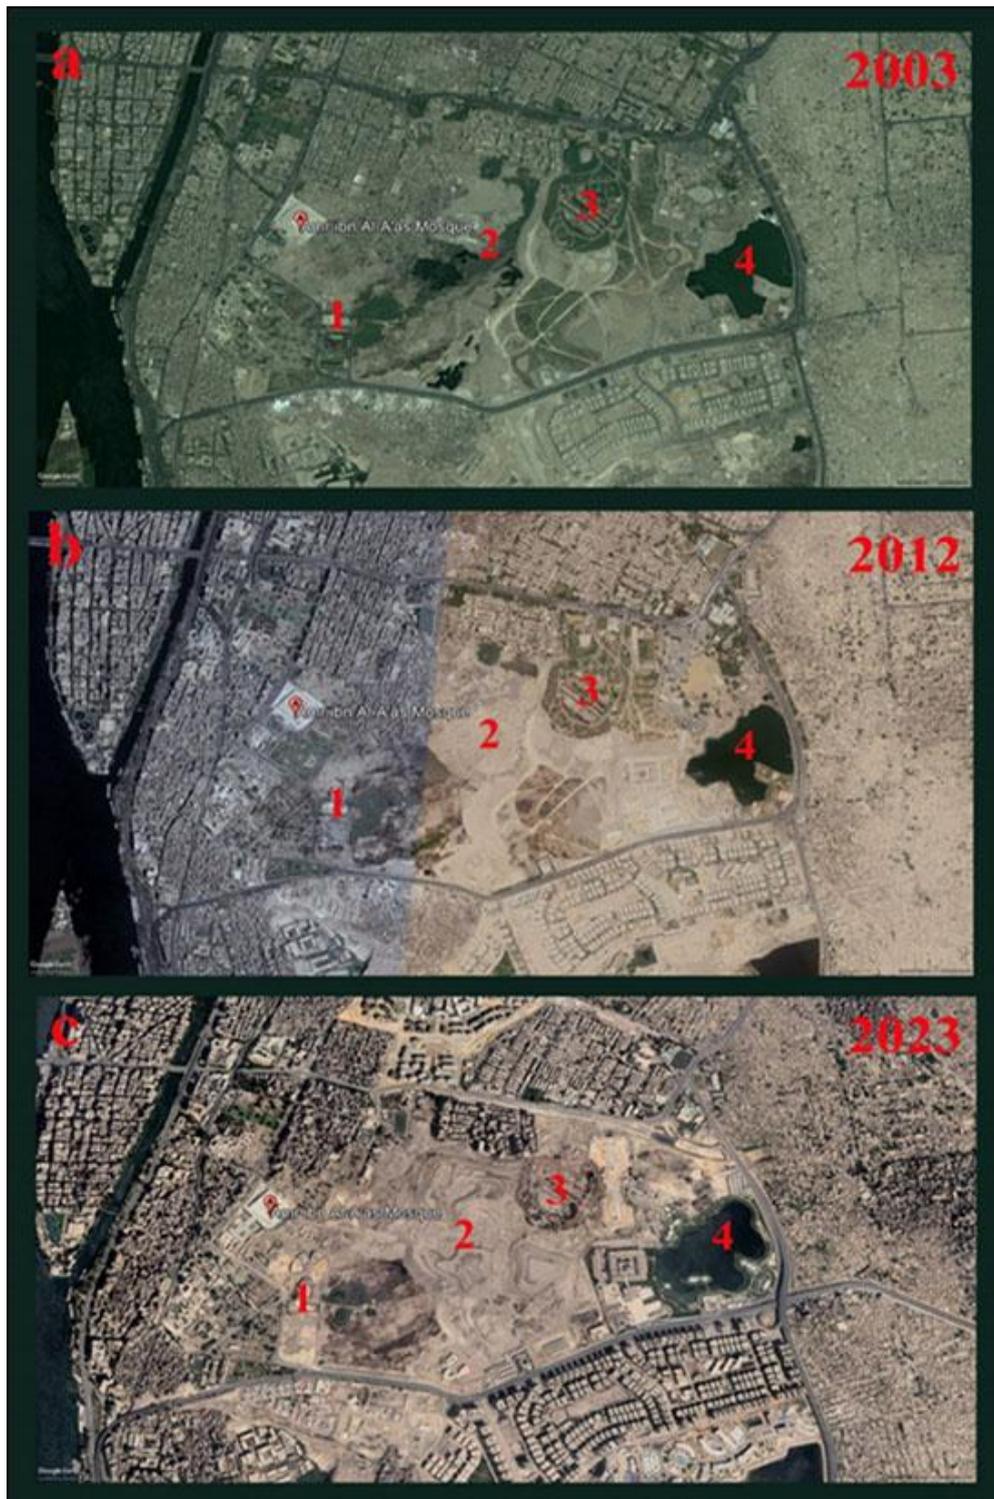
Fustat area suffers from the rise of ground water level [12], due to different factors: a. ground water movement from underground reservoirs through rock fissures [13], b. the low level of the excavation site of +72 feet (+22 m) below the surrounding residential areas with high population density and a high level of ground water + 100 feet (+30.5 m) that causes sewage leakage (Fig. 2), c. gar-

Fig. 2. Aerial photos show the location of the Fustat excavations site in relation to the Nile River on the west and the state of the site during two decades, where 1. Site of the traditional crafts center, 2. the Fustat excavation area, 3. The Fustat Park, 4. Ain El-Sira Lake, a. aerial view in 2003, b. Aerial view in 2012, c. Aerial view in 2023 (Google earth pro, 9-1-2023)

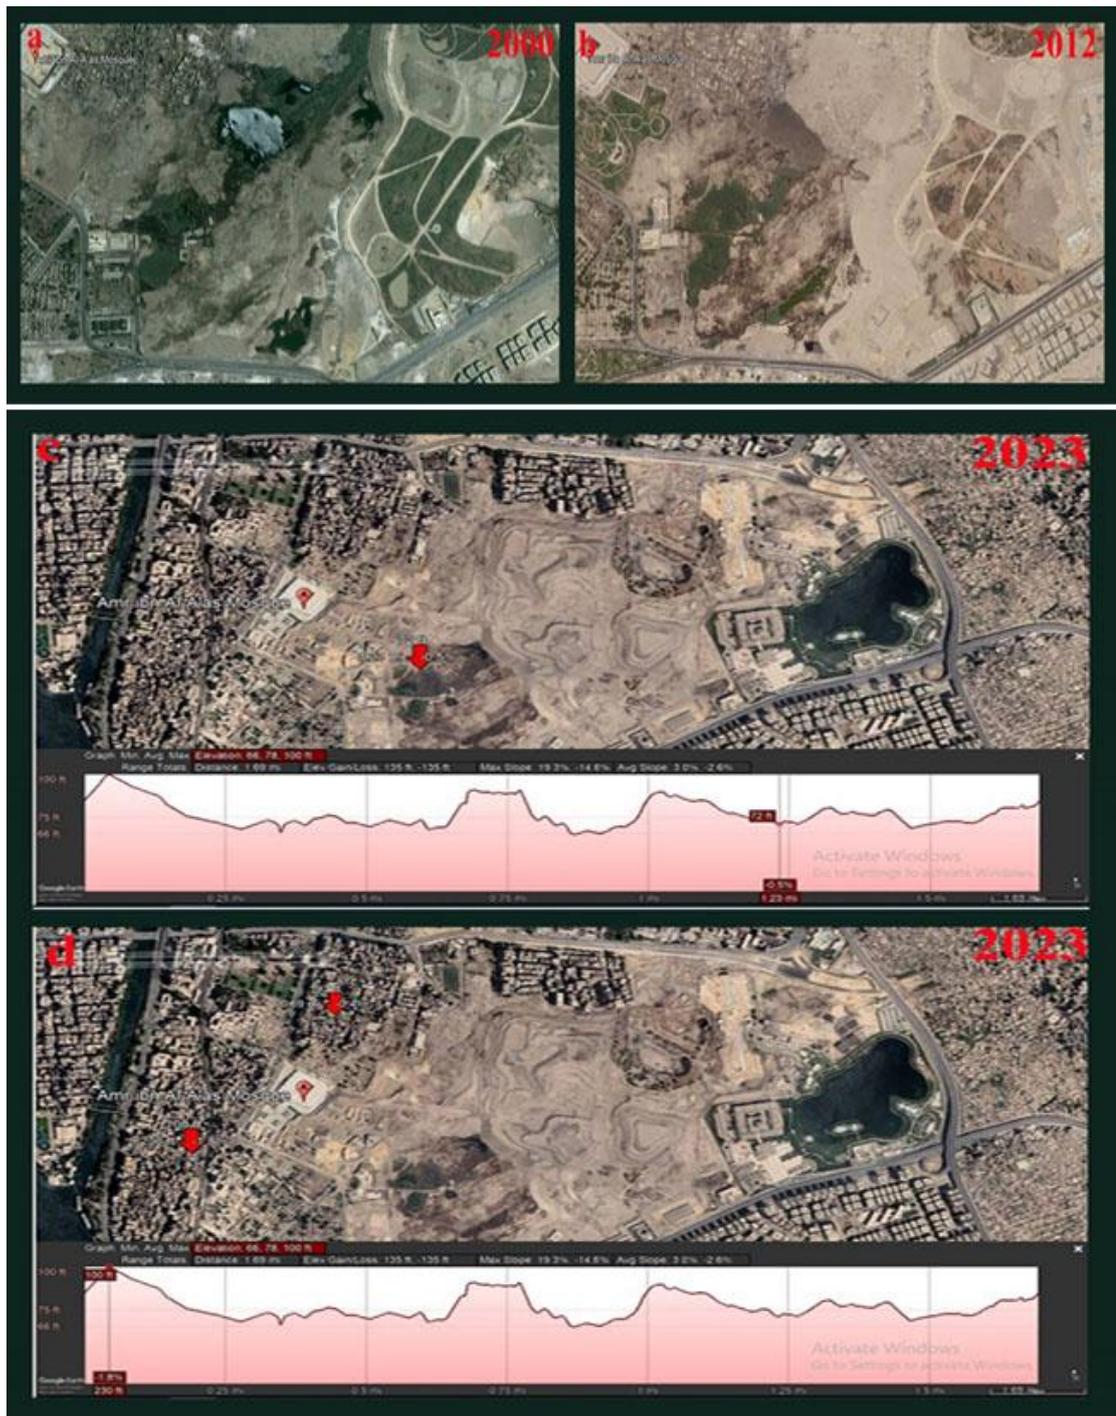
Fig. 3. Aerial photos show the exchange between wet and dry cycles at the site, a. The rise in the ground water level and total immersion of the excavation area, b. Dryness or partial immersion and the appearance of biological damage in some areas of low level, c. The lowest areas in the excavation site (70 - 80 feet), d. The highest areas in the residential surrounding areas (90 - 100 feet), (Google earth pro, 9- 1- 2023).

Environmental variables: are represented by a. the variation of the ground water level and the variation between wet and dry cycles at the site. It is clear from the aerial photographs in 2000 and 2003 that the green area in the site expanded as a result of the biological damage caused by the growth of weeds and plants as a result of the high water level. There is also a noticeable relative decline in the green area in 2012 and its concentration in low-level areas. From recent aerial photographs and from field visits, it is clear that the area is dry, except for some ponds with a lower level, in which the water appears in the form of stagnant water accumulations. b. High temperatures during the day in summer up to 44°C in June and a sharp decrease at night during the winter months less than 10°C in January, with an average monthly rainfall of up to 0.2" in March, November and December. In addition to the high percentage of humidity that can reach up to 65% in Au-

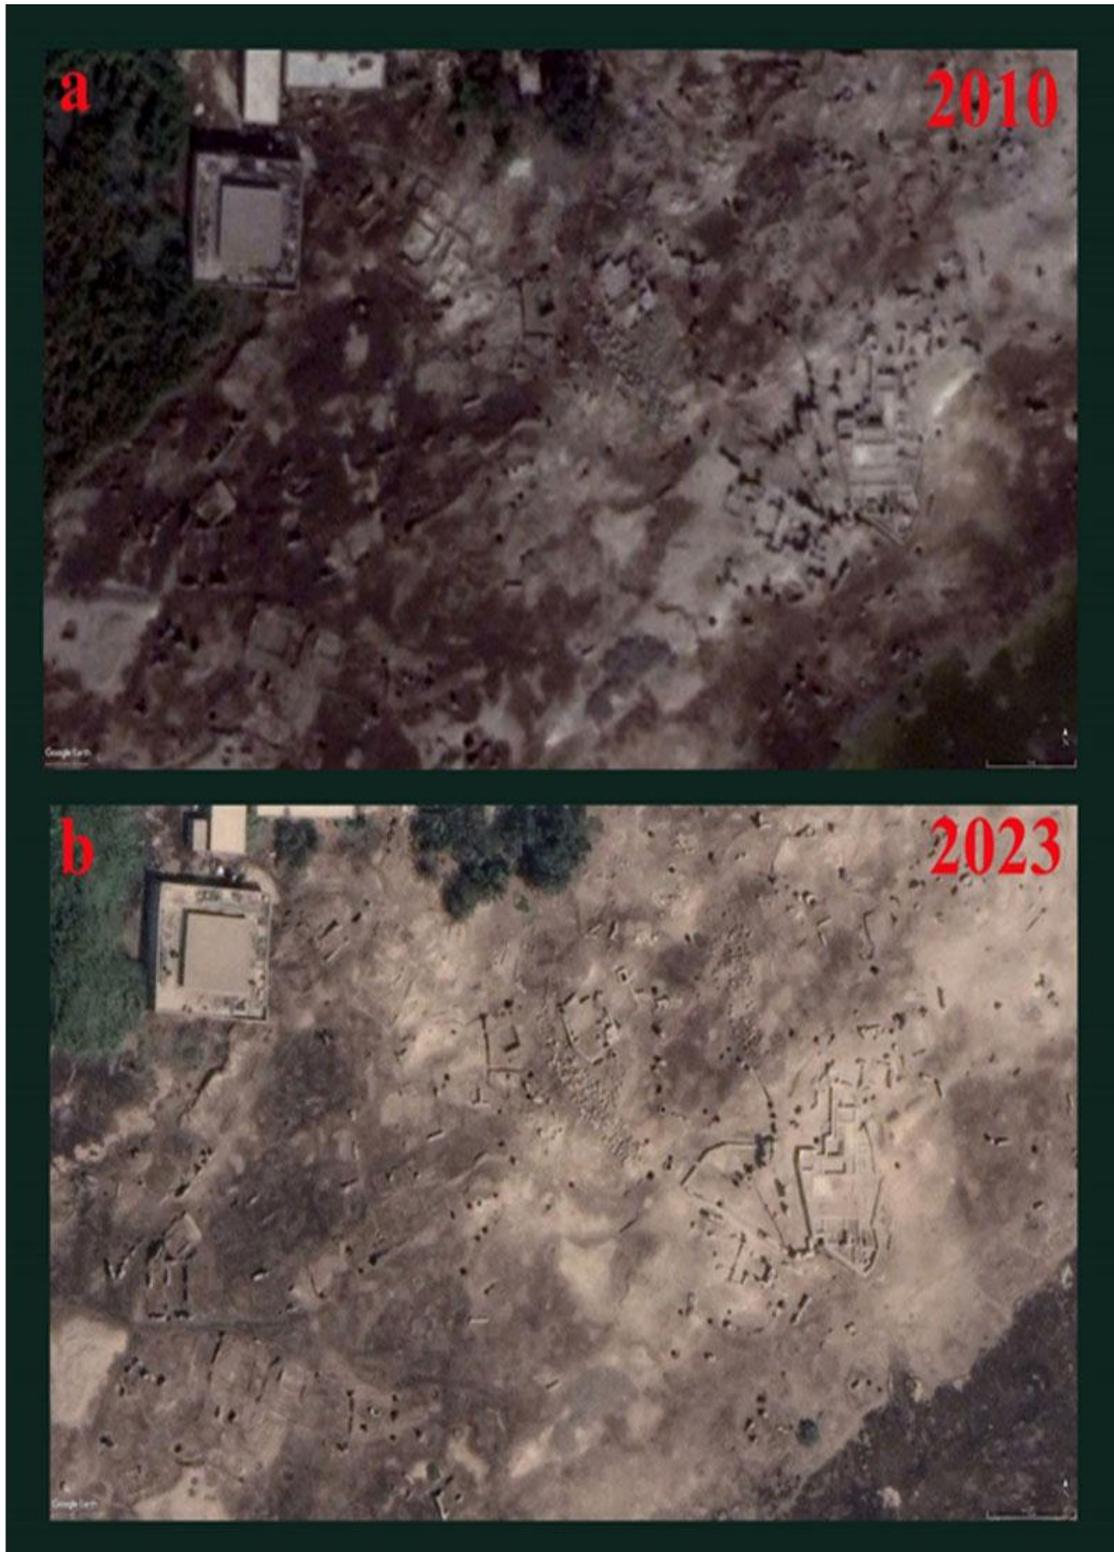
Fig. 4. Aerial photos show the disappearance of the Fustat ruins at a large rate within a short period (13 years), a. The visibility of building foundations, b. Deterioration and loss of building foundations

As a result of environmental and urban variables, it is noted that many archaeological ruins have disappeared at the site in a short period from 2000 to 2023, in addition to the poor state of preservation of the rest of them, which threatens their loss.

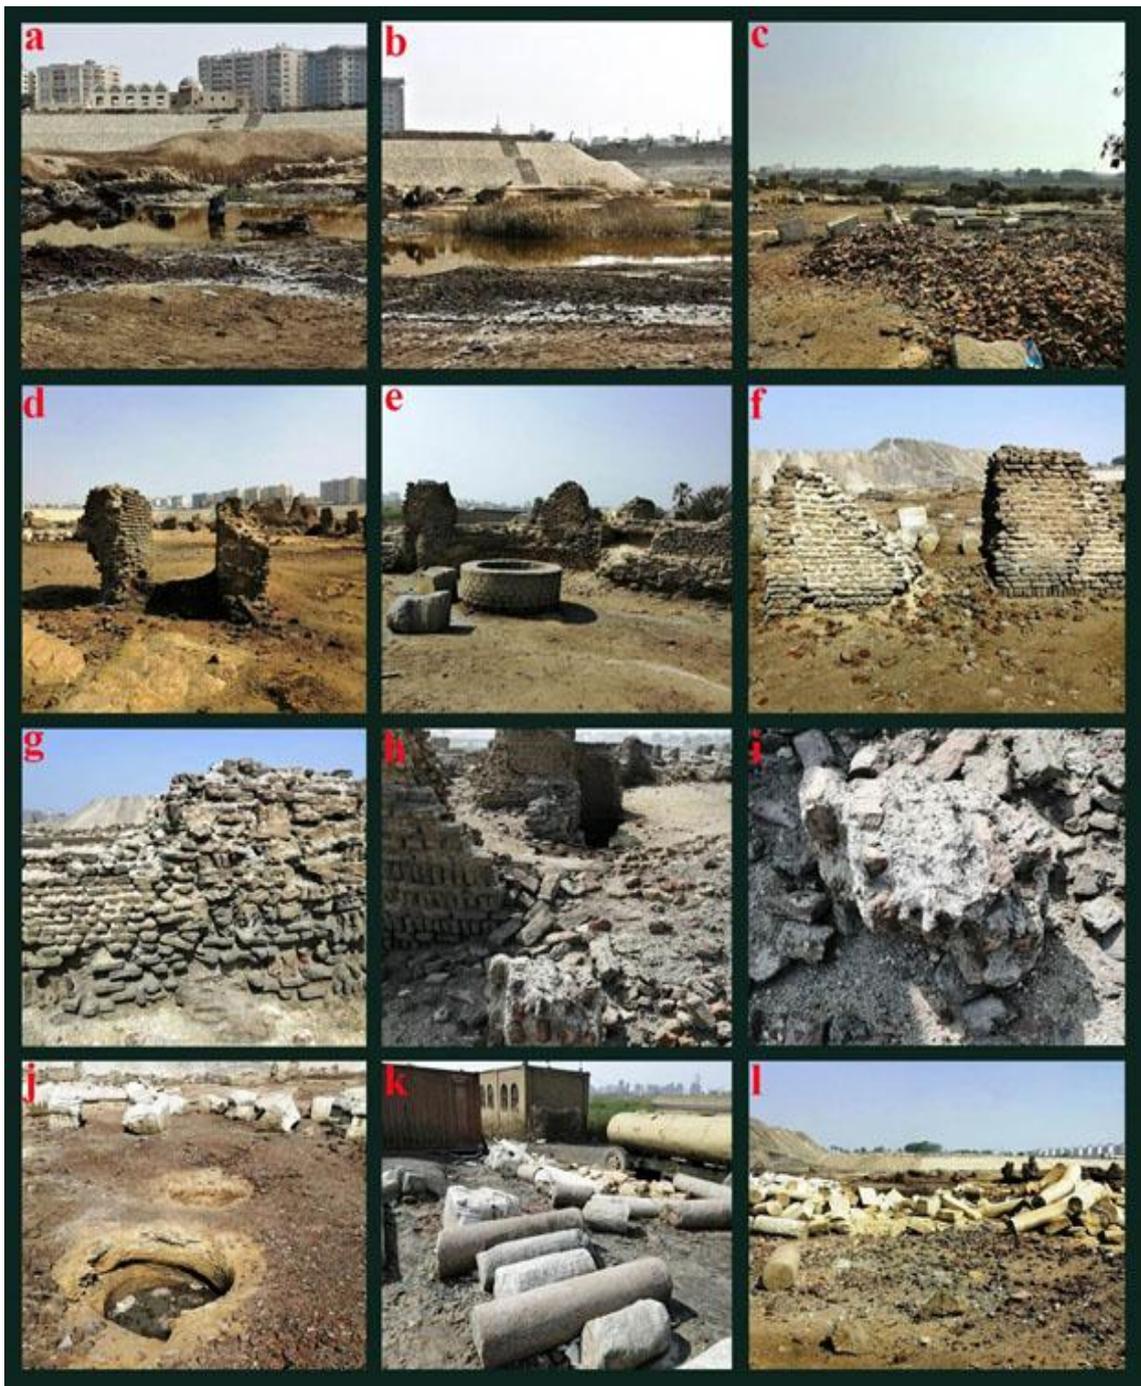
den irrigation water leak, especially after the establishment of the Fustat garden [12]. Underground water seepage has an important effect on the engineering mechanical properties of the soil and its water content which negatively affects the remains and foundations of buildings at the site [14], and also this seepage caused the formation of some lakes such as Ain El Sira Lake that later negatively affected the site [13]. Sewage and irrigation water leakage containing agricultural fertilizers caused ground water contamination with Nitrates, Aluminum and Manganese [15]. The current state of the site is not safe, besides the threat from the rise of ground water level, there are many encroachments from the residents and government agencies, and also there is an urgent need for restoration and intervention to control the loss of the remains of archaeological buildings [2] (Figs. 3, 4 and 5).

Fig. 5. The current state of the Fustat excavations site due to various damage factors, a, b. Ground water intrusion and the formation of ponds and swamps, c, d, e. General deterioration phenomena of the site, f, g. Collapsing of some parts of the archaeological remains, h, i. The fall of stone blocks and the decay of mortars, j, k. Not regulating the site boundaries and defining its protection zone to preserve archaeological remains and ruins, l. Water accumulation and frequency of rising in some areas.

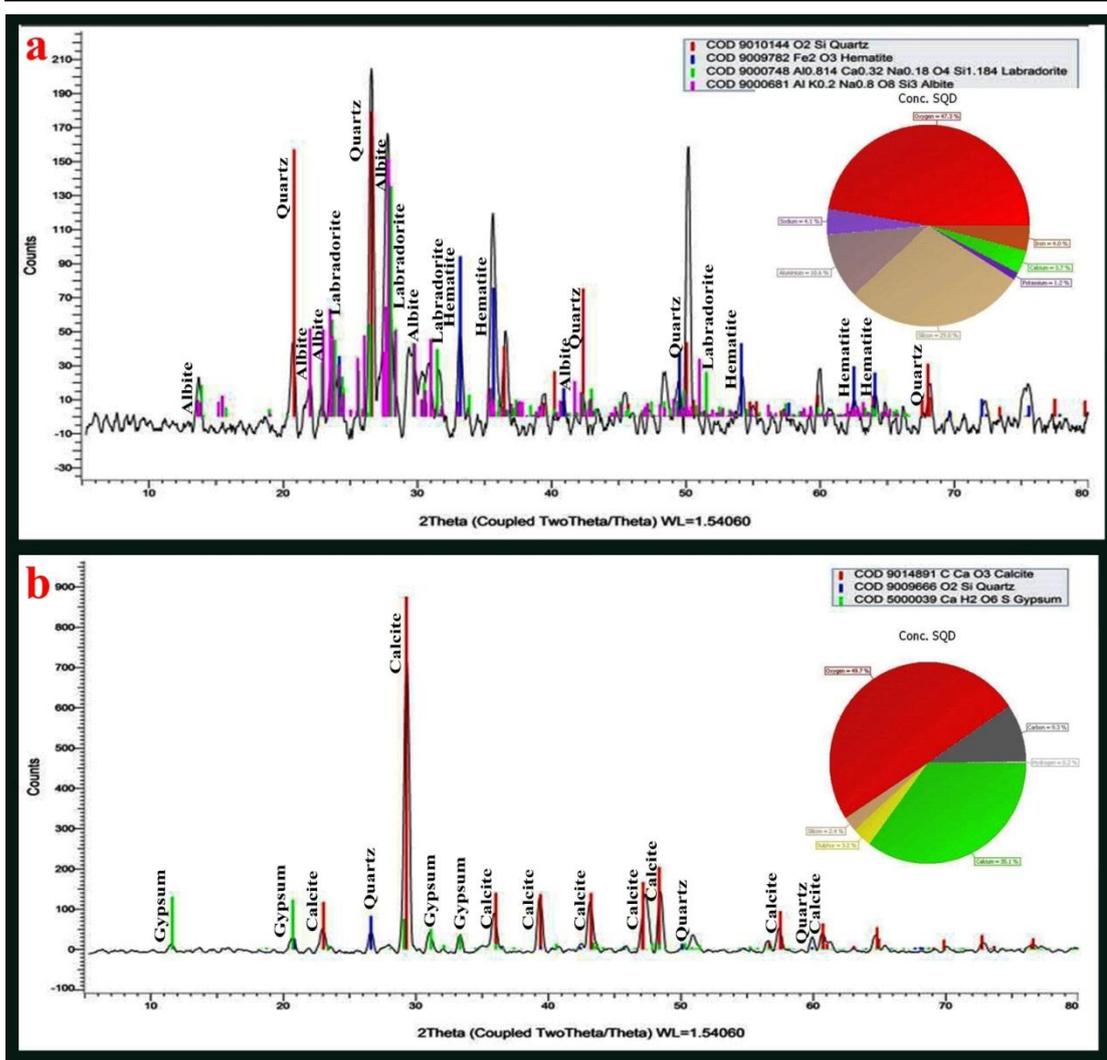
X-ray diffraction results for the main building material (Brick) (Fig. 6 a) showed the presence of Quartz SiO_2 , Hematite Fe_2O_3 , Albite $\text{NaAlSi}_3\text{O}_8$, Labradorite $\text{NaAlSi}_3\text{O}_8$, and Anorthite $\text{CaAl}_2\text{Si}_2\text{O}_8$. The used applica-

tion for results interpretation clarified that the percentages of constituent elements of these minerals are: Silicon 29%, Iron 4.0%, Aluminum 10.6%, Sodium 4.1%, Calcium 3.7% and Potassium 1.2%.

X-ray diffraction results for the building mortar [33], [34] (Fig. 5 b) showed the presence of Quartz SiO_2 , Calcite CaCO_3 and Gypsum $\text{CaSO}_4 \cdot 2\text{H}_2\text{O}$, and the used application for results interpretation clarified that the percentages of constituent elements of these minerals are: Carbon 9.3%, Calcium 35.1%, Sulfur 3.2%, Hydrogen 0.2% and Oxygen 49.7%.

The results in both samples showed the presence of Gypsum mineral, which may have been used incorrectly in previous restorations or as a result of chemical deterioration of calcium carbonate due to the effect of sulfur oxides (as insoluble salt), taking into account what Gypsum does as a source of moisture in the internal structure of the bricks.

The results also showed the presence of both sulfur and sodium due to the deterioration of sewage lines and air pollution gases and the inclusion of those swamps by sulfur bacteria. It leads to weak internal bonds and fragmentation of brick constituents, as it encourages microbiological growth.

Fig. 6. a. X-ray diffraction results of the main building material (brick) with the percentages of the elements in it, b. X-ray diffraction results of the building mortar with the percentages of the elements in it.

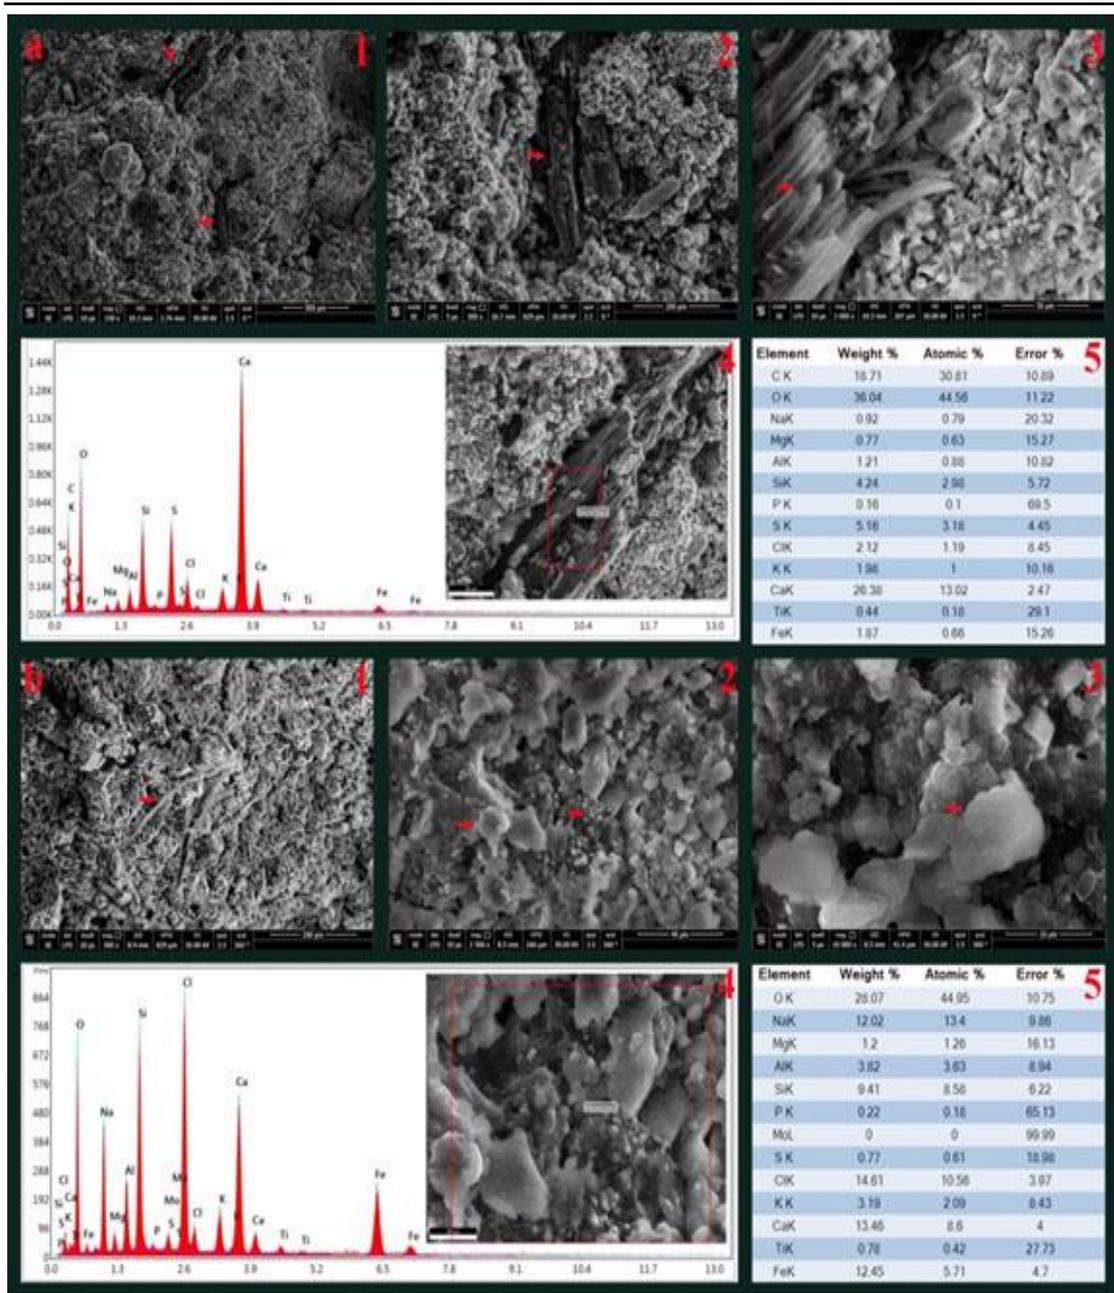
First: The results of the analysis of the fired brick sample using the EDAX unit (Figure 7a1-6a5), showed the availability of calcium, sodium, sulfur, potassium, iron and chlorine in varying proportions, which confirms the spread of calcium sulfate and halite salts. This is illustrated by the results of the examination with a scanning electron microscope of salt crystals.

Second: The results of the mortar sample analysis using EDAX unit (Fig. 7b1-7b5), also showed the availability of chlorine, sulfur and sodium elements, but more than brick constituents, due to the mortar's ability to keep these constituents of salts more than the brick.

This appears remarkably in the results of the SEM examination, where salts and cracks are widely spread which create internal mechanical pressure leading to a weakening of the bonds of the mortar constituents.

Fig. 7. SEM and EDAX results of fired brick and bonding mortar samples that were taken from the Fustat excavations site.

7a. SEM and EDAX results of the main building material (fired brick) and bonding mortar, a1. Organic matters involved in the composition of the brick and formation of clay minerals, a2. Decomposition of organic matter, a3. Clay minerals formation, a4. and a5. EDAX results of the fired brick sample.

7b. Fossil remains within the composition of mortar, b2. and b3. Pores and degradation of crystals, b4. and b5. EDAX results of the bonding mortar sample.

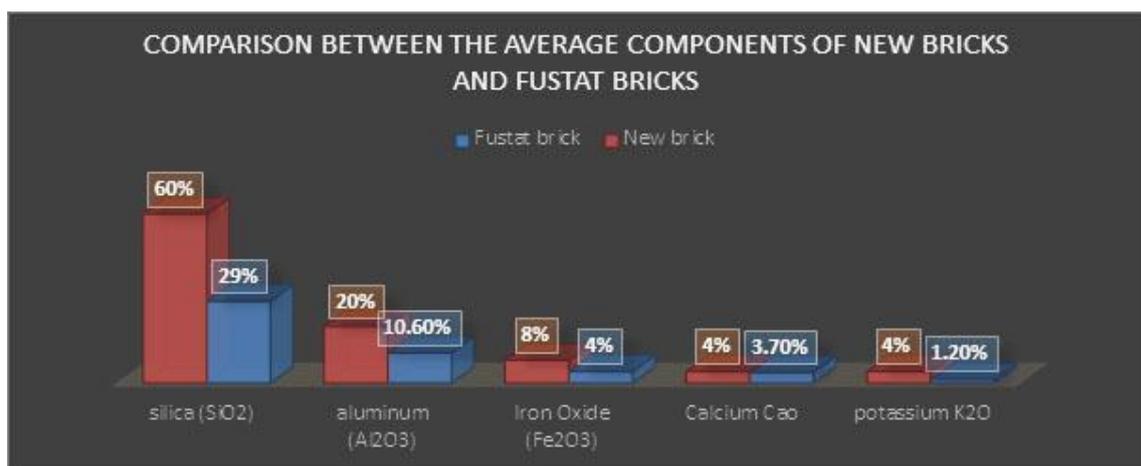
A comparison was performed with standard samples of brick and mortar, to define their state (Table 4), (Fig. 8). As for the presence of Silica in brick, good quality brick should contain about 60% of silica [18], [19]. By comparing this percentage with its percentage in the studied samples, a clear decrease of 51% from the specifications of the good-

fired bricks can be noticed, which caused the ruins to be fragile.

Good-fired bricks should contain about 20% of alumina [20], [21]. By comparing this percentage with its percentage in the studied samples, it became clear that there was a significant decrease in the percentage of alumina, as it decreased by 47% from the specifications of good quality bricks, which made it subject to shrinkage and cracking, and is susceptible to absorbing water.

of lime decreased by 7.5% from the specifications of good quality bricks, which subjected the granules of the bricks to disintegration and non interconnection.

A small quantity of Iron oxide (6-8%) is desirable [20]. By comparing the percentage of the iron oxides in the standard brick sample and the constituents of the Fustat bricks, the percentage of iron oxides is decreased by 50% of the specifications of good quality bricks. This decrease caused color change and made it softer and weaker.

A small quantity of Potassium (4%) is required for good quality bricks [19], but the percentage of Potassium in the studied samples decreased by 70% of these specifica-

tions. This decrease negatively affects the structure of the brick.

Fig. 8. Indicating the comparison between the average constituents of new brick and Fustat brick

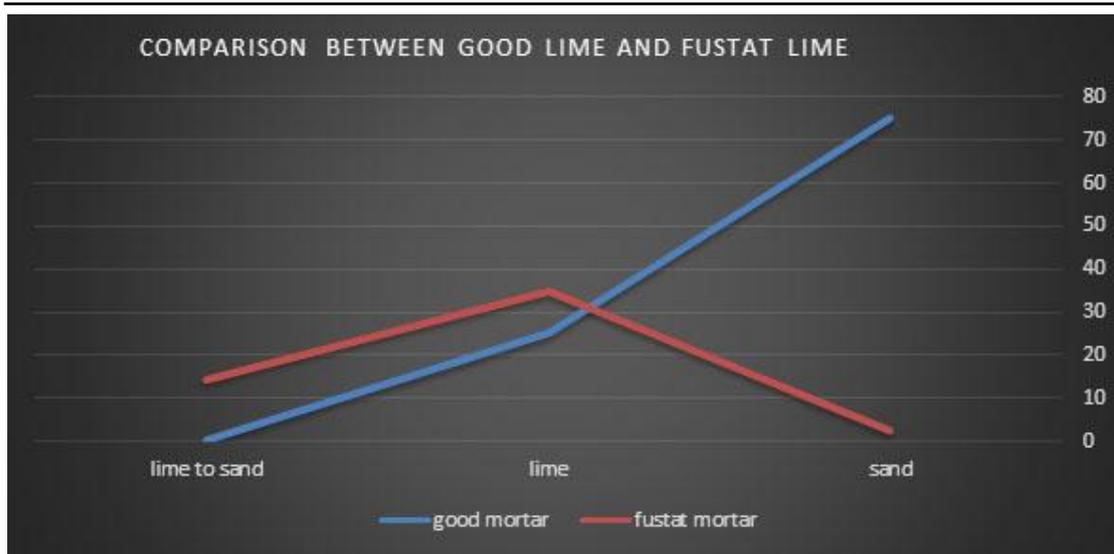
As for mortar (Fig. 8, Table 4), (Fig. 9, Table 5), the results of the X-ray diffraction analysis showed a decrease in the percentage of sand in the mortar in relation to lime which was significant and weakened the mortar and made it unable to withstand the acting forces.

Perhaps this is due to the weakness of the bonding strength of lime due to various deterioration factors which made it lost its most important mechanical properties; tensile and compressive properties. This led to the falling of the mortar layer after layer and it was followed by brick falling.

Fig. 9. Indicating the comparison between the constituents of good quality lime mortar (standard sample) and Fustat lime mortar (studied samples).
