## *Prestressed hollow-core slabs performance at high temperatures- A review*

**Yasmin Hefni Abd El Aziz**

MTI Modern University for Technology & Information, Cairo, Egypt

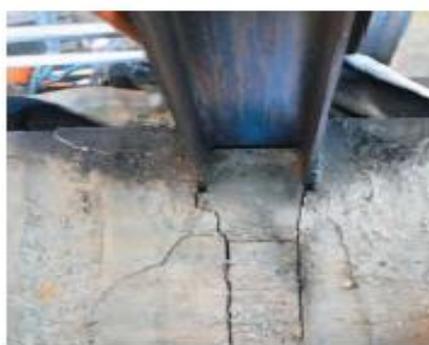
Figure 3: The impact of HCS restraint on its failure [11]

Bailey et al. (2008) investigated 2 full-scale tests, which were conducted on 15 HCS with very intense fires supported by protective steel construction. The fire compartment measured 7020 x 17760 x 3600 mm. The joints between the units were filled with grout. The only variation among the two tests was the end restraint conditions for HCS. In the first test, the units were grooved all around the columns, and slabs were placed directly on the supporting beams. Grout made of C25/30 concrete was used to fill the joints between the HCS and the spaces between the columns and the HCS. During the second test, T12-U bars were positioned in the centers, and a shear stud with a diameter of 19 mm was fastened to the steel beam. Grout filled the spaces between units and steel columns, the cores containing the rebars, and slab ends. Cracking was observed at the centre edge of the column, highlighting that the column was pulled out rather than the units. Test results demonstrated that the steel frame doesn't constrain the units' longitudinal thermal expansion, but because there was no shear failure during the test, it is conceivable that another load-path process was taking place. Additionally, it was noted that a lateral compressive strip formed at the units' ends due to resistance to thermal expansion. Depending on this study, it was found that the compressive strip behaves favourably by raising the unit flexural and shear capacities [11]. Figure 3 clarifies the effect of HCS restraint on its failure.

a Cracking around internal edge column

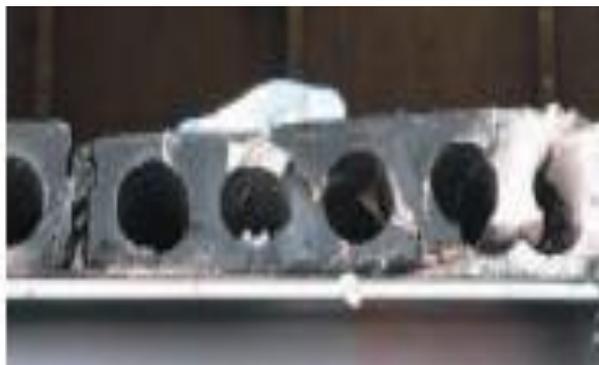
b Compression damage of edge units

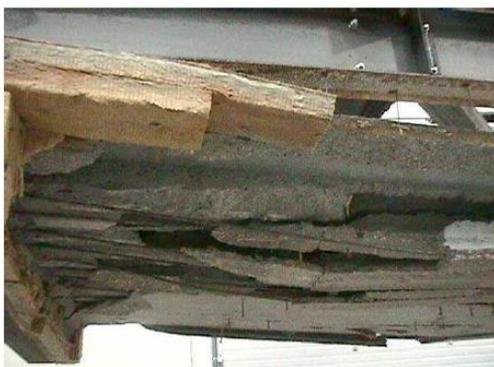
However, only the test-significant correlations for unprotected HCS components exposed to ISO 834 fire were published by Schepper L. and Anderson N. E. (2000). The decks in this project are made of 220mm of pre-stressed HCS, an 80mm cast-in-situ topping of reinforced concrete, and HCS that has been partly filled with shear reinforcement. According to the visual observations, the slab bottom experienced compression failure due to a negative moment at support. Failure of components with cast-in-place reinforced concrete topping occurred after 23 minutes, and the deflection at that time was 250 mm after the fire test. Figure 9 depicts the compression failure of the slab components at the front of the furnace. [5]

Figure 9: HCS Slab failure after fire [5]
