Advanced Research in Conservation Science

Archaeometric Study and Restoration Implementation of Archaeological Roman Adobe Bath at Karanis – Fayoum, Egypt

Mahmoud Abd El Hafez M. Adam

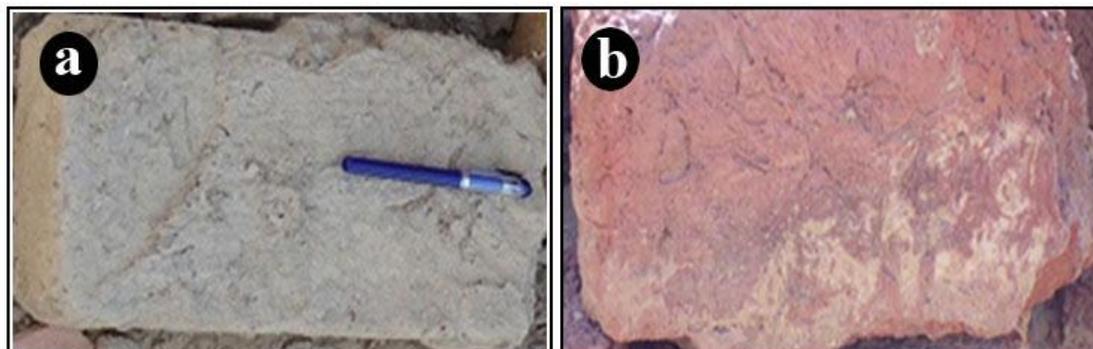
Fig. 4. Shape and dimensions of mud bricks and fired bricks at the archaeological site (a) Mud brick blocks, (b) Fired brick blocks.

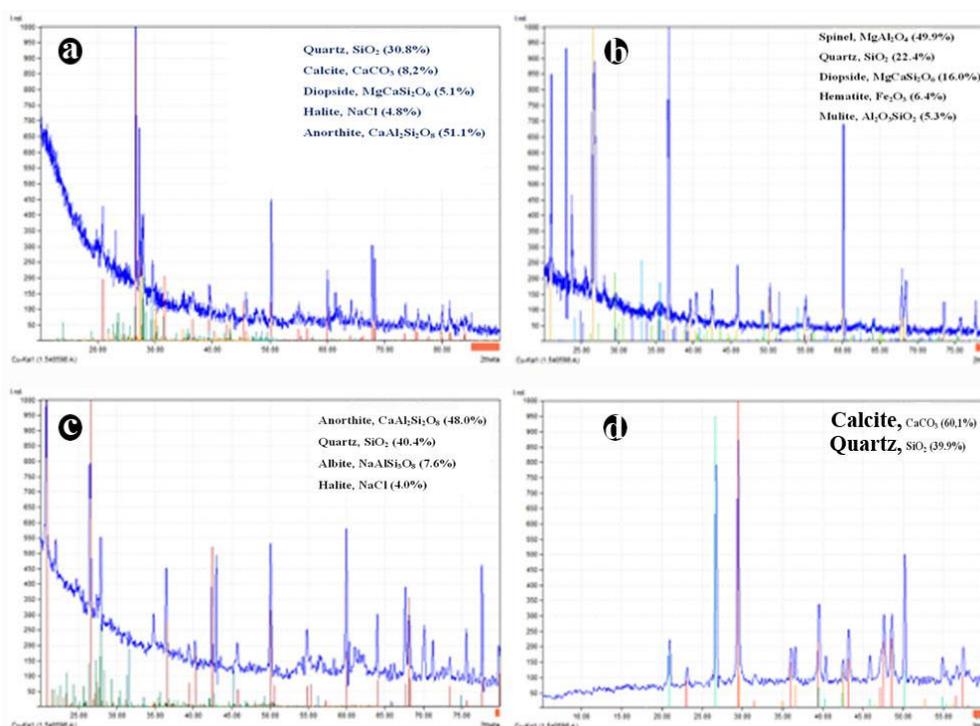
The results of mineralogical analysis by X-ray diffraction (XRD) of mud brick samples (Fig. 6a) showed that they contain quartz mineral (SiO_2) and plagioclase feldspar "anorthite" ($\text{CaAl}_2\text{Si}_2\text{O}_8$) in large proportions, which reflect the addition of a high percentage of sand within the mixture of mud brick. The mineral anorthite is one of the plagioclase

With regard to the mineral components of the archaeological fired bricks, the mineralogical analysis by XRD proved that the fired bricks are of medium to high burning type, according to the mineral components that appeared in the analysis, the most important of which are: spinel (MgAl_2O_4), quartz (SiO_2), diopside ($\text{MgCaSi}_2\text{O}_6$), hematite (Fe_2O_3) and mullite ($\text{Al}_2\text{O}_3\text{SiO}_2$) (Fig. 6b), some of these minerals gave the fired bricks their red color. It is well known that the quartz mineral mainly exists in the components of all muds or clays. Some minerals, such as diopside and mullite, appeared in the high burning temperatures. Moreover, calcite reacts with silica to form diopside at 850 °C, while mullite appears at 950 °C [9], [14], [15]. It is worth noting that the mineral composition of mud mortar did not differ from the mineralogical composition of mud brick, and this is common in adobe architecture, as the mud mortar was composed in the studied samples of anorthite ($\text{CaAl}_2\text{Si}_2\text{O}_8$), quartz (SiO_2), albite ($\text{NaAlSi}_3\text{O}_8$) (both albite and anorthite are plagioclase feldspar minerals) and halite (NaCl) (Fig. 6c). As for the lime mortar, it

was mainly composed of lime and sand, and for this reason the main minerals were: calcite (CaCO_3) and quartz (SiO_2) (Fig. 6d). It is noteworthy that the mortar used for the construction of fined brick walls consist of a fine white-yellowish calcium-carbonate matrix. The main mineral aggregates embedded in the matrix are the local quartz sand and fine gravel in different grain sizes. The dominant feature is the low content of silt and very fine sand in the mortars and plaster. Silt and fine to coarse grained sand are inherited components of the local desert sand, which

Fig. 6. XRD patterns of the studied samples (a) Mud brick, (b) Fired brick, (c) Mud mortar, (d) Lime mortar.

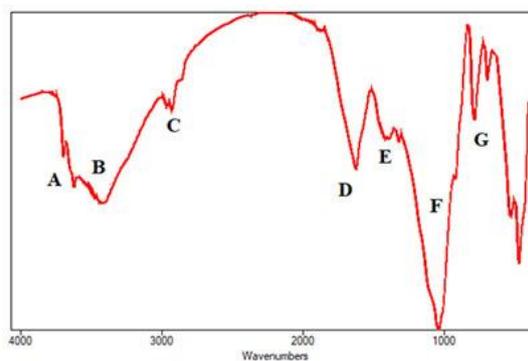
FTIR spectroscopy was used to characterize the minerals and organic content of the archaeological mud brick. The FTIR spectrum of mud brick samples are presented in Fig. 7, and Table 3 lists the characteristic infrared bands of mud brick samples. The results confirmed the presence of kaolinite as a basic clay mineral in the mud bricks, moreover, the results confirmed the presence of silica, which is a clear indication of the abundant use of sand in the mud brick manufacturing. Furthermore, the results showed that the mud brick contained an organic substance of cellulosic origin, which reflects the use of straw among the components of mud brick, and perhaps other plant materials were used beside the straw, but most likely that the use of straw in the manufacture of mud brick was more common, especially in that period. As for the water in the samples, as proven by the analysis, it represents the mixing water or

Fig. 7. FTIR spectrum of mud brick samples from Roman bath in Karanis.

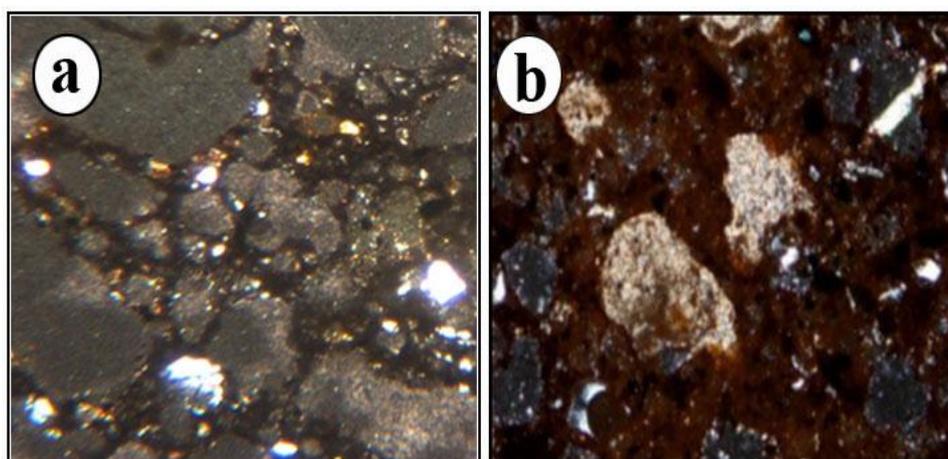
brick samples shown in Fig. 8 a, b showed the presence of quartz as very fine to fine-grained (sand and silt size), rounded to angular in shape, cemented by clay minerals and iron oxides. Mafic minerals occur as very fine to fine-grained, flaky and prismatic crystals scattered in the samples. Clay minerals are deformed as a result of thermal processing. Some parts of the samples are stained by iron oxides. The samples are highly porous due to the presence of remarkable irregular pore spaces and cavities in the brick.

Fig. 8. PLM photomicrographs of studied fired brick samples (a) Showing quartz in rounded shape of very fine to fine-grained size, in addition to clay minerals and carbonate as cement materials, moreover iron oxides, pores and cavities are shown (25 X, CN.), (b) Showing quartz in rounded to angular shape, iron oxides, concretions of carbonates or clays floating in the clay cement, fragments and mafic minerals (10 X, CN.)

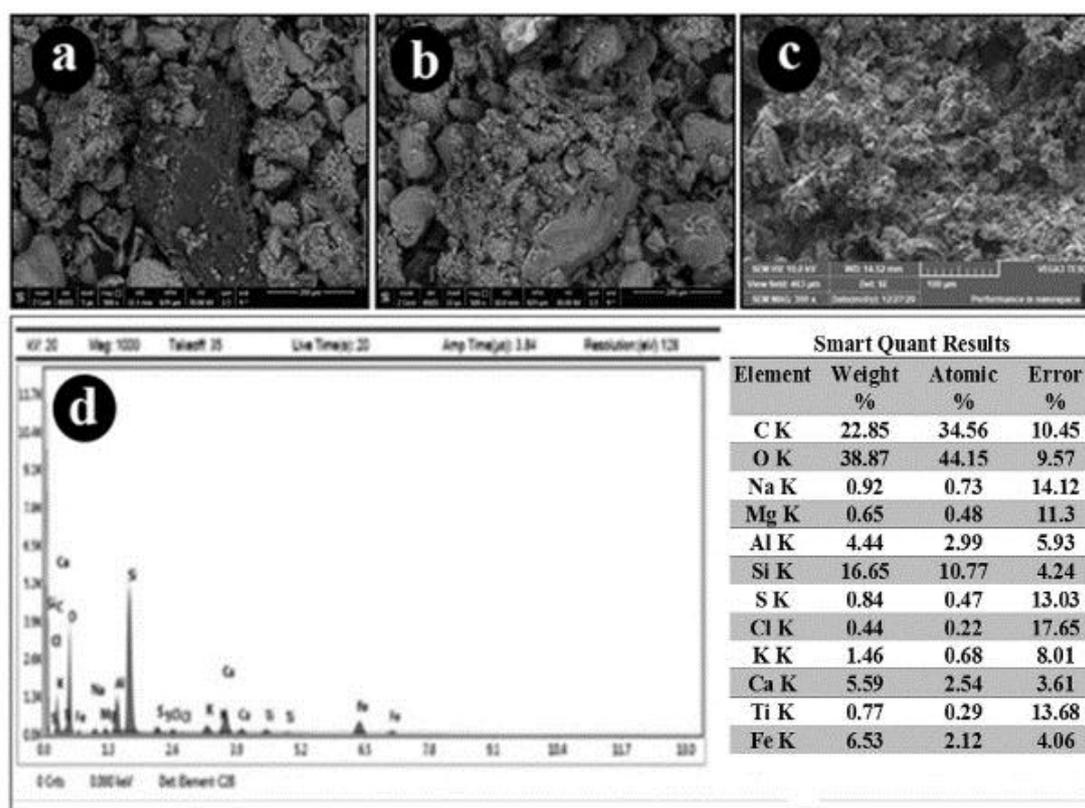
Scanning electron microscope supported by a semi – quantitative (EDX) unit was used in this study to identify the morphological features of mud brick, mud mortar, and fired brick, as well as elemental analysis of mud brick samples. SEM investigation showed the morphology of the internal structure of mud brick, mud mortar, and fired brick. It is clear that both mud brick and mud mortar were subjected to severe weathering in the desert regime, as the mud bricks contain many pores and voids. Weathering is also evident on quartz (sand) grains. Some quartz grains have sharp angles, while most quartz grains have rounded edges due to weather-

ing. Many grains of quartz and other mud brick components are disintegrated, and the same manifestation is observed in mud mortars as well (Fig. 9a, b). Moreover, SEM investigation of fired brick showed a relative homogeneity with some blanks due to weathering processes and the lack of good kneading as well as the lack of good pressing of mud components within the wooden mould used in the brick manufacturing, as shown in Fig. 9c. Through the results of the elemental analysis with (EDX) unit for mud brick samples, it was noted that silica is the main component of the samples. Iron, calcium, aluminum and potassium were found in various percentages (Fig. 9d) [19], [20].

Fig. 9. SEM-EDX results of studied samples (a) SEM photomicrograph of mud brick, (b) SEM photomicrograph of mud mortar, (c) SEM photomicrograph of fired brick, (d) Energy dispersive X-ray (EDX) spot analysis of mud brick samples
