Effect of Impact Angle on Slurry Erosion Behaviour and Mechanisms of Carburized AISI 5117 Steel

The paper reports a study of slurry erosion of carburized AISI 5117 steel using whirling-arm rig. The study is mainly focused on studying the erosion wear resistance properties of AISI 5117 steel after carburizing at different impact angles. The mechanisms of erosion wear at different impact angles are presented using SEM examination of eroded samples. In addition, the SEM images of eroded samples at different stages are presented for better understanding of erosion mechanisms at different angles. The tests were carried out with particle concentration of 1 wt %, and the impact velocity of slurry stream was 15 m/s. Silica sand having a nominal size range of 250 – 355 μm was used as an erodent. The results showed that, carburizing process of steel increased the erosion resistance and hardness compared with untreated material for all impact angles. The erosion resistance of AISI 5117 steel increases by 70, 57, 60 and 36 % at an impact angle of 30°, 45°, 60° and 90°, respectively as result of carburizing, i.e. the effectiveness of carburizing was the highest at low impact angles. Treated an

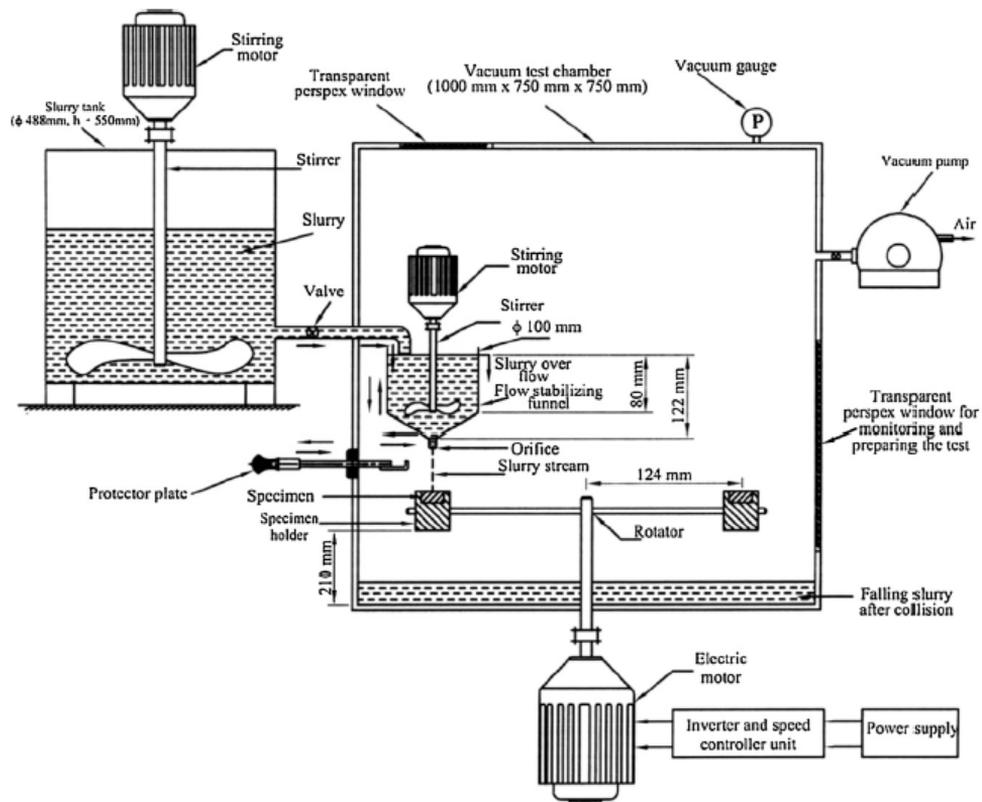
Figure 1 Schematic diagram of the designed slurry erosion whirling-arm rig

Slurry erosion tests were performed using a slurry whirling arm rig, which is shown schematically in Figure 1. The rig consists of three main units: a specimen rotation unit, a slurry unit, and a vacuum unit. Full description of this rig and how it works as well as its dynamics are found in Ref. [12-15]. Two specimen holders are mounted on the ends of two aligned arms, which are tightened firmly to the whirling rotator and balanced for high-speed operation. The effective rotation diameter of the whirling arms is 248 mm. The rotor is driven by a variable speed motor. The specimen holders have tilting and locking facilities to adjust the required inclination of the test specimen. The specimen rotation unit provides impact velocity. During slurry erosion tests, only the front surface of specimen is exposed to the impinging slurry since the sides of the specimen are held by the specimen holder. The front surfaces of the specimens, test surfaces, were of dimensions 23 mm × 10 mm. The impact angle can be adjusted to a required value by rotating the specimen holder around its horizontal axis as shown in Figure 2. The holders are mounted on the ends of the two arms of the rotator which is driven by a variable speed motor.

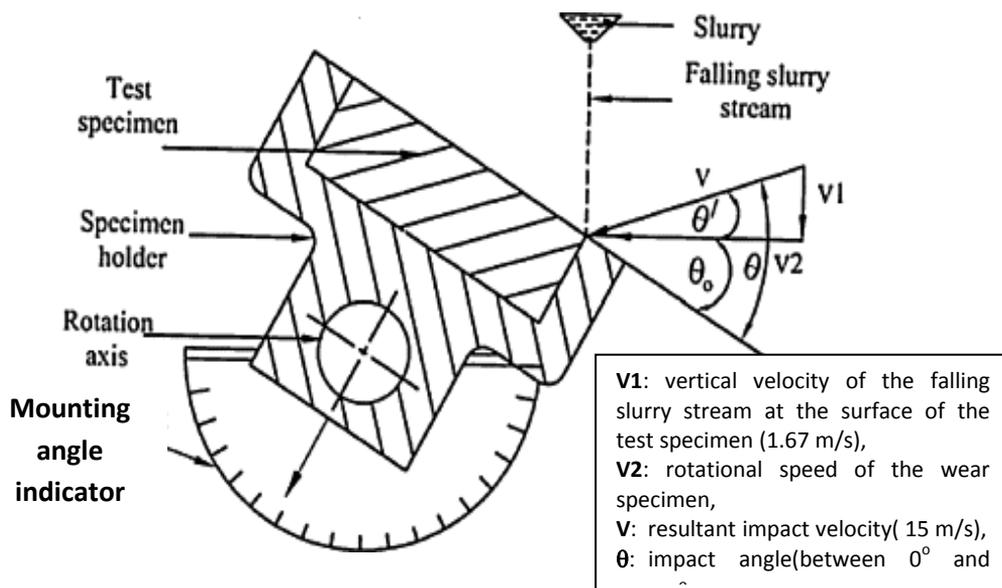
Figure 2 Schematic diagram of impact velocity and impact angle

The difference between the apparatus used in the current study- slurry whirling arm rig - and the other apparatus used in this field is the absence of dependence on time in the present apparatus regarding the comparison among the different impact angles. As shown in Figure 2, the amount of particles which impact the surface of specimen differs from angle to another.

It is important to emphasize that, comparing the effect of different impact angles on the erosion rate at the same test-time will give misleading results. This is due to the fact that, at the same test-time the amounts of particles which impact the surface of the specimen differ at different impact angles. Therefore, the comparison will be performed through subjecting the specimens at all the impact angles to the same amount of particles. In this case, the test time will be different from angle to another. Therefore the erosion rate is defined as that corresponding with the mass loss from a specimen subjected to impact by an assumed fixed mass of slurry particles. The amount of particles which impact the surface of specimen as a function of the impact angle is derived from the geometry of the impacting process, as shown in Figure 2 [13].

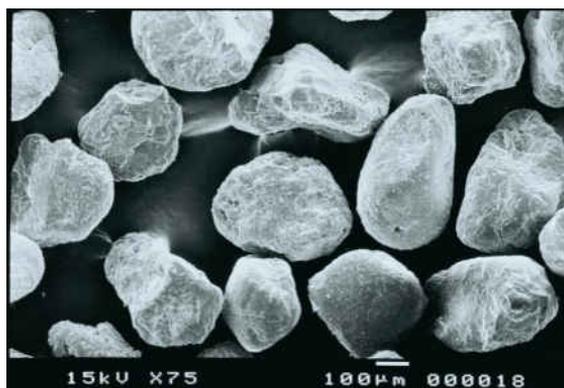
Figure 3 Scanning electron microphotograph of silica sand (size range, 250-355 μm)

Natural silica sand, sieved to a nominal size range of 250 – 355 μm was used as an erodent. A scanning electron microscope (SEM) photograph of typical sand particles is shown in Figure 3. These particles were characterized using an image analysis method in terms of the aspect ratio (W/L) and roundness factor ($P^2/4\pi A$), where W is the particle width, L is the particle length, A is the projected area of the particle, and P is its perimeter. The statistical values of the particle parameters are given in Table 3.

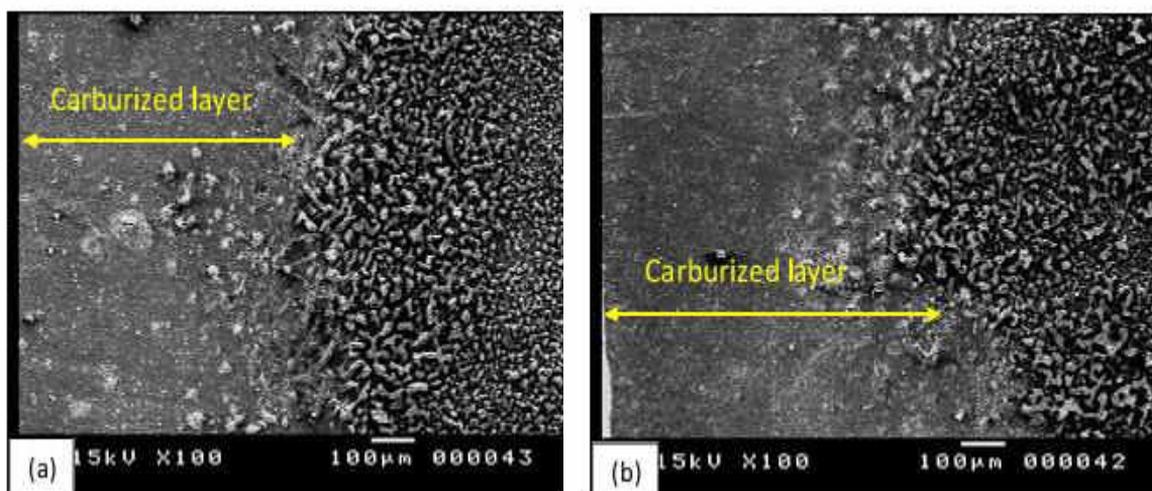
Figure 4 SEM micro photo graphs showing microstructures of (a) Carburized case depth for 6 h and (b) carburized case depth for 12 h

SEM micro photo graphs of the microstructure of carburized steel specimens at 6 and 12 h are shown in Figure 4. From these photos the treated layer can be easily distinguished from the core material. As can be seen in the Figure 4, the carburized case depths are approximately 0.65 and 0.95 mm for 6 and 12 h treated material, respectively. It can also be observed that microstructure near the surface is martensitic with small amount of retained austenite for treatment time of 6 h (Figure4 (a)). For the treated specimen for 12 h, microstructure near the surface is almost completely martensitic due to the high carbon content and again small amount of retained austenite can be seen as well, Figure 4 (b).

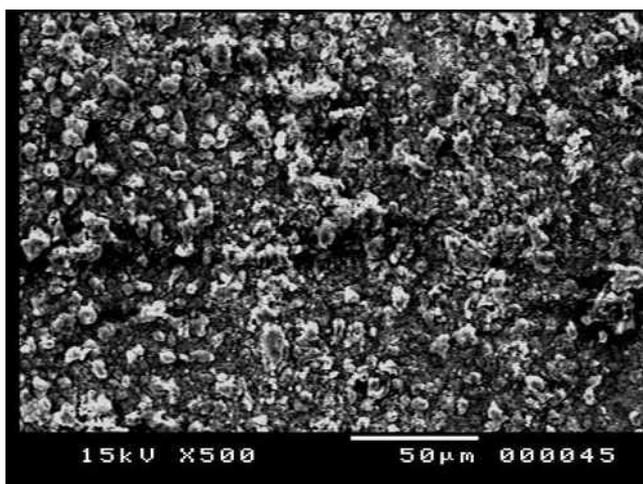
Figure 5 SEM micrograph showing martensite-austenite microstructure in case of carburized steel AISI 5117

Figure 5 is a SEM micrograph showing the typical martensite – austenite microstructure formed close to the surface of carburized steels. The high-carbon martensite (appears dark in the photo) is formed by diffusion-less and shear transformation of the austenite. The white areas of Figure 5 are regions of austenite that have not transformed. This austenite is referred to as retained austenite and is present because of the high stability of high carbon austenite. Retained austenite plays a significant role in the fatigue of carburized steels [16].

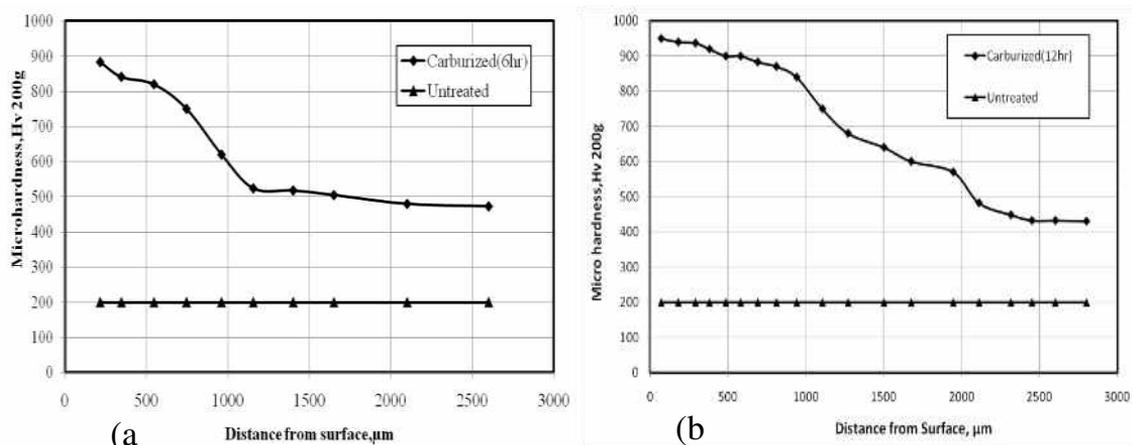
Figure 6 Hardness distribution of treated and untreated material:
(a) treated for 6 h and (b) treated for 12 h

Figure 6 shows micro-hardness profiles obtained from cross sections of treated and untreated samples as function of depth. The hardness at or near the surface attains to more than approximately 883 HV and 950 HV in the 6 and 12 h treated materials, respectively. The hardness of the untreated specimen is 200 HV and is constant with depth. The hardness of treated materials decreases gradually with the depth and reaches a constant value at the cores. The hardness at the cores is 473 HV and 430 HV in treated materials for 6 and 12 h, respectively.

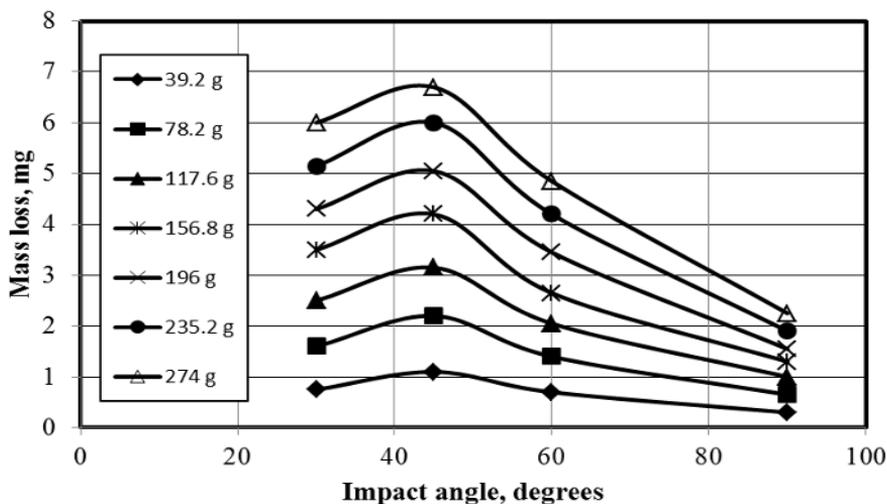
Figure7 Relationship between the mass loss of untreated material and impact angles for different masses of erodent

Figures 7 and 8 (a, and b) show the relationship between the mass loss and impact angle for different masses of erodent for the untreated and the carburized specimens. All the erosive wear curves for the untreated and the carburized specimens show similar characteristic features. It is clear from the results that the increased surface hardness has resulted in lower mass losses. The highest mass losses are obtained in the untreated specimen. The mass loss for all specimens show a similar variation tendency, in which the erosion rate increases and then decreases with increasing impact angle from 30° to 90° and reaches a maximum around 45°. It shows a typical ductile erosion behavior [17-20]. For ductile materials, impact at low impact angles will increase material removal by microcutting because of the oblique shear force [12,21], thus increasing the mass loss. At high impact angles, the resolved normal stress will produce the accumulated damage mainly from fatigue [22], microforging, and extrusion processes [23]. These processes can only produce slighter erosion damage than that caused by cutting removal at low impact angles. Hence, there appears a maximum mass loss at around 45°. These features will be highlighted in the next section. As shown in Figs. 7 and 8(a, and b), the carburized specimens show less erosion rates. Furthermore, the erosion rate of the carburized specimens decreases with increasing carburizing holding time: i.e., the mass loss decreases with increase of the case depth and surface hardness. This improvement is effective even at high impact angles because increasing surface hardness after carburizing is not accompanied by loss in ductility of the material substrate [24].

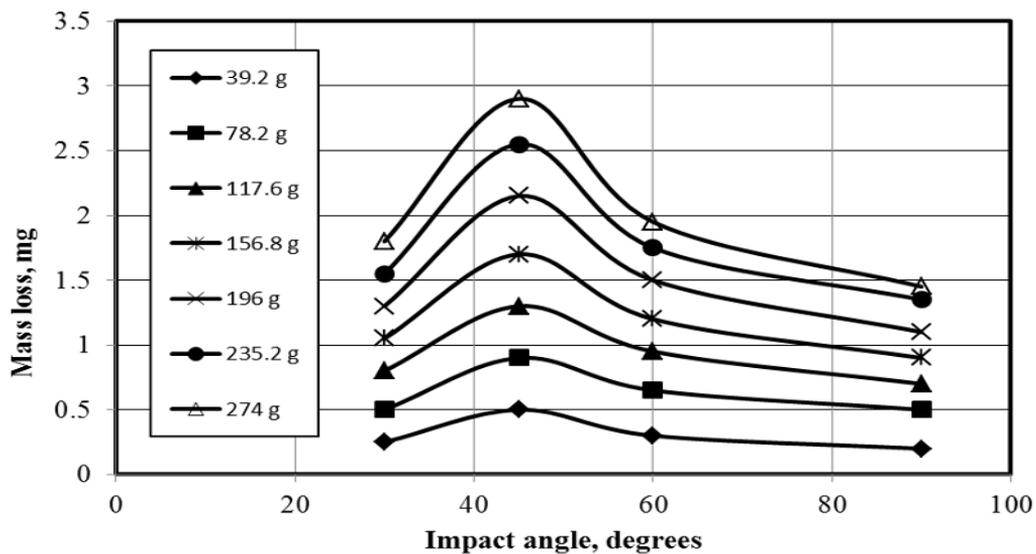
Figure 8a Relationship between the mass loss of carburized specimens at 950°C for 6 h and impact angle for different masses of erodent.

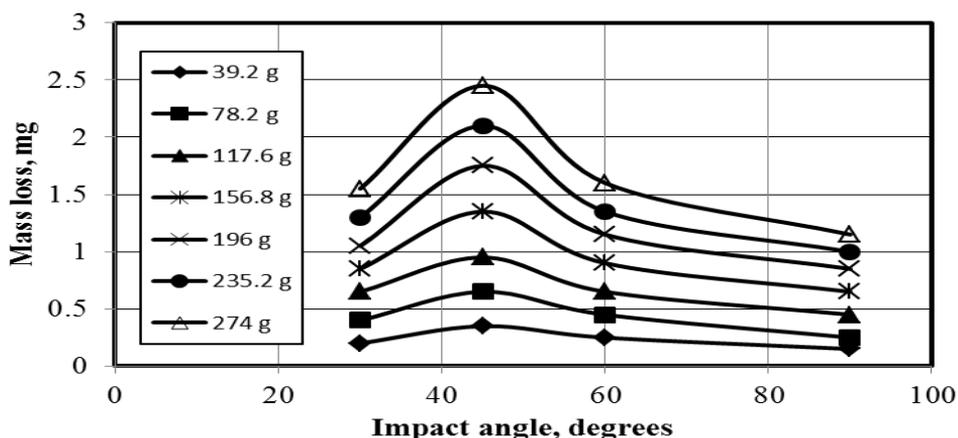
Figure 8b Relationship between the mass loss of carburized specimens at 950°C for 12 h and impact angle for different masses of erodent

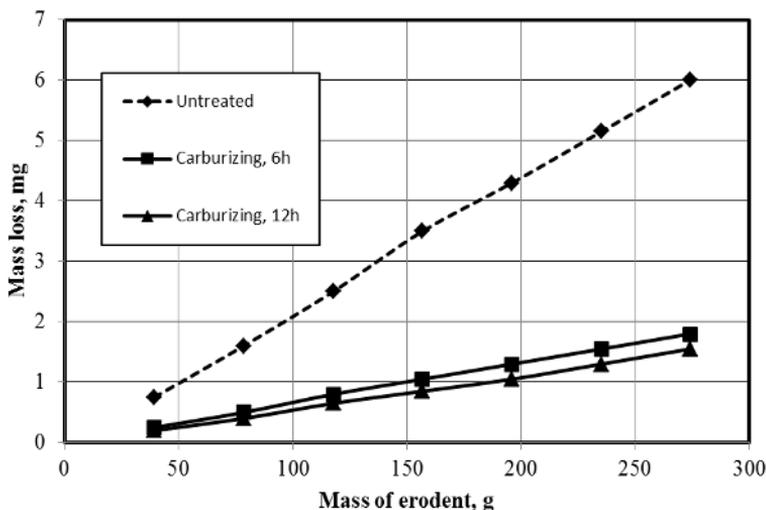
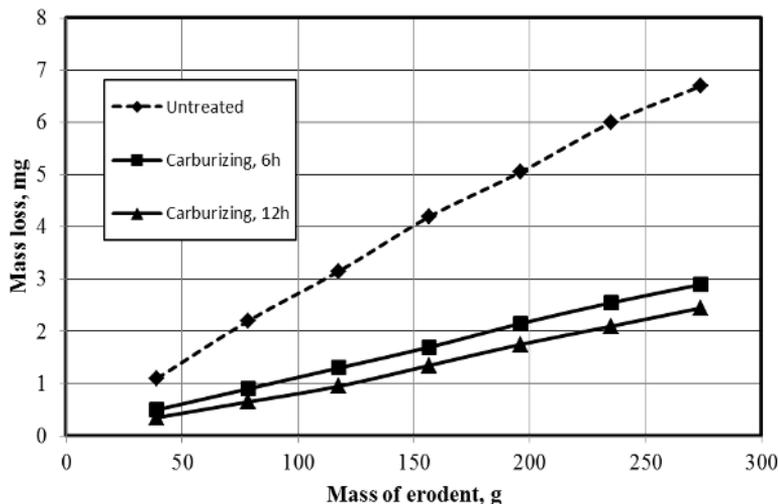
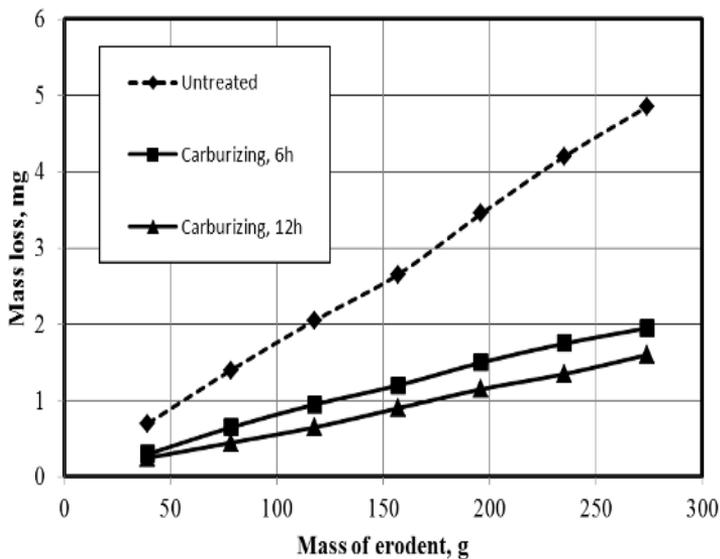
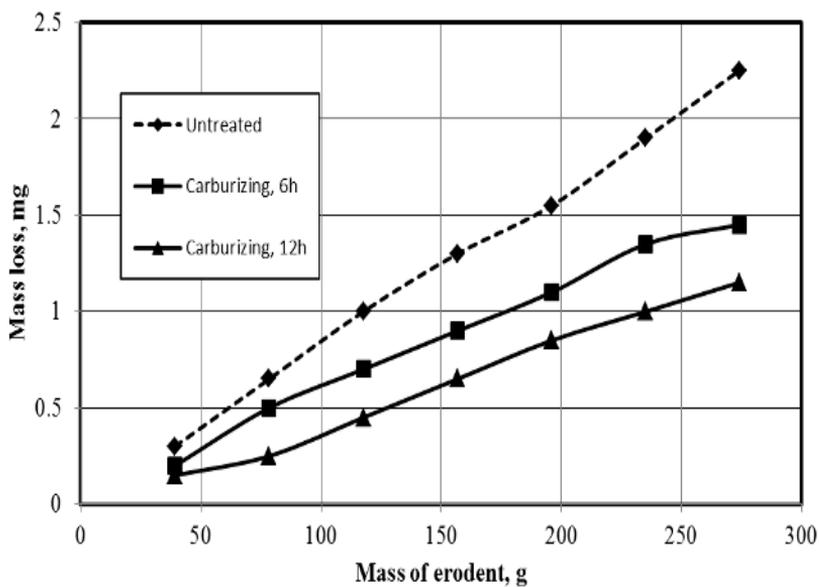
Figure9 Mass loss of treated and untreated specimens versus mass of erodent at different impact angles: (a) 30°, (b) 45°, (c) 60° and (d) 90°.

To throw more light on the effect of carburizing on the enhancement of erosion resistance, the mass losses of treated and untreated specimens versus the mass of erodent at each impact angle are presented in Figure 9(a – d). From these Figures, it is observed that the mass loss as function of mass of erodent for untreated specimen is always more than treated one at all impact angles. This difference in the mass loss between untreated and treated material generally decreases with the increase of the impact angle. For mass of erodent 274 g, the difference in the mass loss between the carburized for 6 h and untreated materials is 4.2, 3.8, 2.9, and 0.8 mg at an impact angle of 30°, 45°, 60° and 90°, respectively. Therefore, the erosion resistance of AISI 5117 steel increases by 70, 57, 60 and 36 % at an impact angle of 30°, 45°, 60°, and 90°, respectively as result of carburizing for 6 h. As result of carburizing for 12 h the erosion resistance of AISI 5117 steel increases by 74, 63, 67, and 49% at an impact angle of 30°, 45°, 60°, and 90°, respectively. Based upon these results, it can be concluded that the carburizing process enhances the erosion resistance of AISI 5117 steel. The enhancement of carburized material is maximum at small impact angles (30°) and decreases almost continuously with the increase of the angle down to a minimum at 90° at the test conditions used in the experiments. The reason behind the high erosion resistance of the carburized specimens compared to the untreated ones can be attributed by the increase in hardness and the change of the microstructure of the former, as will be illustrated in the next section. The higher microhardness can effectively block the interaction and propagation of cracks in the carburizing layer. The fine carbides participated in rows, due to the tempering of carburizing specimens, is tough enough to survive the particle impact; hence, they show minimum slurry erosion compared with the untreated specimens.

It can be observed from Figure 9(a-d) that the mass losses are found to increase linearly with increasing erodent mass for treated and untreated specimens. This illustrates that the erosion mechanism does not change noticeably, implying a steady erosion damage during the impact process, regardless of the variation in the impact angle.

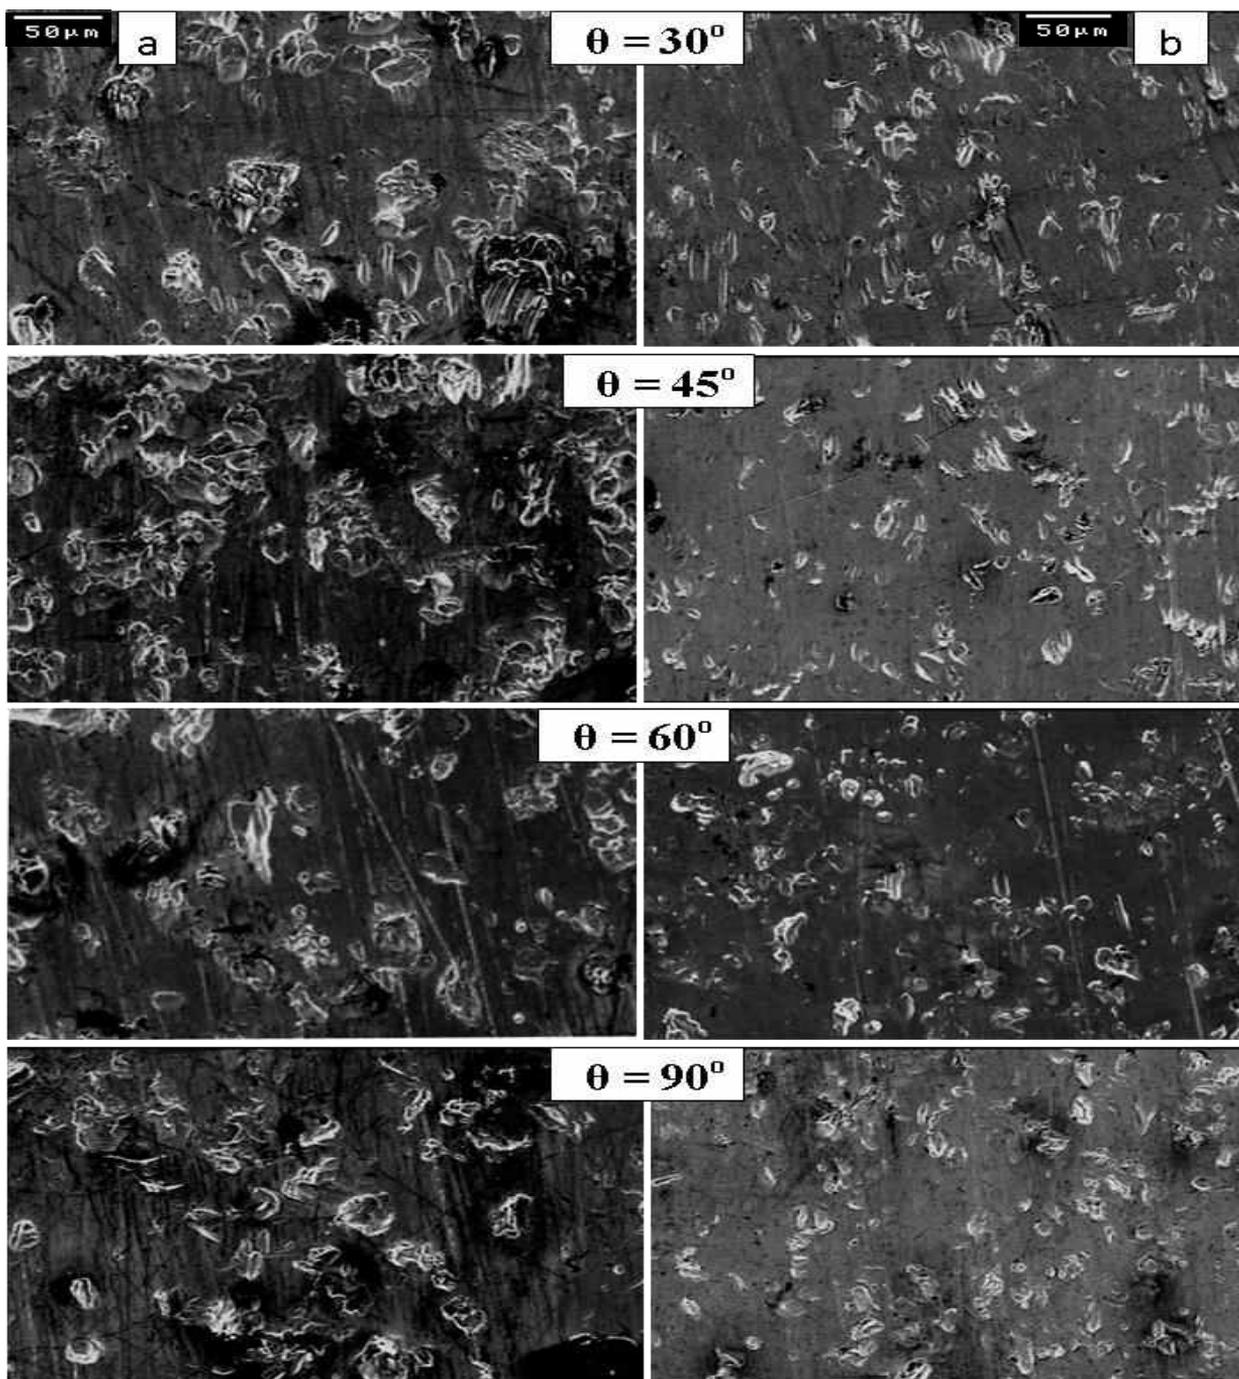
Figure 10 SEM features of eroded surfaces of treated (b) and untreated (a) steel at different impact angles

The morphologies of the eroded surfaces of the untreated and treated specimens at different impact angles and mass of erodent of 3.9 g are shown in Figure10 (a and b) Due to the low hardness, the surface of the untreated specimens are severely deformed during the erosion test for all impact angles, but in the same time the degree of erosion differs with impact angle as shown in Figure10(a). It can be seen from Figure 10 (a and b) that the erosion tracks developed on the untreated specimens are the wider and deeper than that formed on the carburized specimens. Furthermore, the erosion tracks of the carburized specimens are shallower and more superficial Figure10(b). The wear test results, shown from this figure and that presented in Figs. 7-9, revealed that on carburization, wear resistance of carbon steel improved greatly over that in the untreated state. These changes in wear properties of steel are being primarily controlled by alteration in its carbon content, hardness and microstructure [25]. For treated and untreated specimens, the erosion tracks are formed by ploughing and microcutting for acute angles and by material extrusion for normal impact angle.

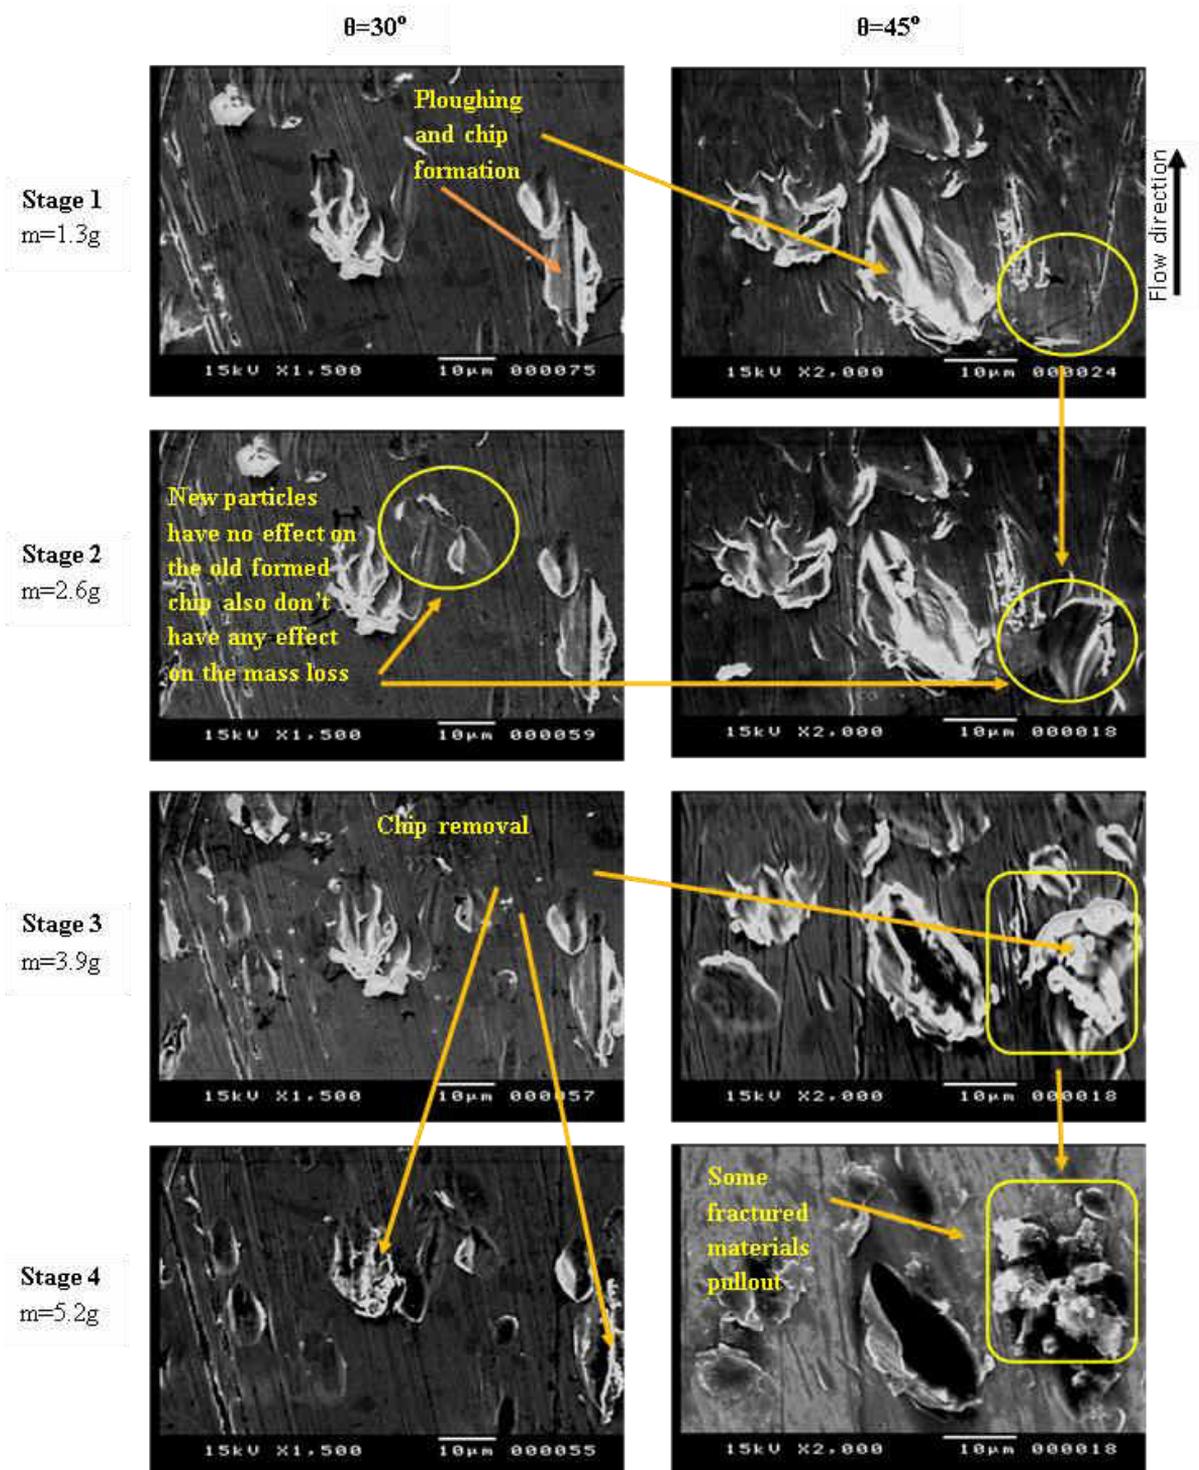
Figure 11 SEM microphotographs of carburized steel AISI 5117 impacted at low

impact angles, $\theta=30^\circ$ and 45° .

To give practical and visible evidence of how the damage to be developed with subsequent impacts, systematic microphotographs for four successive stages were taken. The amount of erodent which impacts the specimen was 1.3 g for each stage at impact angles of 30°, 45°, 60° and 90°. The results are presented in Figs. 11 and 12. The white areas in these microphotographs represent the impact sites. The inclined vertical lines shown in these photos are the traces of polishing lines. These photos illustrate that the shape of impact sites depend upon the angle of impact. This accentuates the previous findings about the change of erosion mechanism with impact angle. Some of the impact sites are formed with directionality. This directionality is in the direction of slurry stream at small impact angles $\theta = 30^\circ$ and 45° ; but for angles larger than 45° this directionality shows some deviation from the slurry stream direction. This can be referred to impacting particle dynamics [12, 13]. At any given stage and angle in Figure 11, it is easy to see that the impact sites have different sizes. Some of these sites appear to be shallow and the others are relatively deep. This can be explained in the light of the effect of particle size range, particle trajectory and material structure. The particles have the size range of 250-355 μm , so the kinetic energy will be differed by about 27% from small to large size range. The particle-wall collisions, which influence particle motion [26] will lead to the change in the actual impact angle and impact velocity from the nominal values. The examination of slurry erosion behavior of subsequent stages shown in Figs. 11 and 12 reveals that the particle impact processes include the following events; forming new impact sites, impacting former sites and impacting the surface but without noticeable effect. The new impact sites that are formed in the subsequent stages, after stage no. 1, are encircled as shown in Figs. 11 and 12. The number of impact sites versus the mass of erodent is not carried for carburized material, but it is measured for untreated material [27]. It was found that the number of impact sites is more in low impact angle compared with high impact angle. This may be explained in the light of particle rebound effect. The coefficient of restitution decreases with the increase of impact angle [26]. When new particles impact former impact sites, the chips and the extruded materials formed at low and high impact angle, respectively, in the impact sites will be detached. Under subsequent impacts for these sites, it was observed that in some of the impact sites craters were formed and the others disappeared. For particles that have a small kinetic energy and are not able to create visual effects on the surface, this does not mean that these particles have no role in the process of erosion, but they lead to the surface hardening.

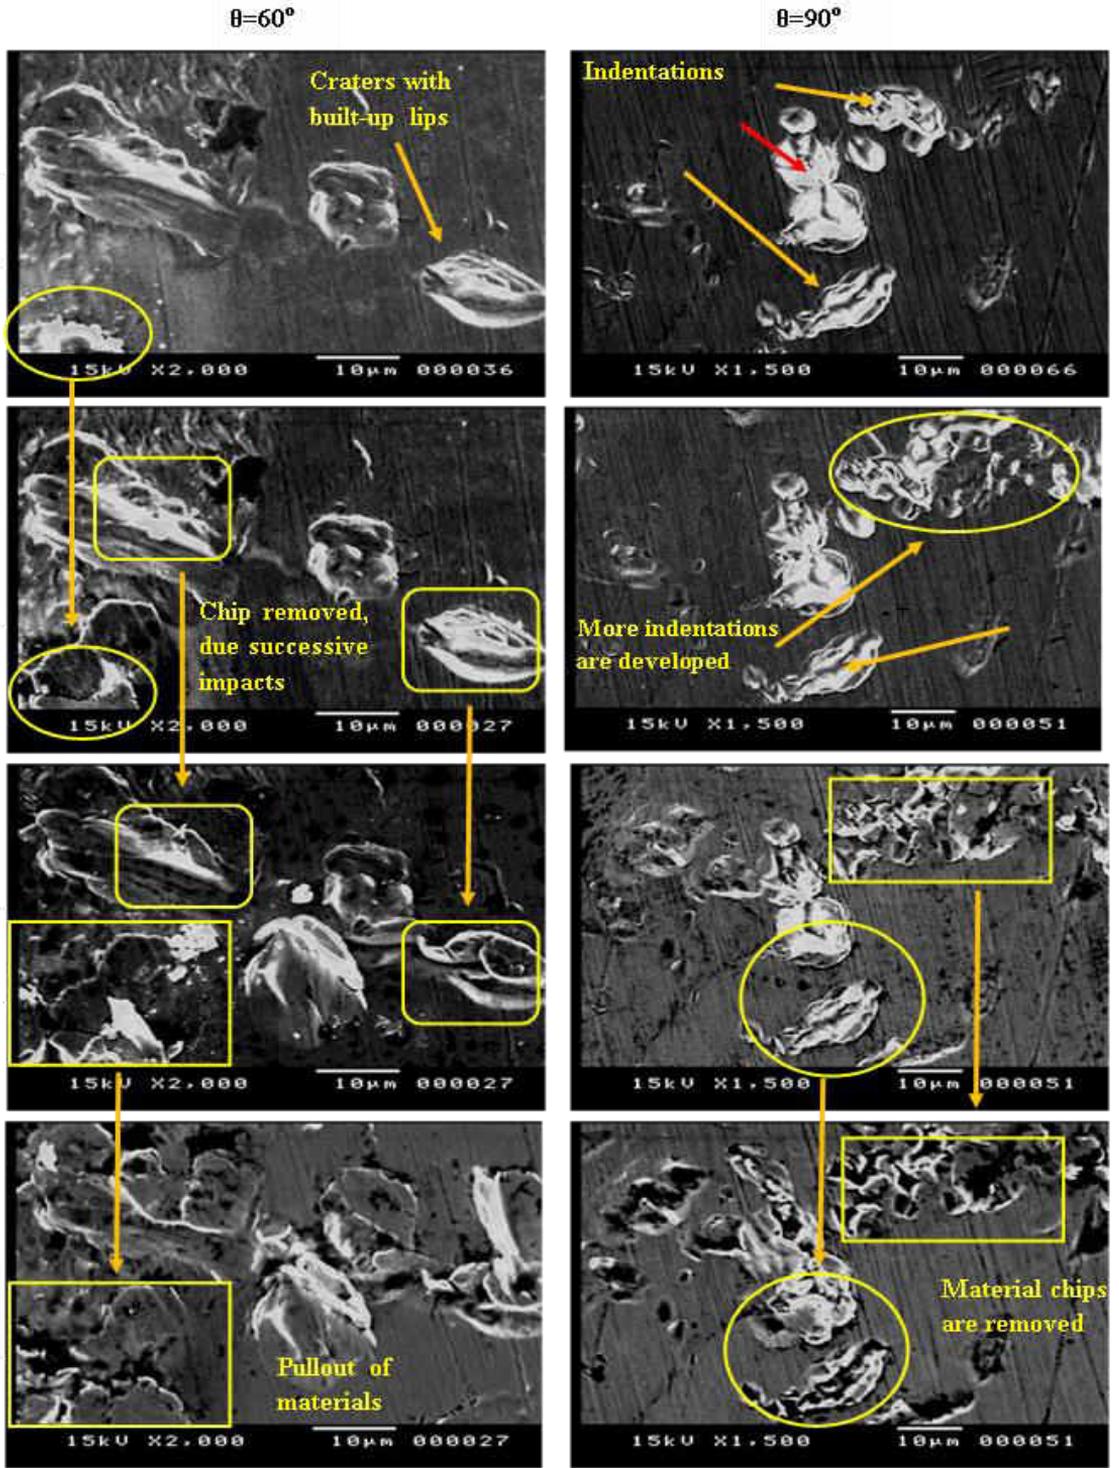
Figure 12 SEM microphotographs of carburized steel AISI 5117 impacted at high impact angles, $\theta=60^\circ$ and 90°
